REPORT ON THE ANALYSES OF RECOVERED 1201-3 FILM SAMPLES

(KODAK High Definition Aerial Film 1414 (ESTAR Ultra-Thin Base).

1201-3

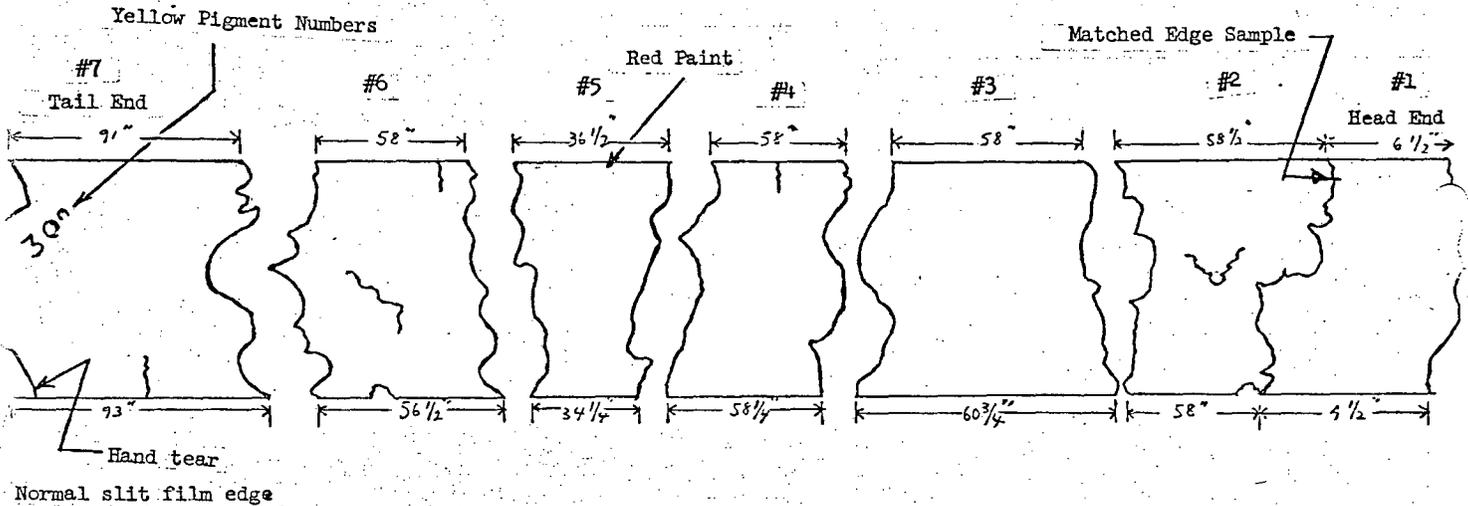
Attempts were made to reassemble the pieces as a continuous length of 6.6 wide film. Only two pieces had one common irregular shaped matching edge. See Figure No.1 (Parts 1 and 2). This match-up was made after the pieces were dried

1. Shock forces were severe enough for the film assemblies to hit or be hit by nearby mechanical assemblies. The force was sufficient to cause paint transfer in two places. Referring to Part #5 of the sketch red paint pigment was imbedded into the pelloid film base. On Part #7 the number "300" is partially legible. (See 20X enlargement). The material imbedded is brown-yellow paint pigment on the base side of the film. The pigment location of "300" and a length of 93 inches indicates this strip was probably an outer convolute.

One and two were only sections that edges matched. Film was badly wrinkled and some emulsion was visible. When roll was assembled, all sections overlapped and taped with exception of one and two. Sections totaled 30 feet, 7 inches.

- Section #1 One tear 1 1/2 inches from edge
- Section #2 Small piece missing near splice  
Tear with hole in center of section
- Section #3 No tears, badly wrinkled
- Section #4 One tear 1 inch from edge
- Section #5 Several marks resembling red paint along edge
- Section #6 Tear in center area approx. 6" long.  
Piece missing along edge 1/4 x 1/4  
1 tear near splice from edge 1 inch
- Section #7 1 tear from edge 2 inches  
A number resembling 300 (yellowish pigment) noted 1 inch from end and 1 3/4 inches from edge of section #7. Each number was .120 x .085 inches.

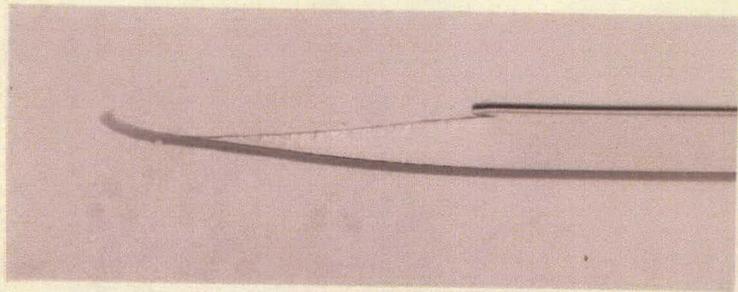
1414 Raw Stock

Figure 3 depicts four typical edges. The first edge is produced by very rapid snapping of the film (a "fracture"). The "wedge" profile is typical of this type film break and is caused by tensile shearing. The second edge profile illustrates the fracture and separation occurring on the recovered film. Three physical samples all showed this characteristic cross-section. Third edge was produced by nicking a salvaged film sample with scissors and applying tearing forces by hand. This edge shows relaxation of the film base and recovery shrinkage resulting in a slightly thicker but short edge profile. The fourth picture is the edge profile typical of film slitting.

Cross-section (200X)  
Produced by "whip  
snap" shattering.

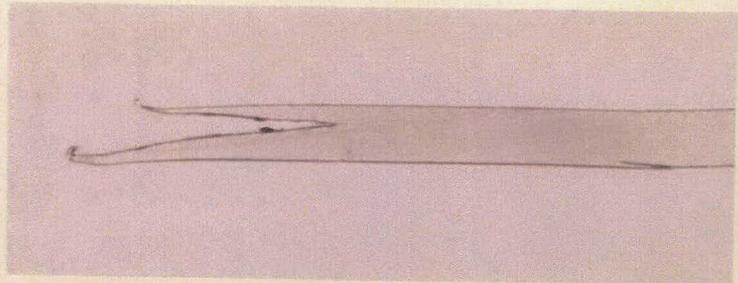
Recovered 1414

By comparing the edge profiles, the "recovered film" most closely matches that caused by sudden tensile shear failure.

Cross-section (200X)  
Film edge caused in  
overall recovery  
operation.

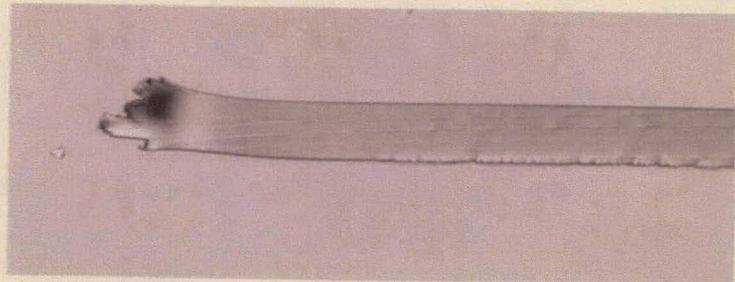
Recovered 1414

Cross-section (200X)  
Film edge caused by  
hand tearing.

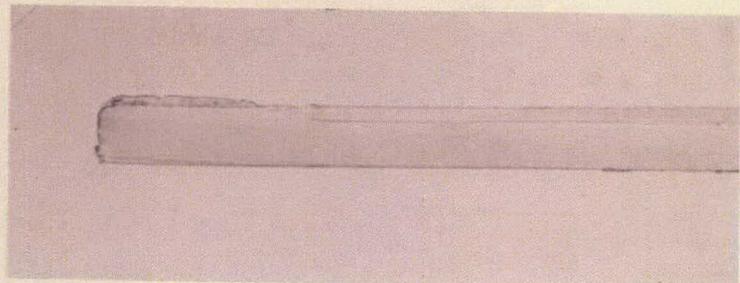
Recovered 1414

Cross-section (200X)  
Film edge normal to  
manufacturing.

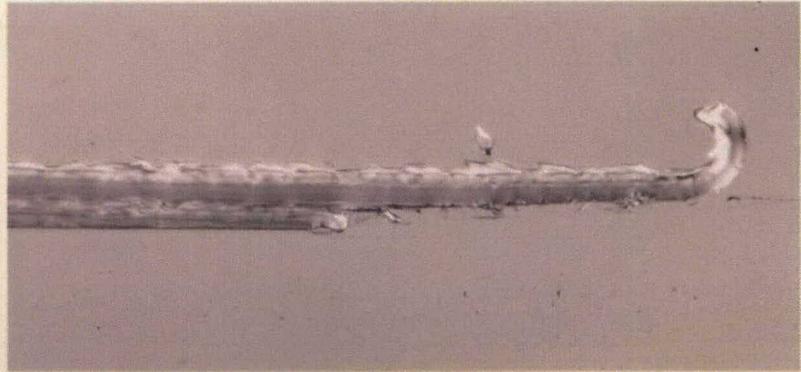
RECOVERED 1414

Figure 4 shows opposite edge profiles of a film sample removed at the interface of Parts 1 and 2. The edges were within 1/32 inch of being matched across the full width of the film. Thus an exact fit of the two profiles was not attained due to this displacement but the film profiles are typical of tensile shear failure. The lower photograph is a 40X of the "matched" edges.

Cross-section (200X)  
Part 2 edge between  
Parts 1 and 2

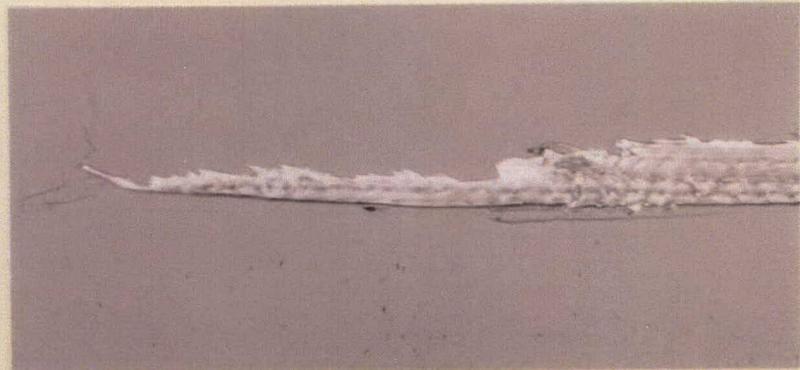
RECOVERED 1414

Cross-section (200X)  
Part 1 edge between  
Parts 1 and 2
