# ACCIDENT FOLDER

<b>USAF ACCIDENT/INCIDENT REPORT</b>							
(Fill in all spaces applicable. If additional space is needed, use additional sheet(s).)							
1. DATE OF OCCURRENCE (Year, month and day)  9 July 1964		2. VEHICLE(S)/MATERIEL INVOLVED (TMS & Serial Nr., if applicable)  A-12			3. FOR GROUND ACCIDENTS ONLY (Base Code and Report Serial Nr.)  N/A

Investigation of major accident involving A-12 aircraft S/N 133 which occurred at Det 1, 1129th USAF SAS, Las Vegas, Nevada on 9 July 1964.

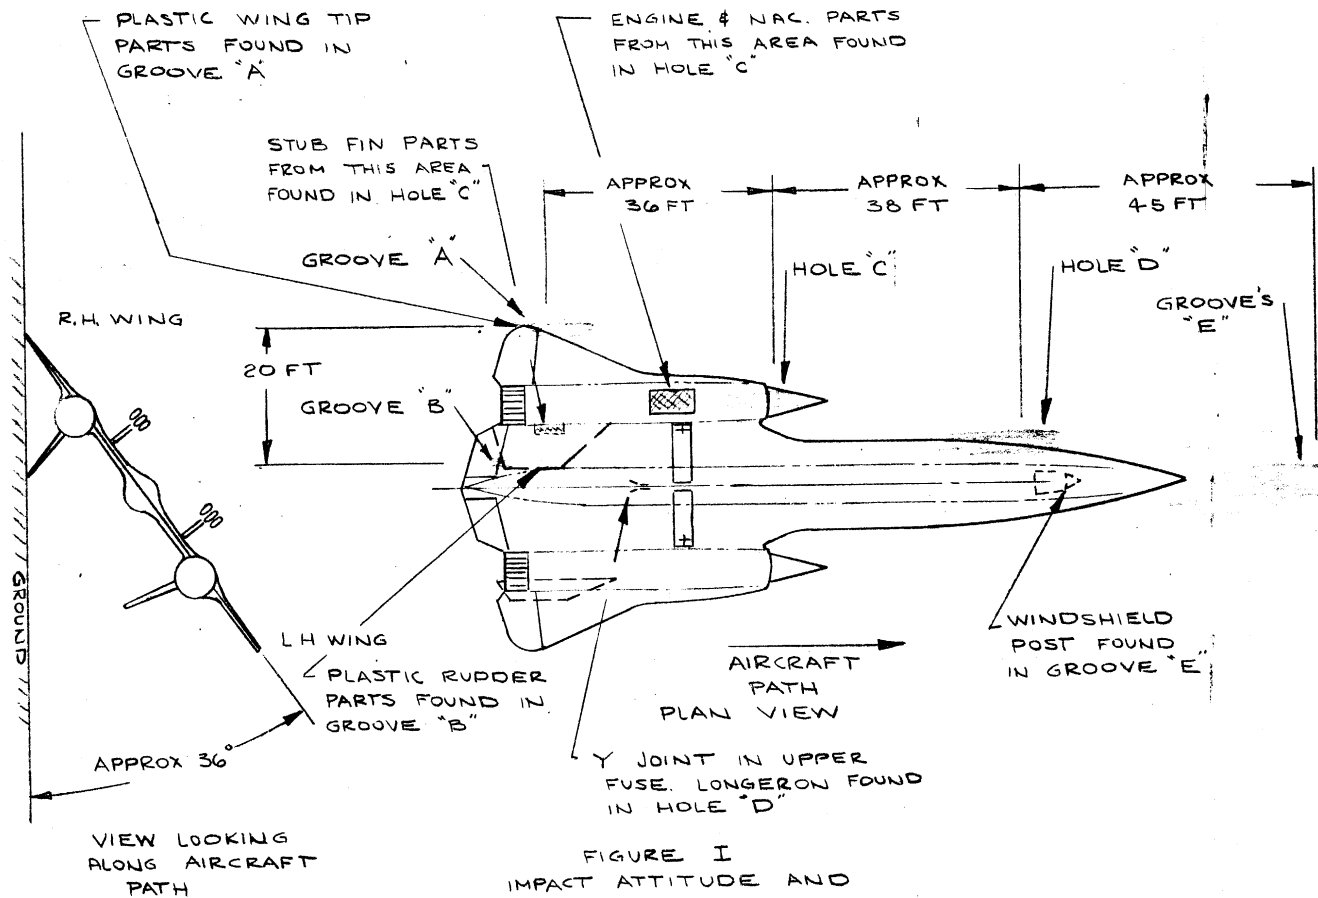
FIGURE I  
IMPACT ATTITUDE AND  
RELATIONSHIP OF AIRCRAFT PARTS  
TO INITIAL IMPACT MARKS

(b) The flight recorder was destroyed on impact and no evidence could be obtained from it. Evidence obtained from the wreckage indicates the following conditions existed on impact:

(c) Reviewing the events, evidence and pilots comments presented above it can be concluded that the right outboard elevon valve jammed in a partially open condition. It is apparent that the valve did not jam full open. Had this occurred the elevon would have been moving at 30 degrees per second and the pilot would have lost roll control in .29 seconds and had a full down right elevon condition in .85 seconds. This was not the case, however, for the pilot stated he applied corrective action slowly. In addition, the pitch transient would have been quite severe. The lack of comment on a severe pitch transient and the slow input of corrective aileron establishes the fact that initially the control surface was drifting to the full down position slow enough to be well within the pilots capability to apply corrective action. The action of the pilot then to correct for a right roll-off or possibly a small pitch or roll damper input would be sufficient to crack the valve to an open position where it could jam. This would result in driving the right outboard elevon to the full down position in which it was found. When the pilot ejected, the stick returned to neutral position. Thus the aircraft went out of control in both roll and pitch. The roll rate should increase to approximately 41 degrees per second and a large nose down pitching movement would be applied. This nose down movement applied to the inverted aircraft would explain why the aircraft impacted in an almost flat to slightly nose high attitude.

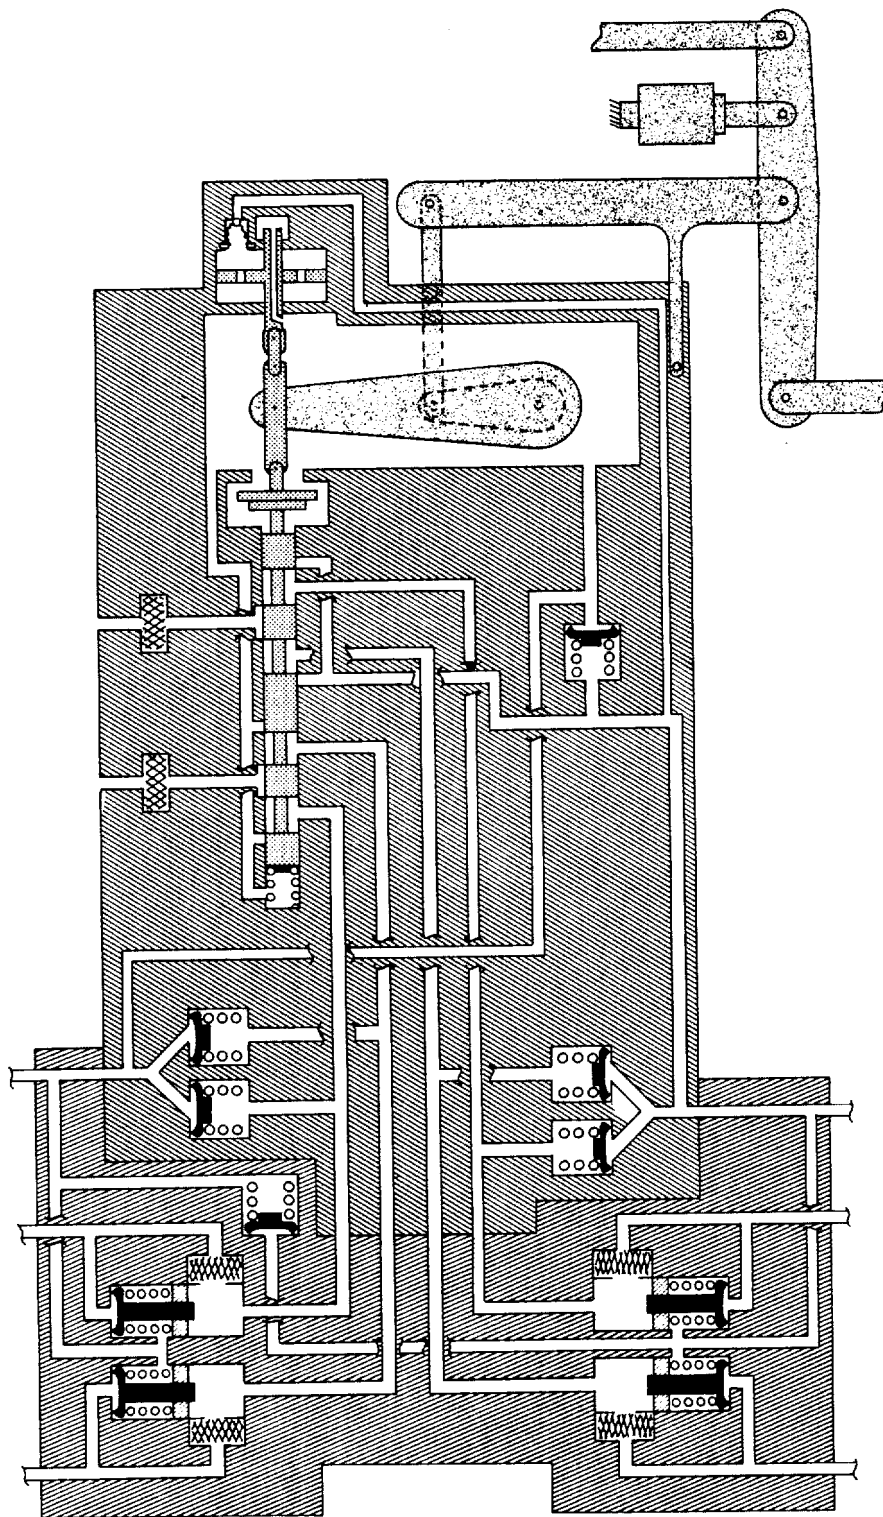
MAPLE-2-C-3  
SERVO - OUTBOARD ELEVON FIGURE 4

(1) Investigation revealed that the position of the right outboard elevon was full down on impact. Further investigation was then centered on determining how this condition could have occurred. The right outboard elevon servo valve was subjected to exhaustive tests at Lockheed-Burbank and it was determined that binding had definitely occurred. This particular valve apparently incurred warpage in operational use as evidenced by burnishing on the valve wall. The described warpage caused the valve to bind but not to a degree that would prevent the elevon mechanical transmission system from overcoming it. However, oil samples revealed contamination within the servo valves, probably the result of metal chips accumulated during manufacture. This contamination would add to the drag caused by warpage. Additionally it was concluded that because of a rapid change in flight conditions, the valve was subjected to a temperature shock condition that further aggravated the the warpage. From the foregoing it was concluded that the metering spool in the right outboard elevon servo did bind to such a degree that it could

1. The primary cause of this accident was that the outboard elevon servo valve stuck in the partially open position causing the right outboard elevon to gradually move to the full down position. This imparted more left roll to the aircraft than could be overcome by the pilot. The sticking of this valve resulted from the combination of three conditions; warpage of the valve incurred in operational use, a temperature shock condition due to a rapid change in flight conditions and metal particles within the servo valve probably accumulated during manufacture.
