Date 24 May 1957

Subject: Engineering Report - Installation Shelter

- 1.1 This report covers the requirements for and the field evaluation of the Photo Systems Installation Shelter, Part No. 735915, as delivered and tested under Contract 44, Schedule I, Item No. 8. Also included is the report of damage incurred by the shelter due to high velocity winds at the project test site.

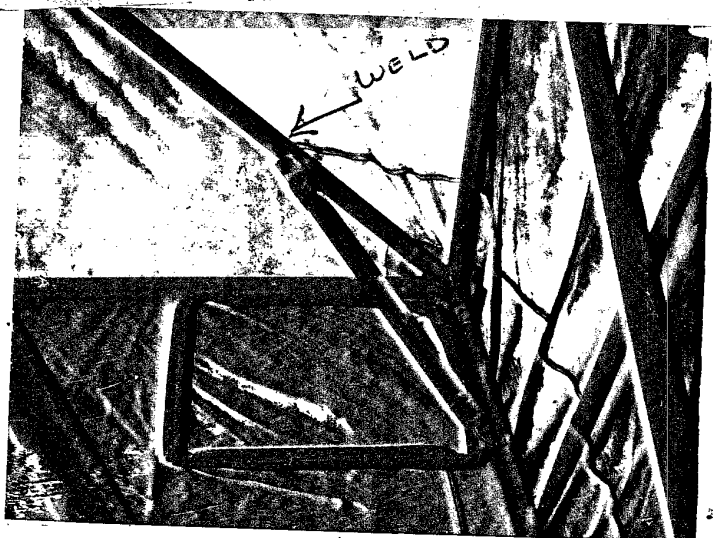
18

9. One of the welds on the framework gave way during assembly. This point was temporarily wired securely in place. (Ref. Encl. "B" Photo No. 18)
10. The plywood floor provided was too thin and had a tendency to warp when the weight of a configuration was on it. The small casters on the carriage would catch when moved across the floor. There was insufficient plywood to give complete coverage of the entire floor area.
