PHOTOGRAPHIC INTERPRETATION MEMORANDUM

REPAIR ACTIVITY  
HAIPHONG PORT,  
NORTH VIETNAM

NPIC/R-101/68  
SEPTEMBER 1968

REPAIR ACTIVITY, HAIPHONG PORT, NORTH VIETNAM

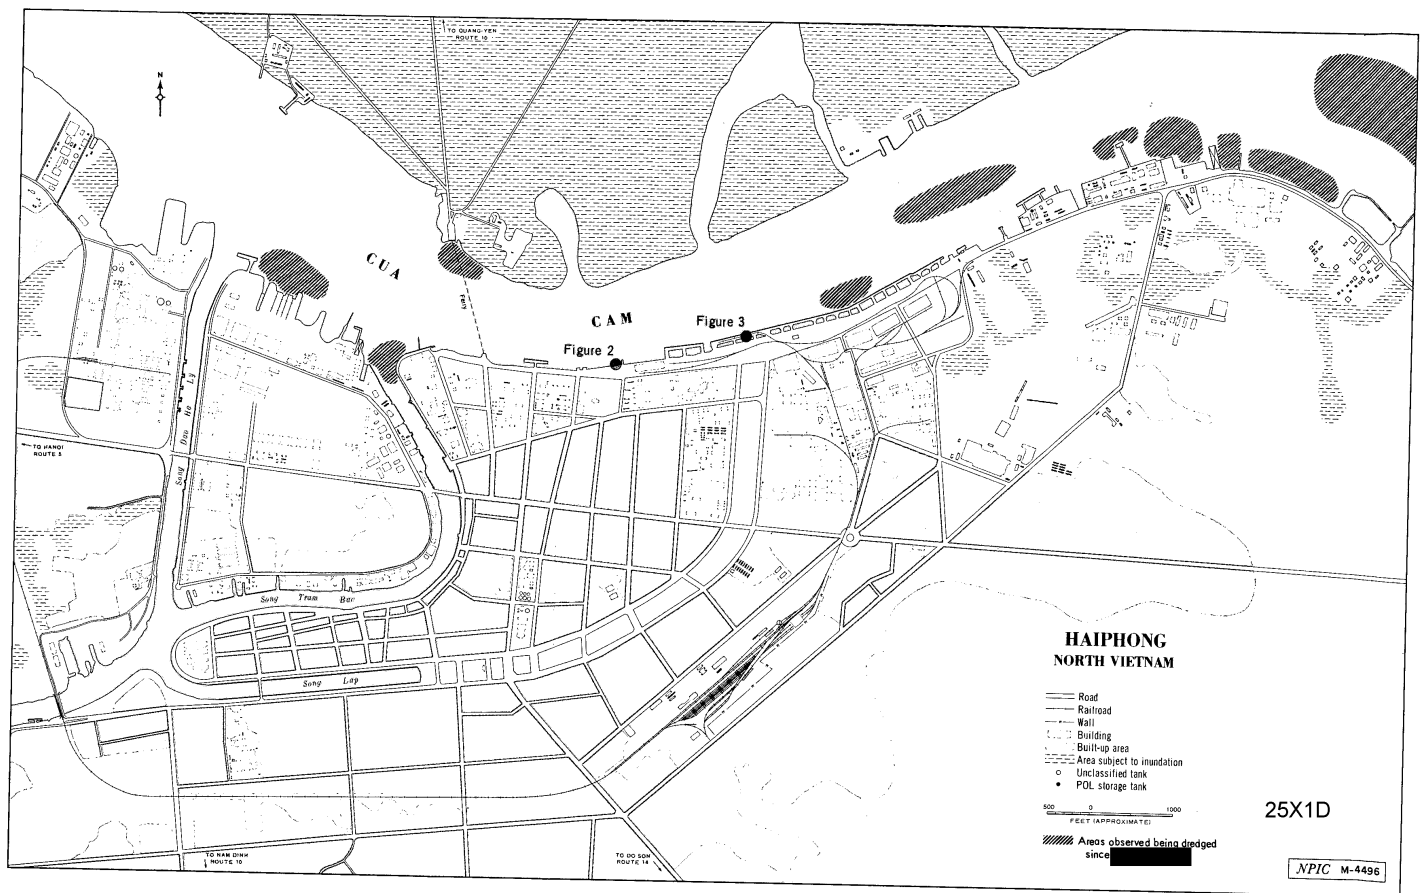
FIGURE 1. DREDGING ACTIVITY, HAIPHONG PORT, NORTH VIETNAM.

Important maintenance activity currently taking place in the port area is the dredging of the Cua Cam (Figure 1) and the Maritime Channel, which provides access to the Gulf of Tonkin. The large suction dredge, the "1954" and "1957" bucket dredges, and numerous small suction dredges have been observed operating extensively throughout the area since 31 March 1968.

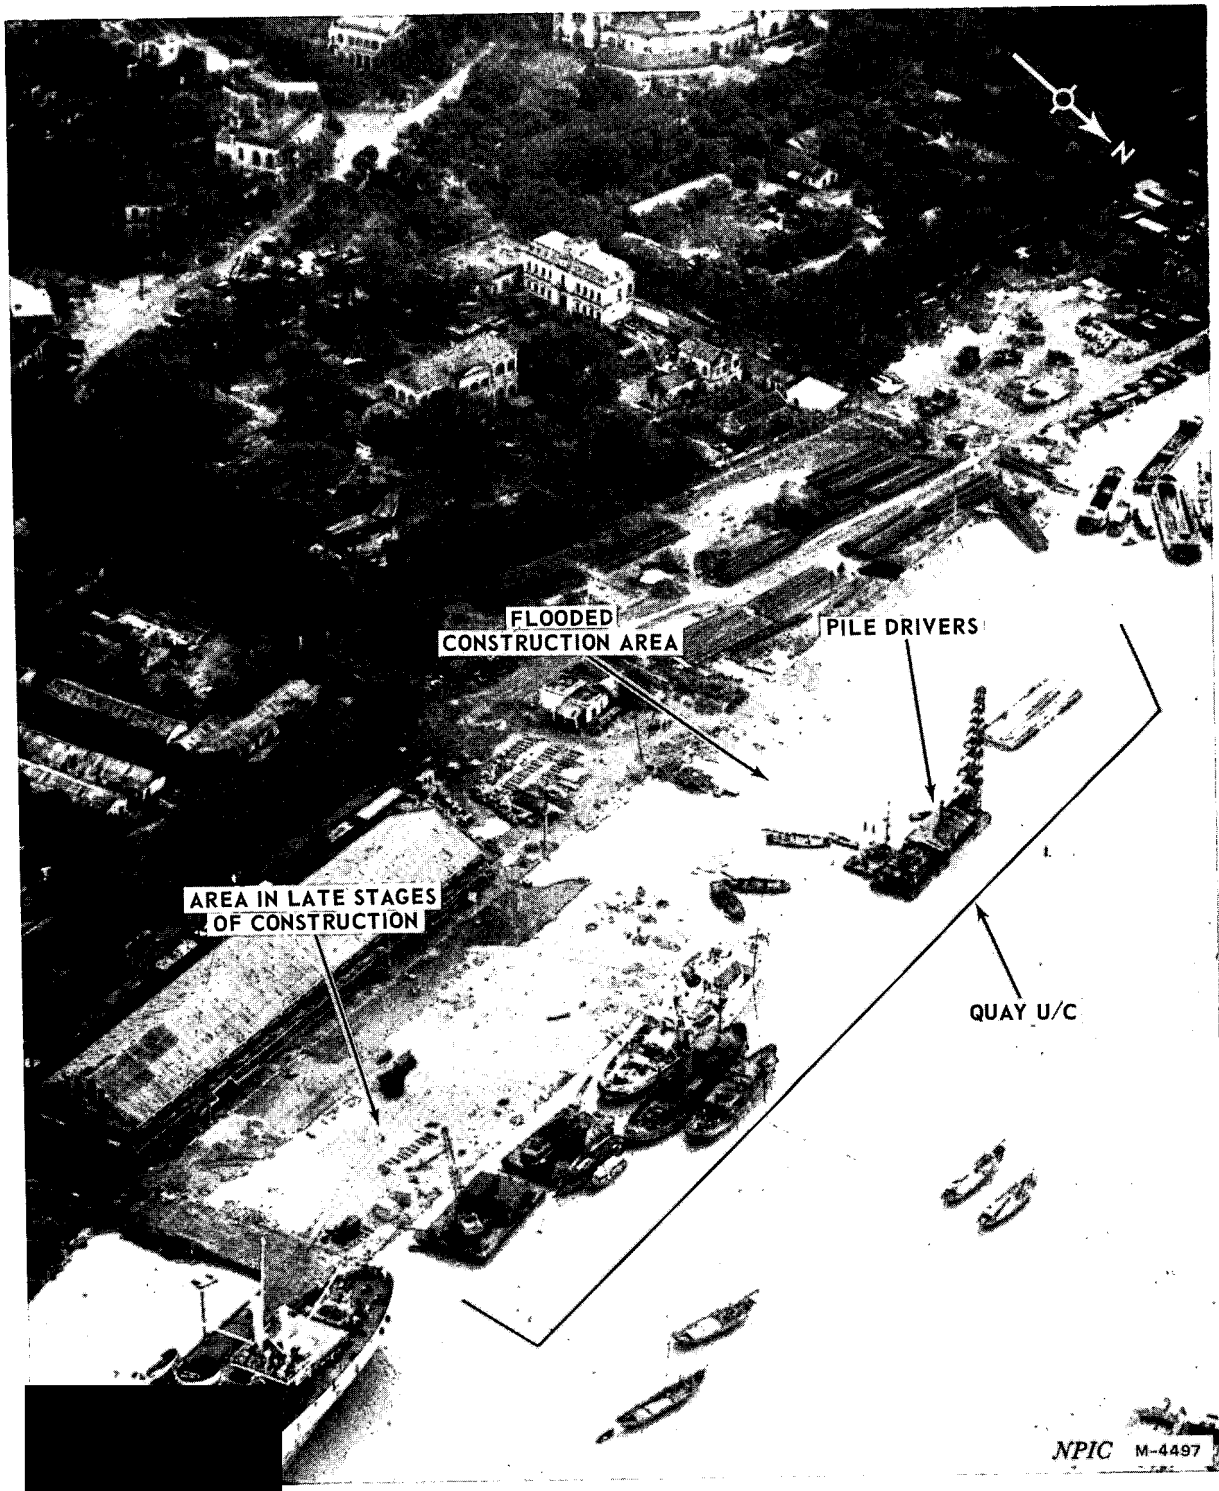
The most significant construction activity in the port is the new quay extension to the Chamber of Commerce Wharf (Figure 2). When complete, this quay will be able to accommodate at least two merchant ships, bringing the total berthing space available at the port to approximately 13 ships. Numerous vessels have been observed off-loading their deck cargo directly onto lighters in the channel, because all available berthing spaces were in use.

FIGURE 2. NEW QUAY CONSTRUCTION, CHAMBER OF COMMERCE WHARF, HAIPHONG.

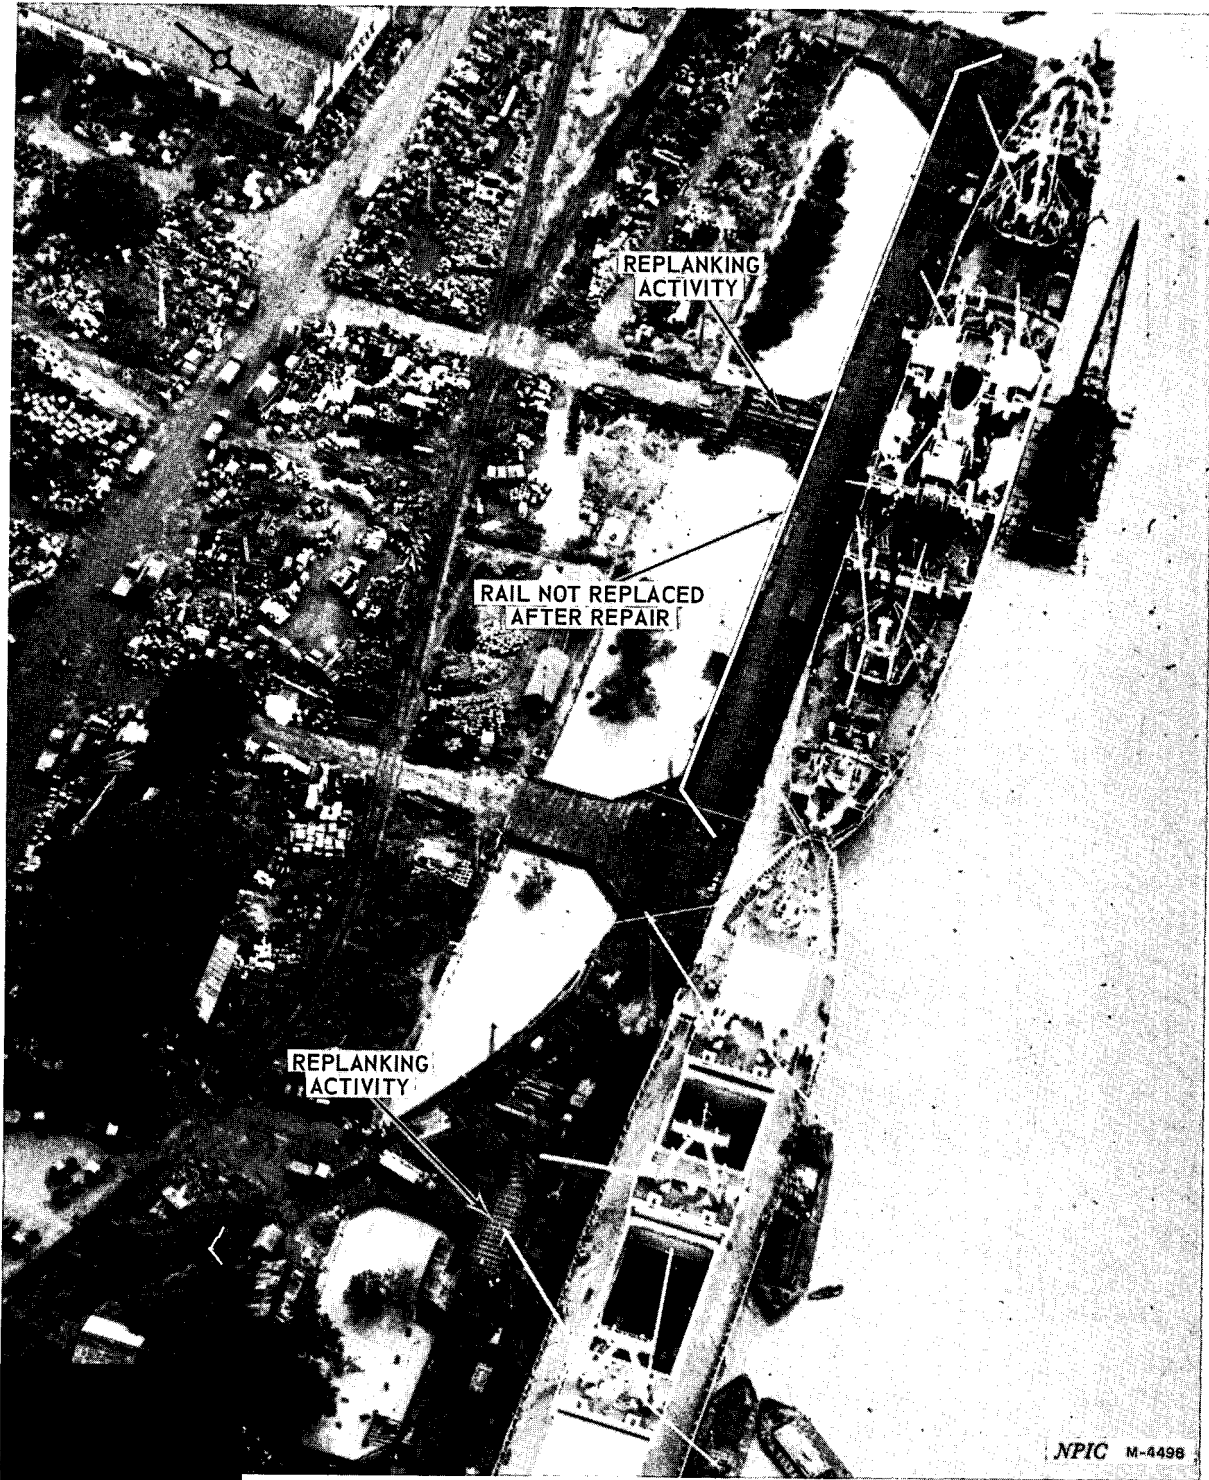
Extensive repair work and replacing of planking has been observed at several locations on the Chamber of Commerce Wharf (Figure 3). This repair activity apparently has not presented significant obstruction to the off-loading of ships in port, since the turn-around time has decreased in recent months. A rail spur has been removed from the Chamber of Commerce Wharf and there are no indications that it will be replaced at the present time. There are still several areas of deteriorated planking along the port which are in need of repair.

FIGURE 3. REPAIR ACTIVITY, CHAMBER OF COMMERCE WHARF, HAIPHONG.
