**PHOTOGRAPHIC
INTERPRETATION
REPORT**

**NATIONAL PHOTOGRAPHIC
INTERPRETATION CENTER**

DAMAGE OBSERVATIONS - EAST PAKISTAN

**MAY 1972
COPY NO 122
21 PAGES
PIR-014/72**

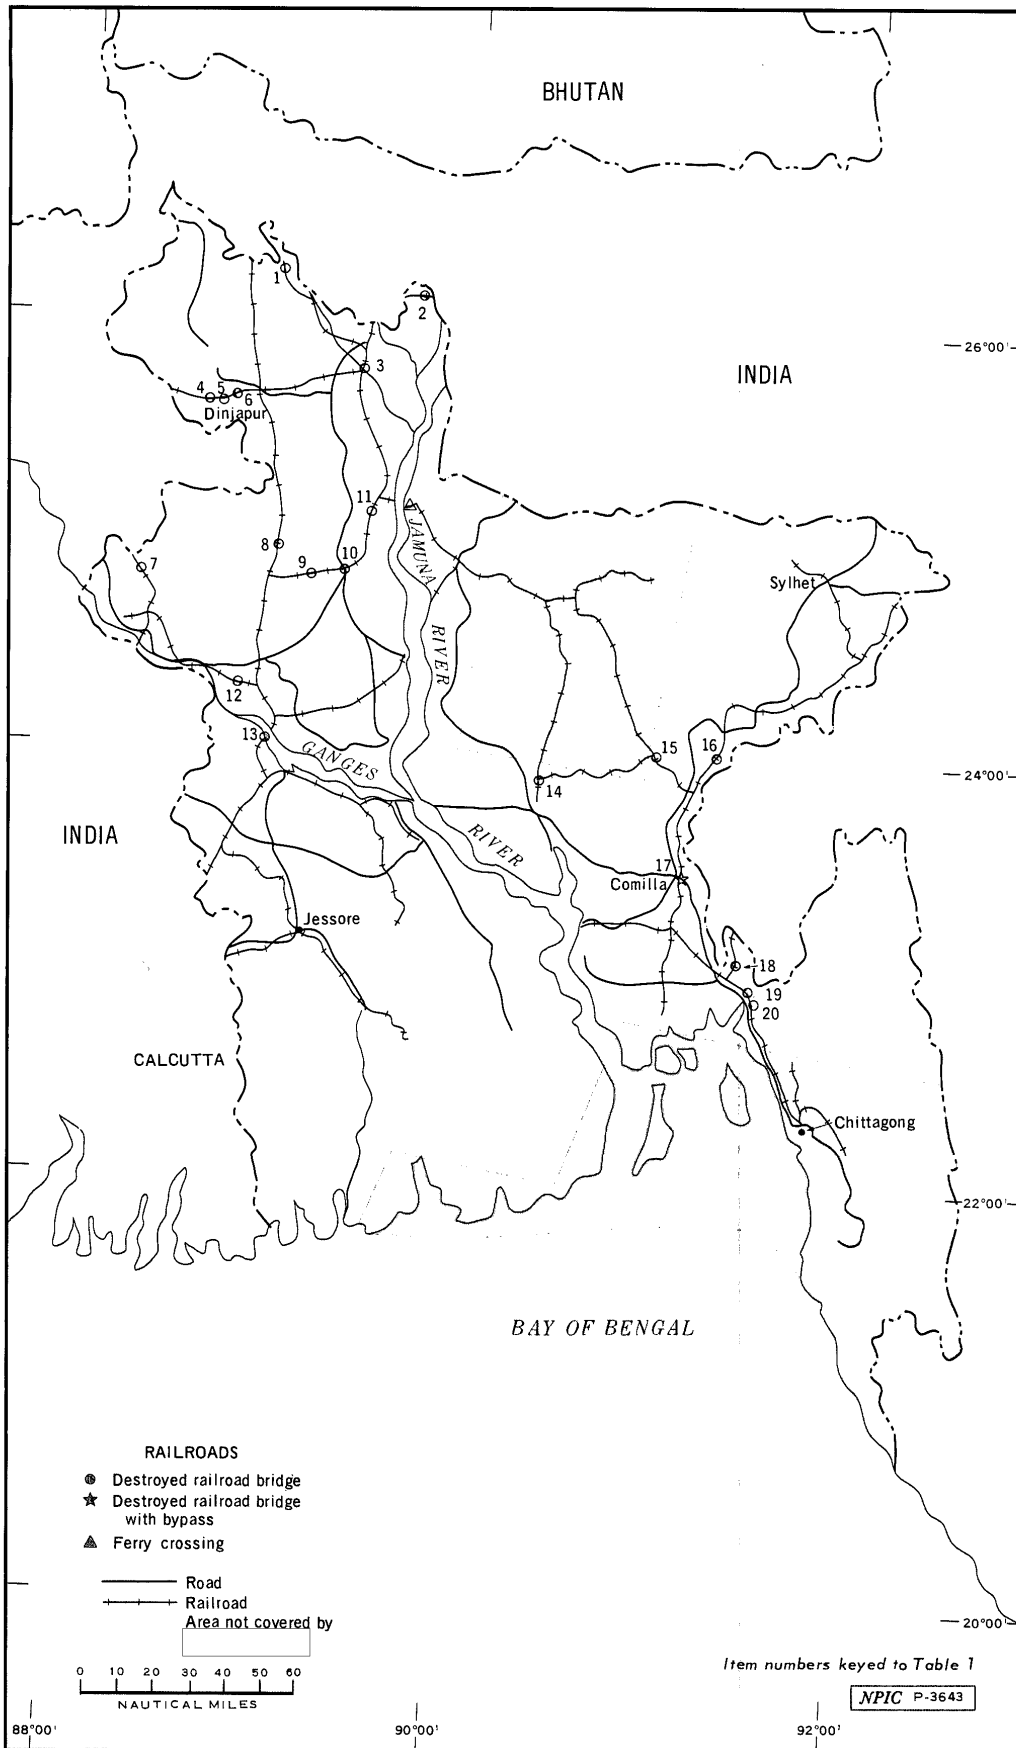
FIGURE 1. RAILROAD DAMAGE, EAST PAKISTAN

10. Twenty major railroad bridges in the East Pakistan rail network (Pakistan Eastern Railway) were damaged, resulting in the virtual elimination of all through rail traffic within the country (Figure 1 and Table 1).

11. Five of the damaged bridges are on the vital Chittagong-Dacca rail line, the major trunk of the meter-gage system serving the eastern half of the country. The disability of this rail line prohibits rail distribution of goods from the country's only major seaport at Chittagong to Dacca or other supply points on the eastern rail system. One bridge, the Comilla Railroad Bridge over the Gumti River has been bypassed by a temporary rail bridge. Indications of reconstruction were also evident at two other damaged bridges near Feni: the Fozilpur Railroad Bridge over the Muhari River (Figure 2) and the Zararganj Railroad Bridge over the Fenny River. Three of the thirteen spans of the vital Bhairab Bizar Railroad Bridge over the Megna River (Figure 3) were destroyed and no reconstruction efforts were apparent. In addition to the five damaged bridges, two bridges on branch lines of the Chittagong-Dacca line were damaged.

12. In the western part of the country, west of the Ganges and Jamuna Rivers, the rail system consists of a main north/south broad-gage trunk line with broad- and meter-gage branches. Thirteen rail bridges on the western system were destroyed. Only two of these, the Shra Railroad Bridge over the Ganges River and the Akkelpur Railroad Bridge over the Vanuan River Tributary, are on the main trunk line. The other eleven damaged bridges are on branch lines. Repair of the two bridges on the trunk line could provide rail service to much of the western half of the country. The eastern and western rail system of East Pakistan are connected by a ferry over the Jamuna River.

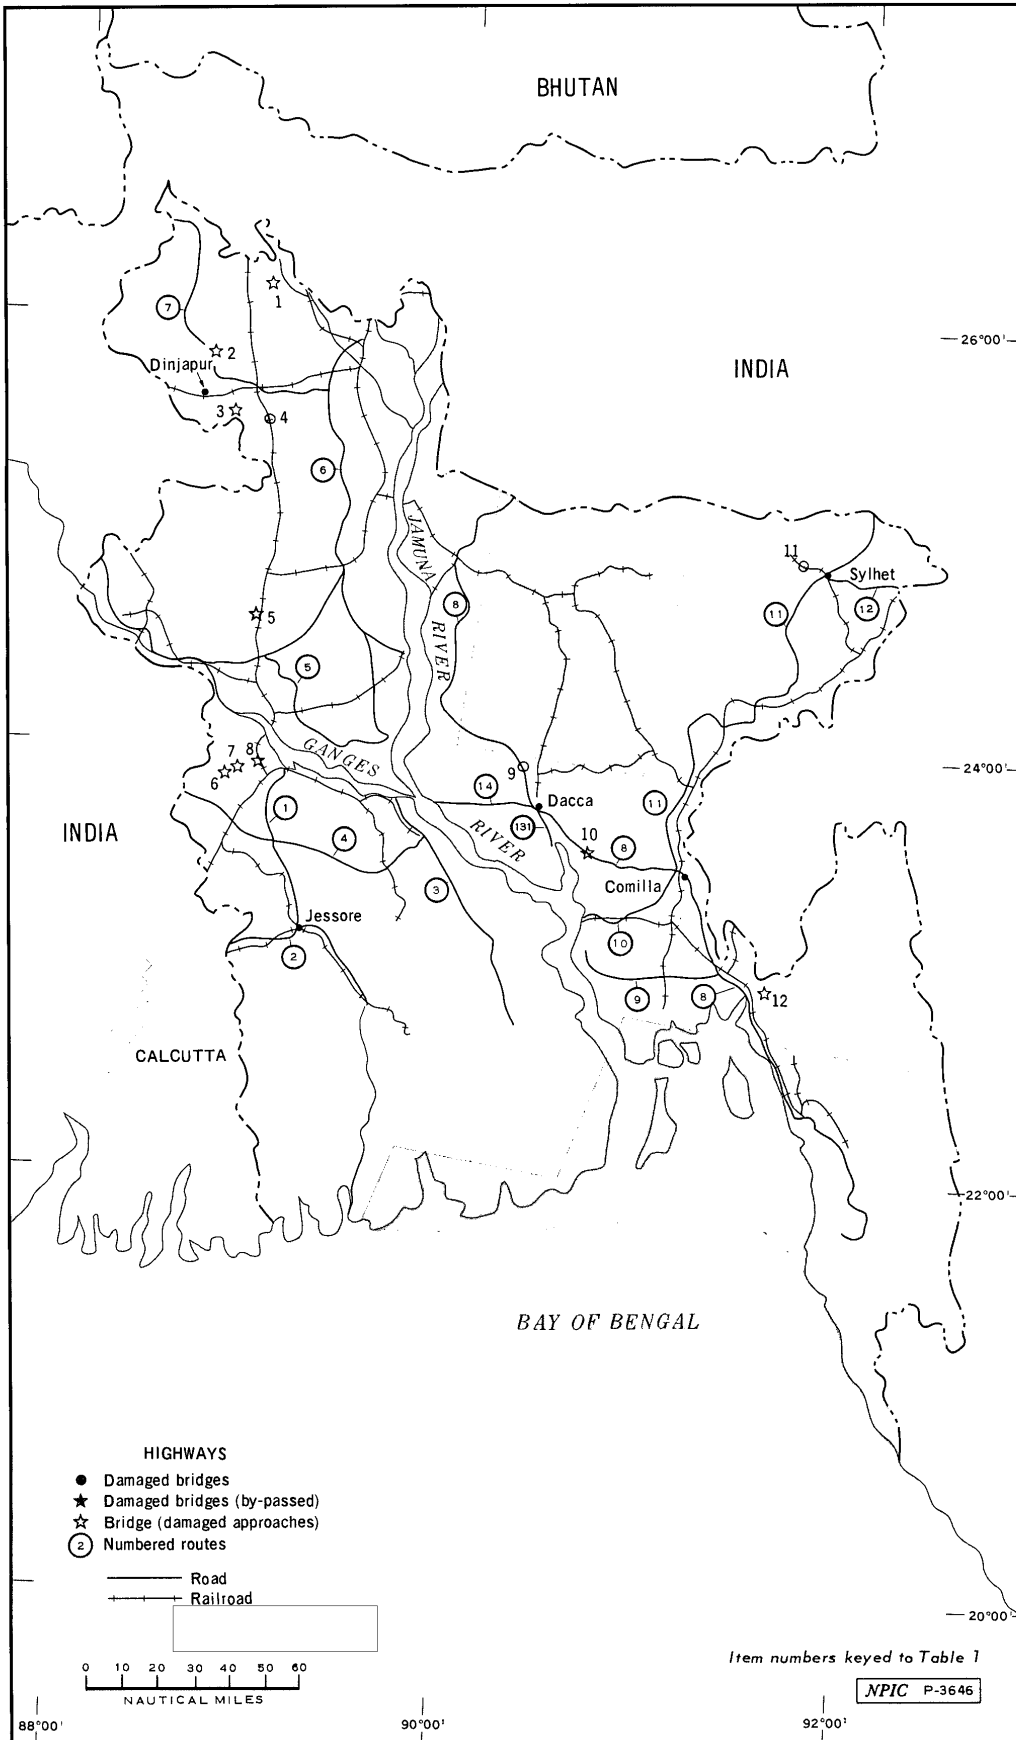
FIGURE 4. HIGHWAY DAMAGE, EAST PAKISTAN

13. Damage to twelve major highway bridges and numerous small and single-span highway bridges has caused disruptions to East Pakistan's already poor road system (Figure 4 and Table 1). Eight of the major damaged highway bridges are west of the Ganges and Jamuna Rivers; the other four are east of Dacca. Eight of the twelve major damaged highway bridges have been bypassed by temporary bridges, fords, or ferrys (Figure 5). These bypass measures may not be serviceable during periods of high water in the monsoon season (May thru September). Although most of these damaged bridges are on secondary routes, one bridge on the main route between Dacca and Comilla has been replaced by a ferry (Figure 6).

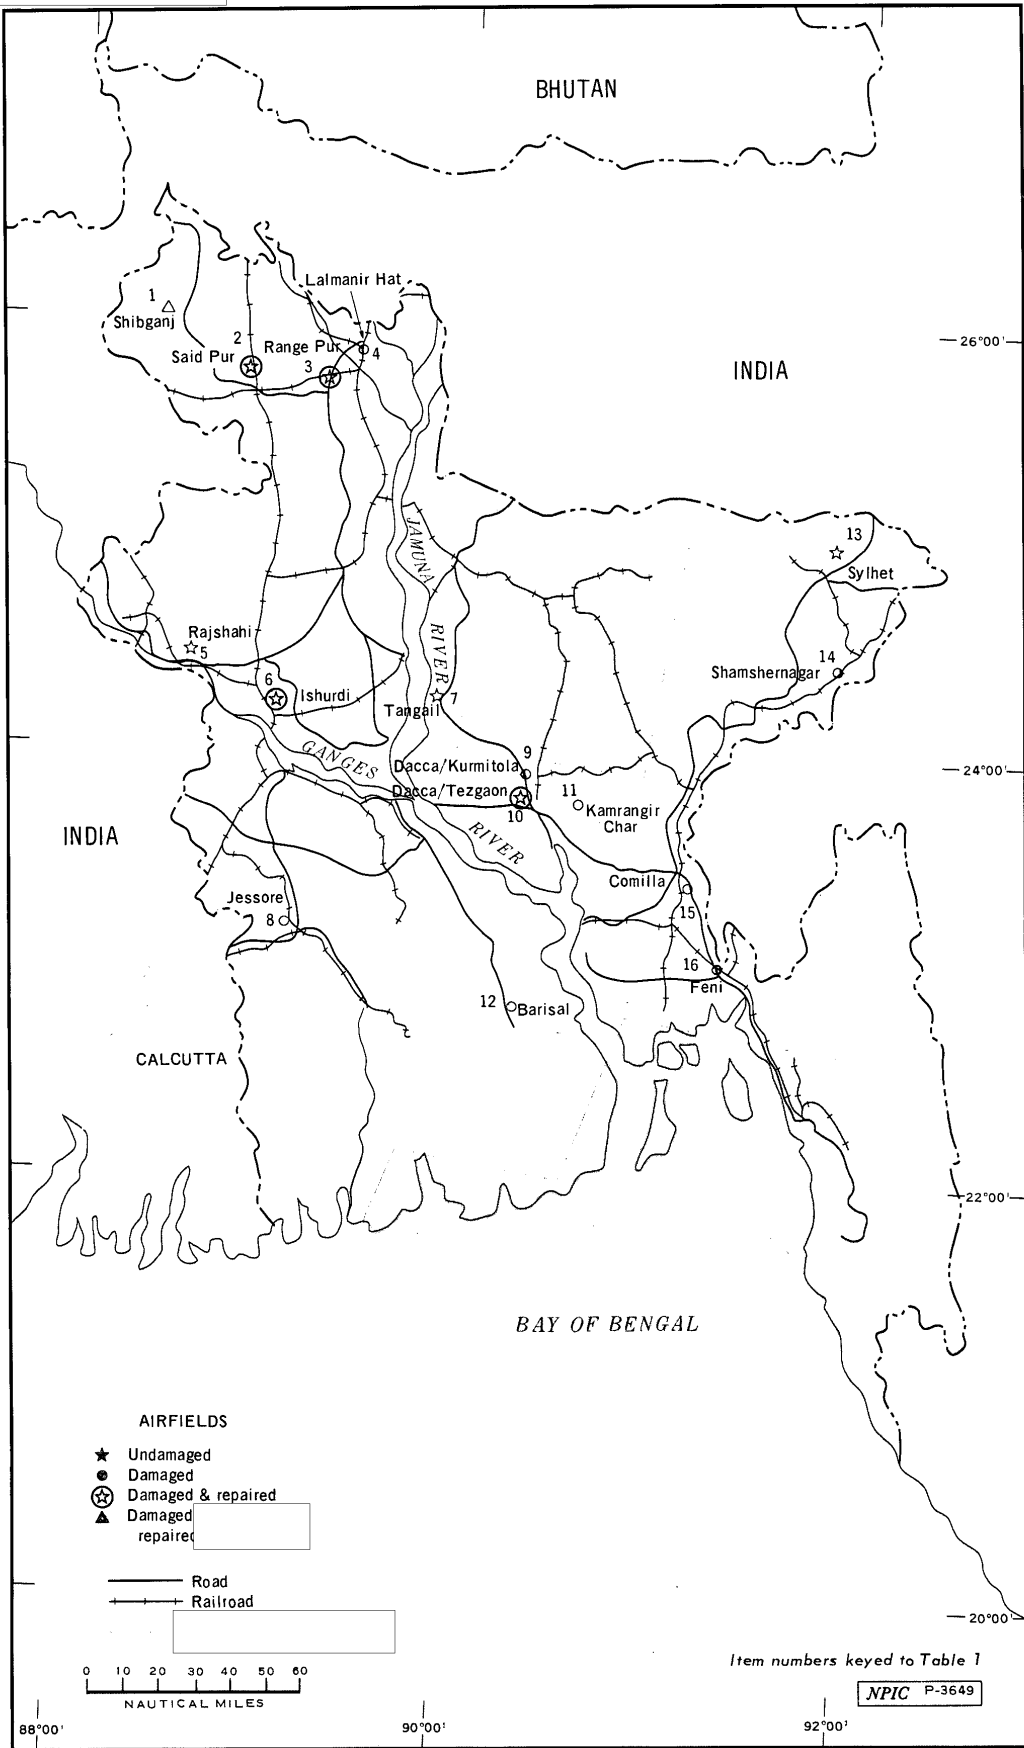
FIGURE 7. AIRFIELD STATUS, EAST PAKISTAN

14. The two major airfields at Dacca and 11 other smaller airfields in East Pakistan were damaged by aerial bombing or shelling (Figure 7 and Table 1). Most of this damage was restricted to the runways with little destruction apparent to other airfield facilities. The regular pattern of craters at three fields, Shibganj (Figure 8), Lalmanir Hat, and Shamshernagar, suggests that they resulted from cratering charges. Damage at the Feni Airfield resulted from probable bulldozer cuts across the runway. Craters on the runway at Dacca/Tezgaon Airfield (Figure 9), the country's principal airfield, have been repaired and the airfield was operational [redacted]. The airfields at Ishurdi, Saidpur, Rangpur, and Shibganj have been repaired and are serviceable. The eight other airfields, including Dacca/Kurmitola (Figure 10), are still unserviceable. Only three airfields in East Pakistan--Sylhet, Tangail, and Rajshahi--appeared undamaged.

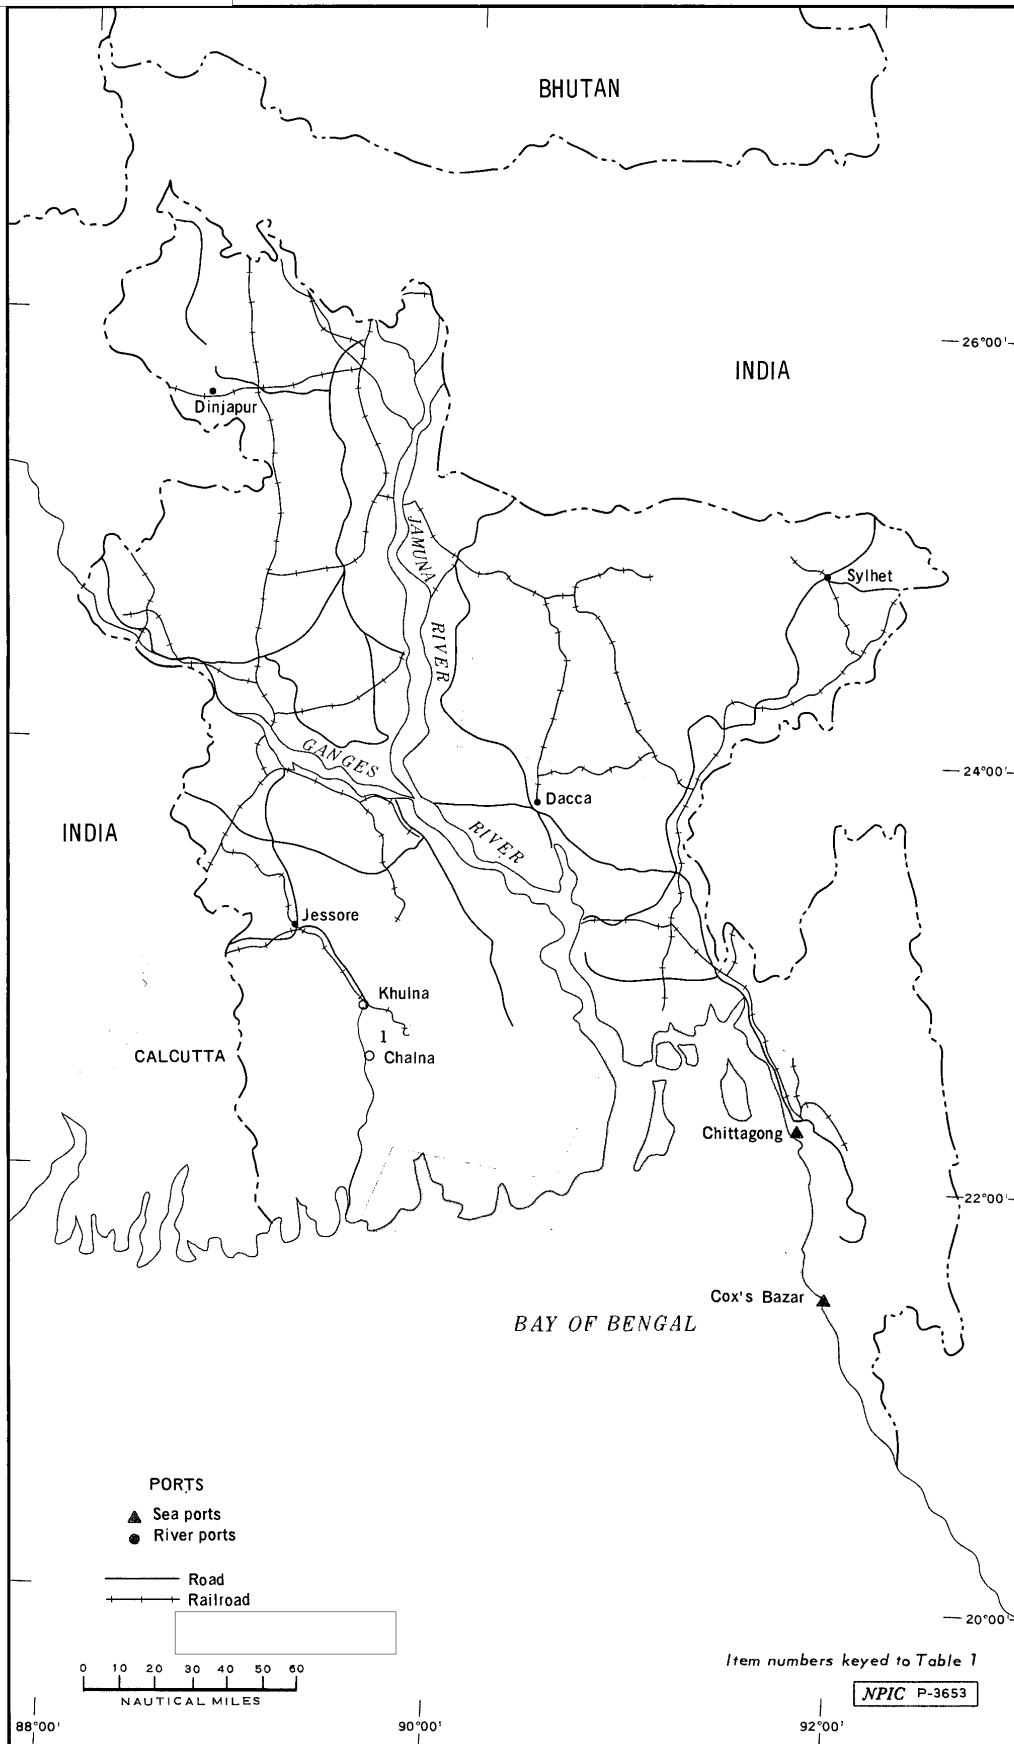
FIGURE 11. PORT FACILITIES, EAST PAKISTAN

16. Five (possibly seven) capsized freighters in the Pursur River have possibly on the Mungra Anchorage at Chalna (Figure 11 and Table 1). The river remains navigable,

however, to small craft and barges. Damage to the port facility at Chalna was apparent at one large storage building, ten warehouses, and at least 200 smaller buildings. Undamaged facilities at Chalna included 14 finger piers, ten warehouses, two large storage buildings, and numerous small open storage areas (Figure 12).

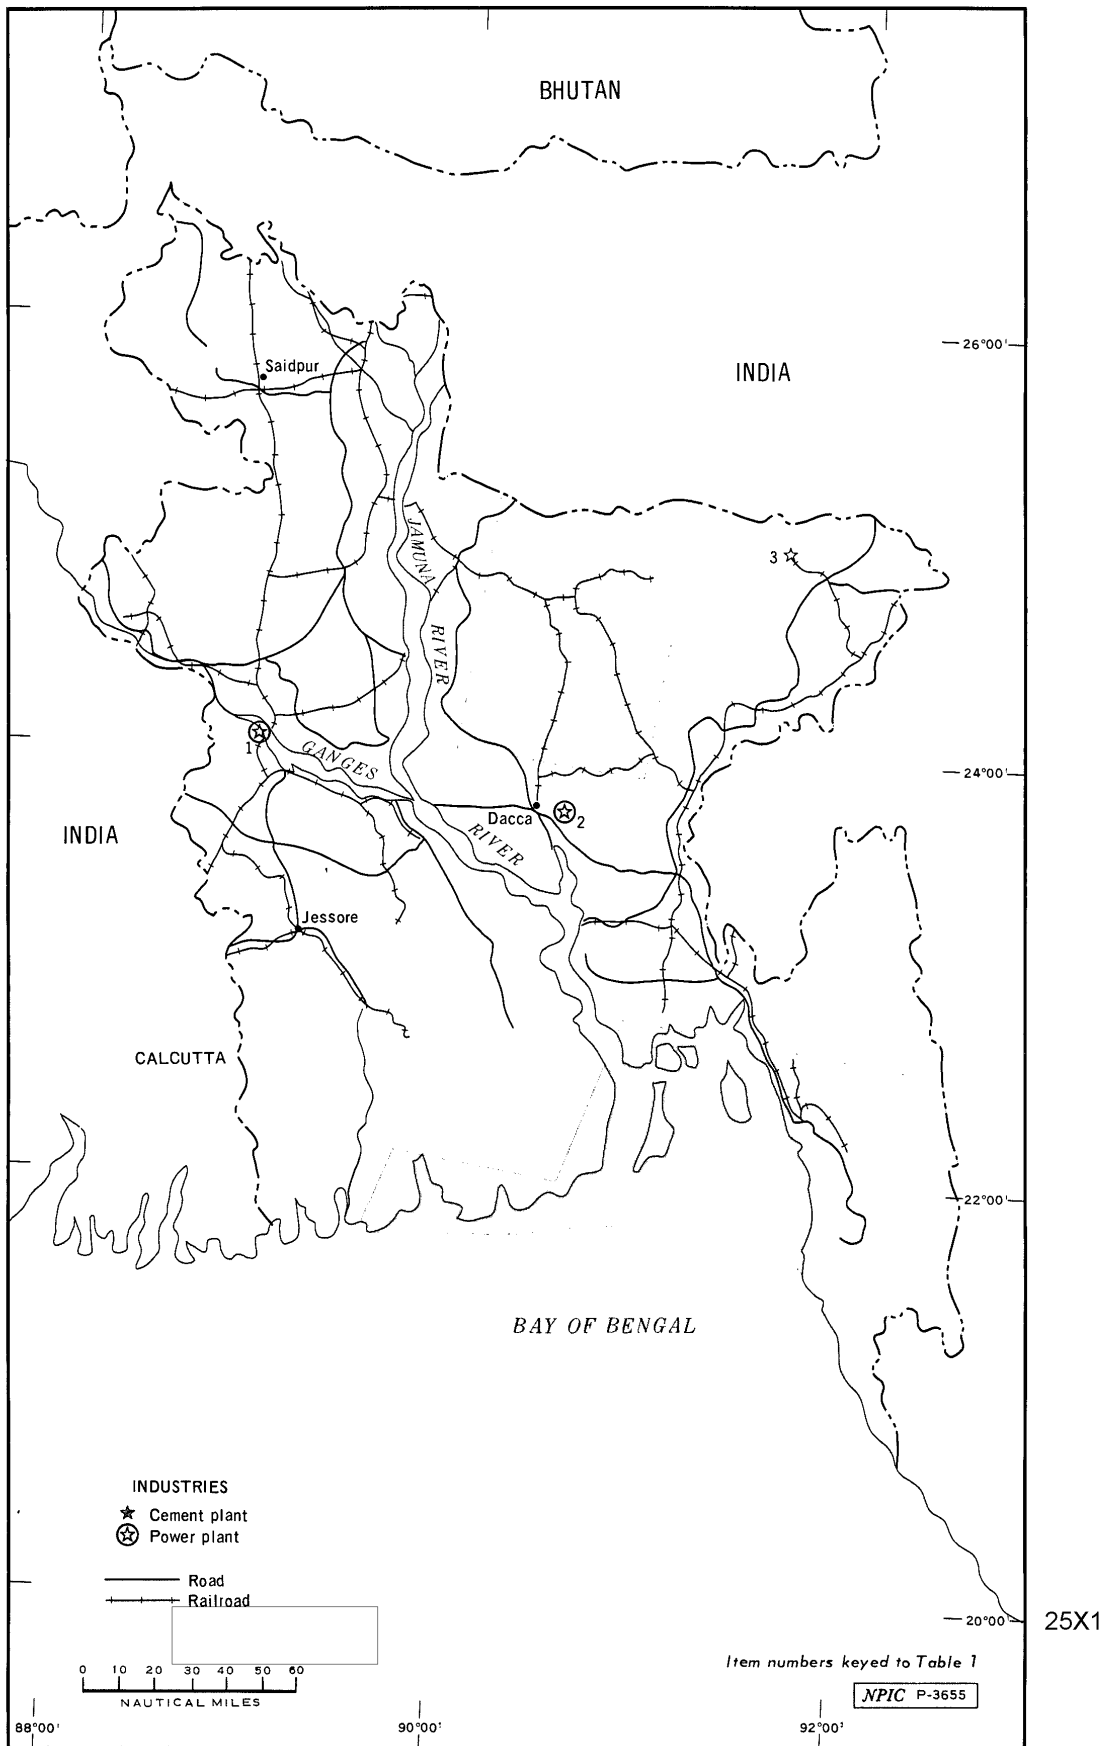
FIGURE 13. INDUSTRY DAMAGE, EAST PAKISTAN

18. The industrial base of East Pakistan is made up primarily of small widely scattered industries and manufacturing plants. The majority of these are located along waterways or within cities. A search of photography revealed 22 jute mills, eight cotton mills, two pulp and paper mills, nine sugar mills, four fertilizer plants, and one flour mill, and 36 unidentified light industries. Positive evidence of damage was observed at only one jute mill (23-49-25N 093-34-40E) located on the east bank of the Lakhya River (Figure 13 and Table 1). Four buildings at this mill had been severely damaged (Figure 14). All other such plants and mills observed appeared undamaged.

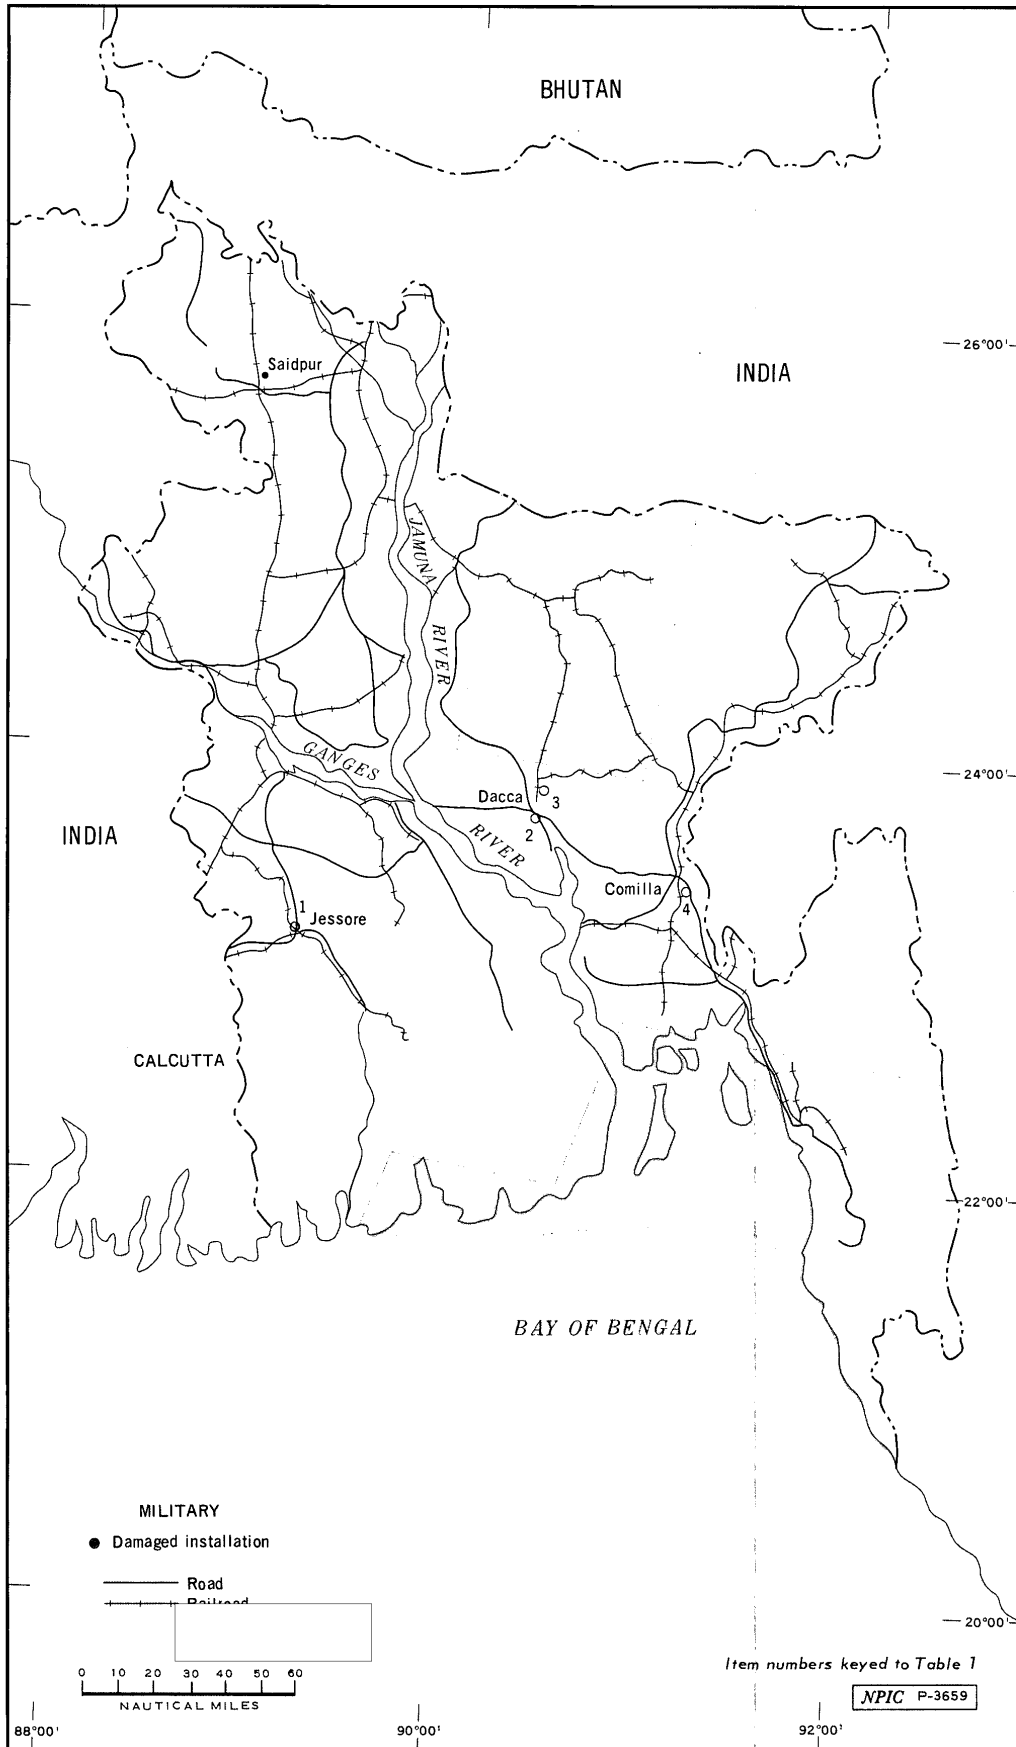
FIGURE 17. MILITARY INSTALLATION DAMAGE, EAST PAKISTAN

21. All major military installations, except those in the Chittagong area, were covered [redacted] Only very limited damage was observed at four cantonments (Figure 17 and Table 1).
