Title: FORMATION OF ICE PLUG OBSTRUCTIONS IN THE DRAINAGE SYSTEM
OF AN AIRFIELD NEAR THE SOUTHERN PERMAFROST BOUNDARY, by
A. N. Tolstov

FORMATION OF ICE PLUG OBSTRUCTIONS IN THE DRAINAGE
SYSTEM OF AN AIRFIELD NEAR THE SOUTHERN PERMAFROST BOUNDARY

A. N. Tolstov

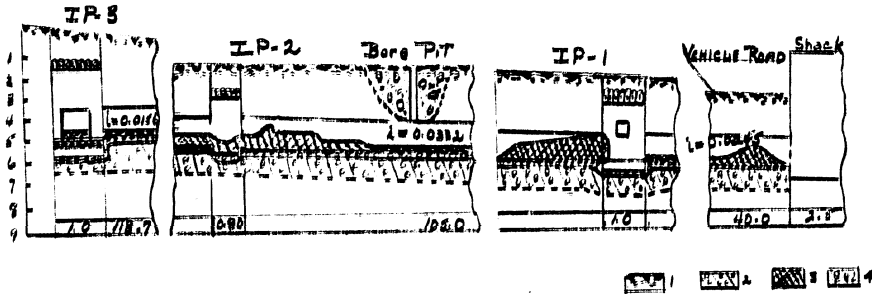
As seen in Figure 1, ice formed in collector 1 mainly near the inspection pits and near the temporary shack for construction work. Below inspection pit 2, ice froze in beads and one layer gradually covered another until a thickness of 0.4 meter was reached. Near inspection pit 1, ice filled the entire collector pipe.

As was found in the summer of 1942, an ice plug obstruction formed solidly in a collector about 12 meters long. In inspection pit 2 of the collector, the ice reached 0.28 meter on the high side, 0.2 meter on the bottom of the pit, and 0.15 meter on the low side. There was a fill of 0.35-0.37 meter on the pit roof.

The formation of ice in the collector near the shack can be explained partially by its low fill (namely, 0.85 meter) but mainly by the fact that a hard-rolled vehicular road passes through the fill of the collector some 12 meters above the shack. This road contributes to more intensive freezing of the ground.

An ice plug obstruction formed in inspection pit 1, apparently when water trickled in with a temperature close to 0°C. The water immediately froze because of the rapid penetration of cold air through the roof of the inspection pit, due to the low soil fill and complete absence of heat. In addition, the water flowing out of the collector into the inspection pit also froze.

The formation of ice plugs in the collector pipe can be explained by the fact that the ground around the collector and the collector itself was frozen and therefore the water flowing through the pipe at a temperature close to 0° quickly froze. Contributing also to the rapid freezing of the water flowing through the collector was the fact that the gutters on the concrete runways were not covered for the winter. Therefore, the cold air going through them which was forcefully drawn in by the shack, rapidly cooled the water flowing through the collector pipe. Another contributing factor, which became evident when the collector was opened up in June 1942, was that it was filled not only with pebbles and gravel but also with local soil (yellow-brown sandy loam with boulders) and mainly stones.

Figure 1. Diagram of Longitudinal Profile of Collector 1. 1- Soil Fill, 2- Rock Rubble with Clayey Soil, 3- Ice on January 1942, 4- Gravel-Pebble Fill (p. 70 Text).

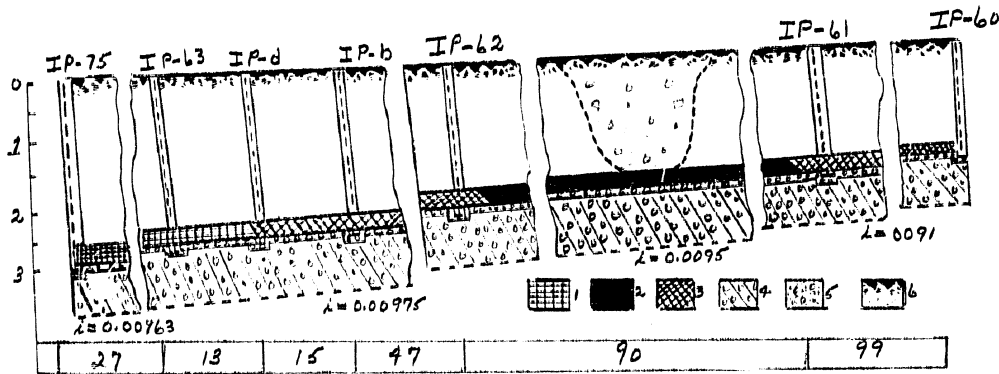
During the winter of 1941-42, ice plugs formed in the southeastern part of the strip in the collector of a taxi strip, which started from inspection pit 75 of collector 3 and continued to pit 60 of the collector RD-2, a distance of 295 meters (see Figure 2). The ice plugs at these points first were revealed in the spring of 1942, when puddles of water started to appear on the surface of the collector. In addition, a small lake, about 75 meters long and 15-20 meters wide, was created each time after a rain in the place where the taxi lane crossed the collector in the lowest eastern part. It disappeared a day or two after its appearance mainly because of runoff along the base of the RD-2 fill towards the east and partially because of evaporation.

The collector was first opened and the ice-plug obstruction removed from it in the section between inspection pit 75 and the taxi lane on 25 June 1942 and the removal was completed 24 August 1942. Pits 75, 62 and "a" were opened first (the latter, size 0.30 x 0.30 meter, was probably intended as a gutter). It turned out that the last two pits, 62 and "a", were full of water. When the collector was opened by trenches, it was found that the

The collector was made easier to open by the fortunate construction of its covers. These were made from separate semi-circular joists 12 to 13 centimeters wide and 22 to 23 centimeters long laid cross-wise across the pipe. When the section of the collector between inspection pit 75 and the taxi strip was opened up by trenches, an ice plug was found in the pipe which filled the entire pipe solid over a distance of 40 meters.

When the work ended (24 August 1942), the ground in this section had thawed to 1.7-1.8 meters; the permafrost was no deeper than 2.0 meters at this spot in the fall of 1941 and 1942. Consequently, the collector, which was laid at a depth of 2.25 meters, entered the permafrost layer and apparently froze through in the fall of 1941 from below.

The ice plug described possibly formed in the fall of 1941 in the section from inspection pit 75 to pit 61 and above, in the direction of pit 60; formation of an ice plug in the last section was favored by the 23 centimeter small cobblestone fill over the wooden covers of inspection pit 60, which helped to cool it rapidly. However, we can assume that an

ice plug formed only in the section between pit 75 and the taxi strip in the fall of 1941. In the section between the strip and pit 61 and above (towards pit 60), ice plugs may have formed in the spring of 1942; after thawing in RD-2 reached 0.60 meter, atmospheric water from the rains during this period started to flow from the gutters into the collector pipe. Since the ground around the collector was frozen at this time, the water, standing motionless in the collector pipe, could gradually freeze solid in the pipe.

The ice plug in the collector pipe in the section between the pits "a" and No 62 thawed on 24 August 1942 because these pits were opened on 25 June 1942 and warm air flowed into the collector pipe through them. The ice plug in the section between pits 61 and 60 also thawed in the fall of 1942. Only the plug in the section between pits 62 and 61 could not be thawed or removed. As a result, a great deal of water formed in the collector pipe and in the ballast fill over it, pumping of which continued to 5 December 1942.

Figure 2. Diagram of Longitudinal Profile of Collector for Taxi Strip 2. 1- Ice Plug Removed During the Summer of 1942; 2- Ice Plug Left for the Winter of 1942-1943; 3- Ice Plug Which Thawed Out in the Summer of 1942; 4- Clayey Soil with Rock Rubble; 5- Gravel-Pebble Fill; 6- Soil Fill (p. 71 Text)
