The Port of Callao

South America's Most Modern Port in the Making

JUNE 1953

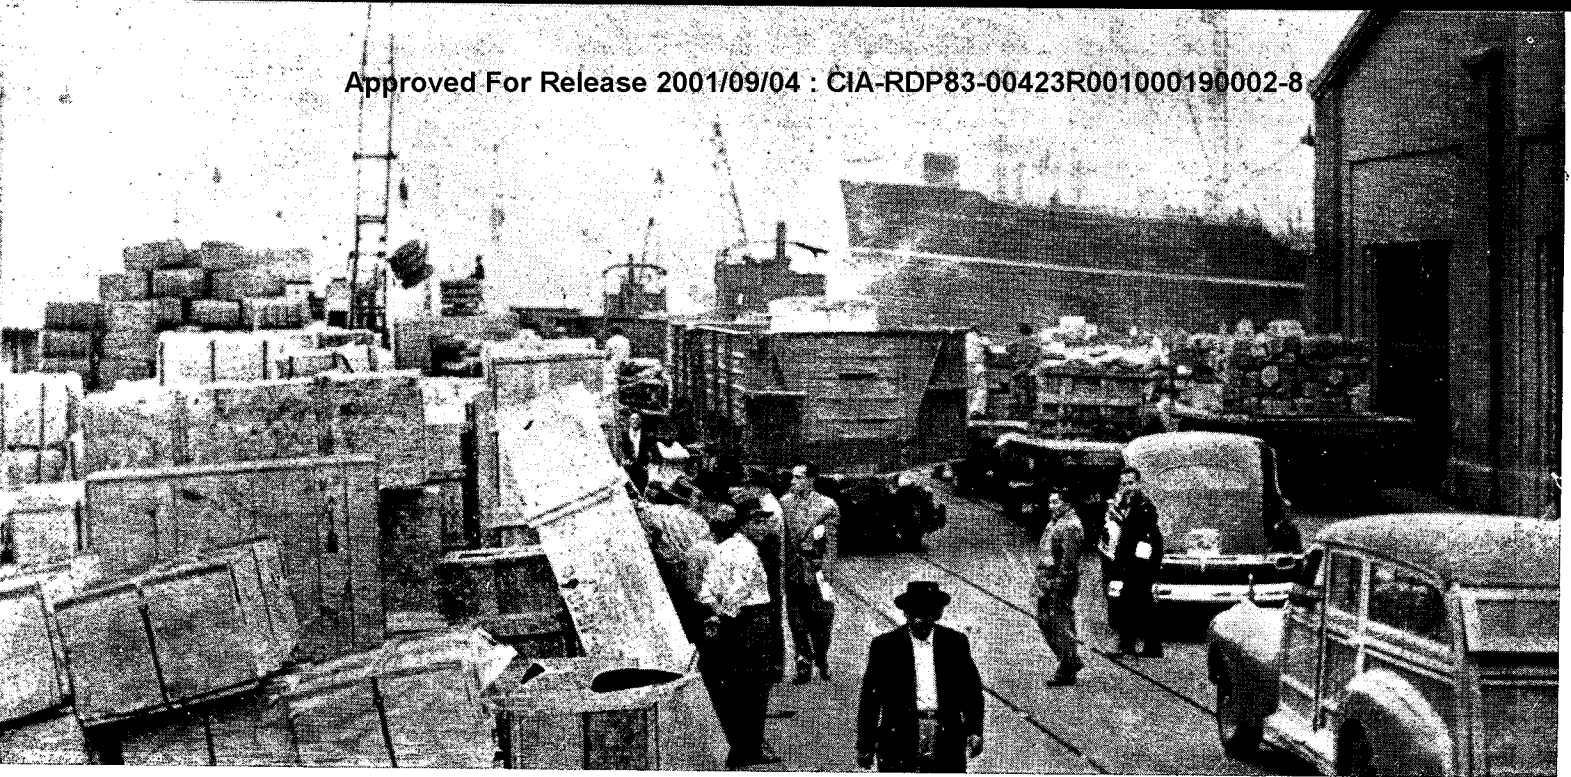
Before: Scene in front of the main piers, showing general confusion, congestion and lack of traffic control, Sept. 1, 1951.

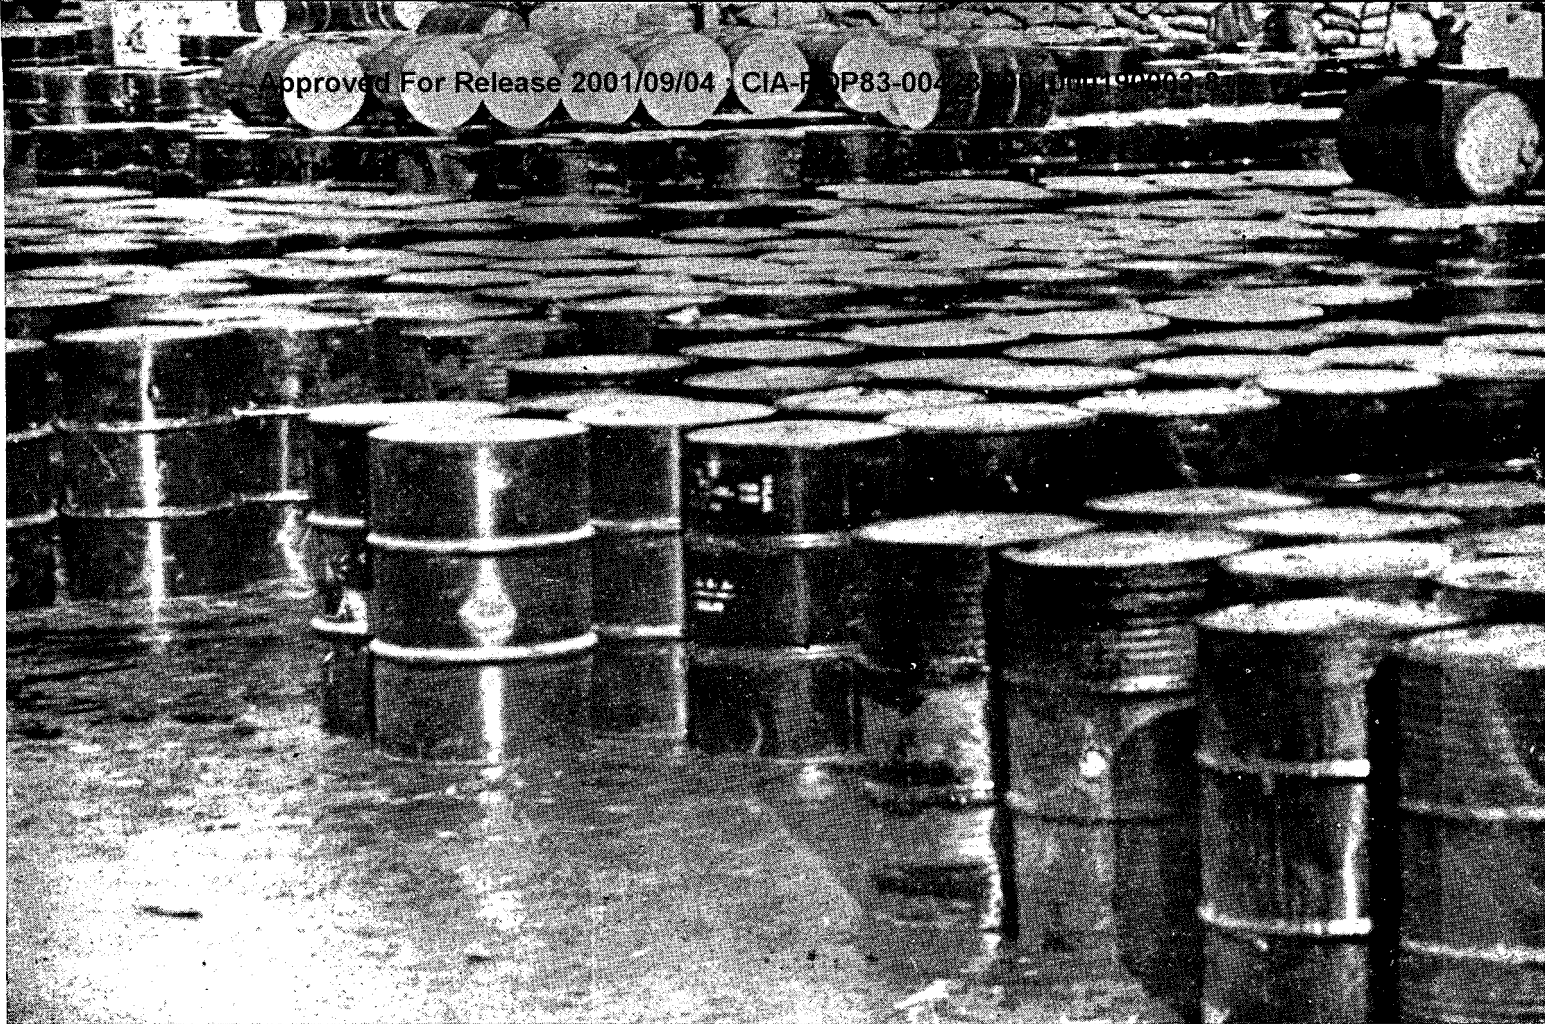
Before: Fire Hazards: Storage of drummed petroleum products and general cargo in an oily lake.

After: Drummed petroleum products segregated by lot and stored in an isolated area.

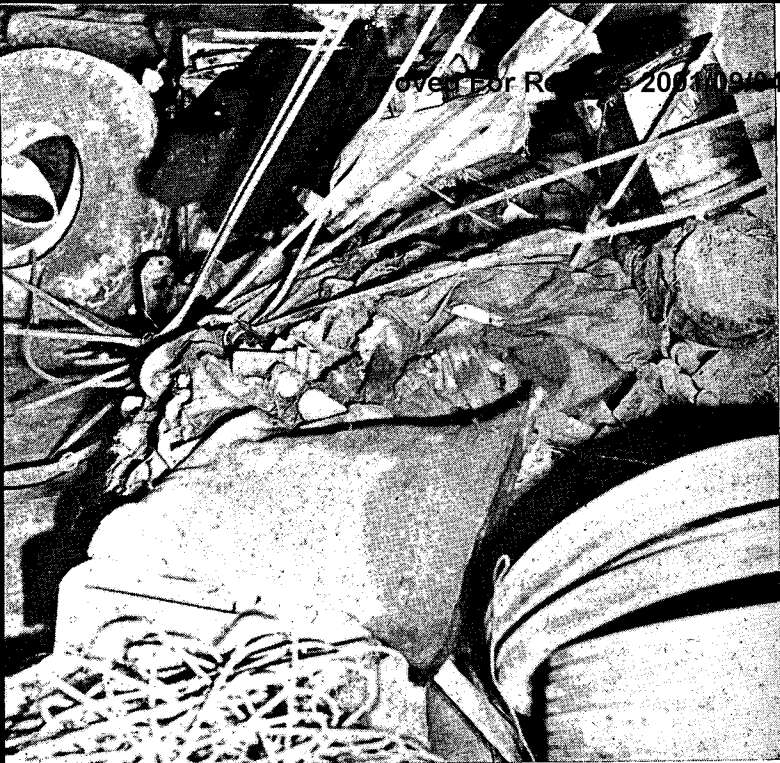
Before: Accumulations of junk and abandoned cargo in warehouses, August 1951.

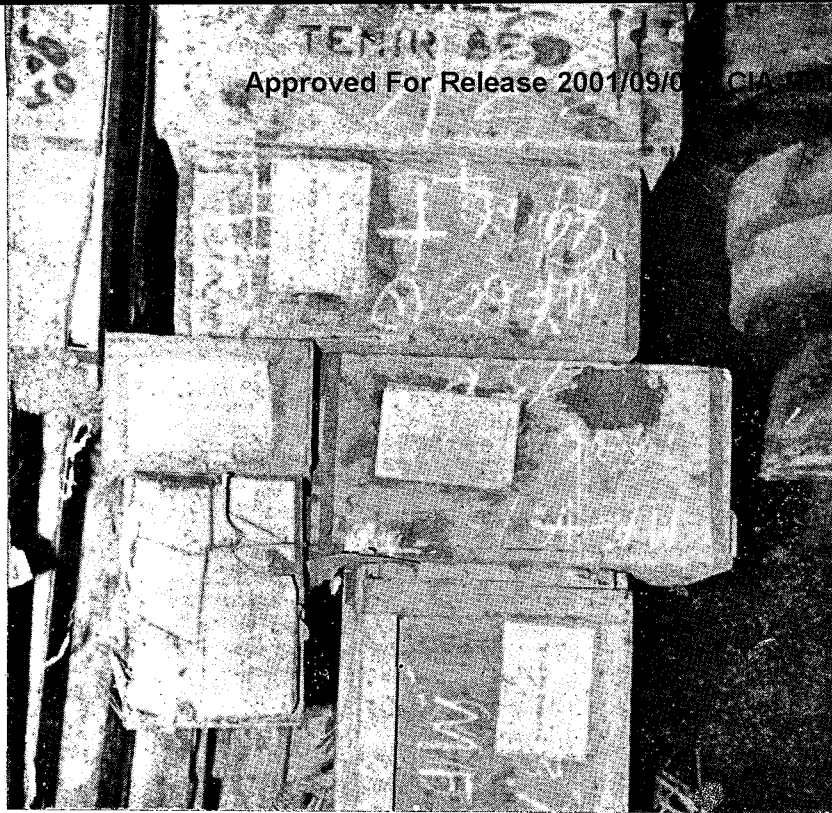
Before: Cargo landed in 1936, still occupying valuable warehouse space, August 1951.

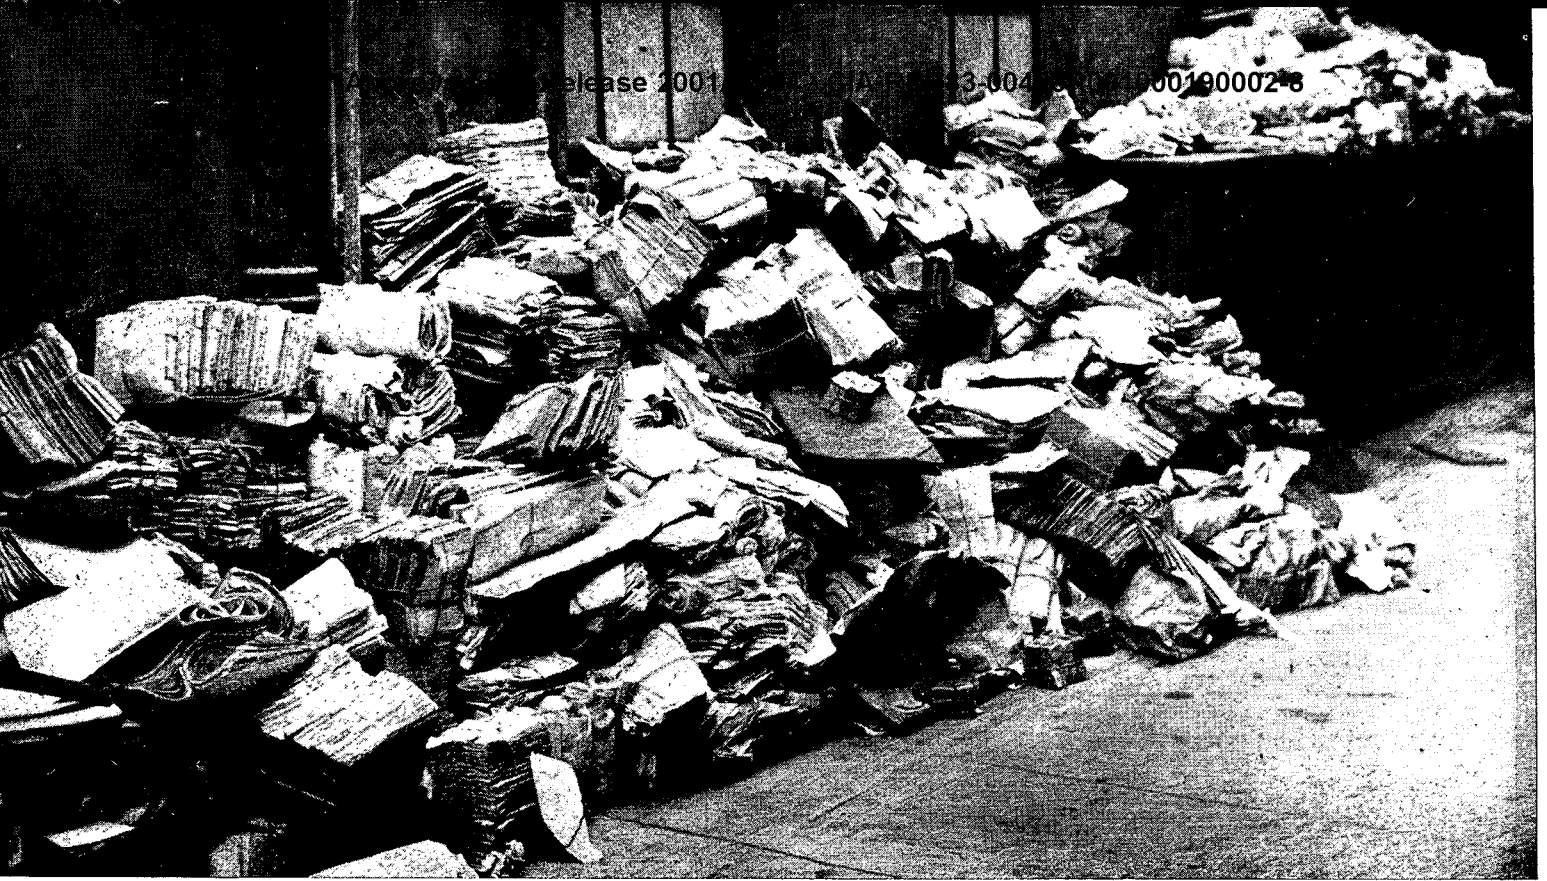
Before: Storage of official documents outside of main offices, May 1952.

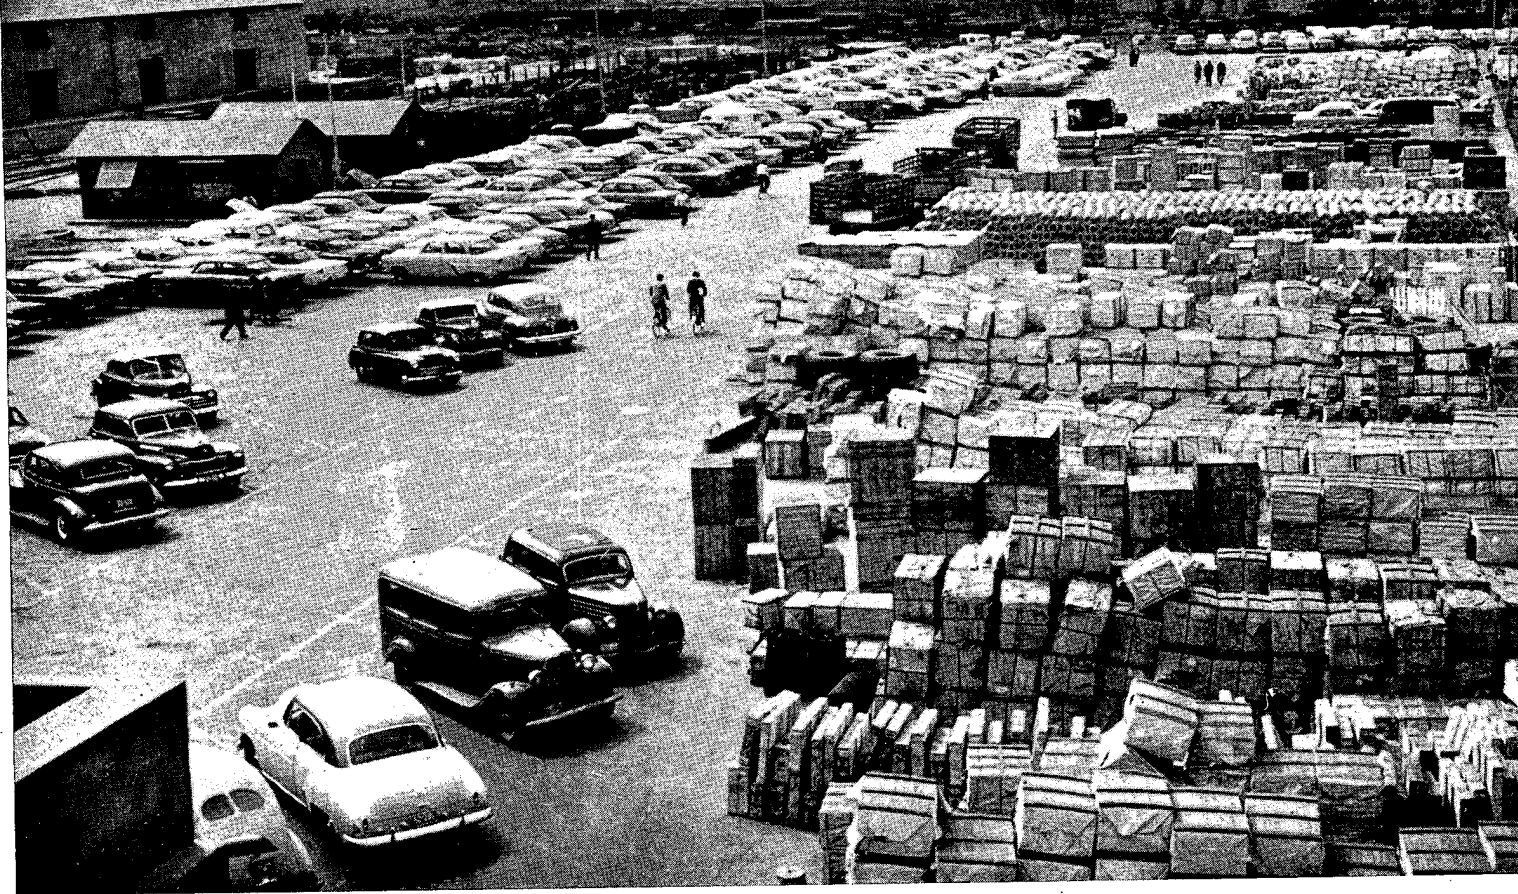
Before: Port congestion, cargo stacked in vehicle parking place, May 1952.

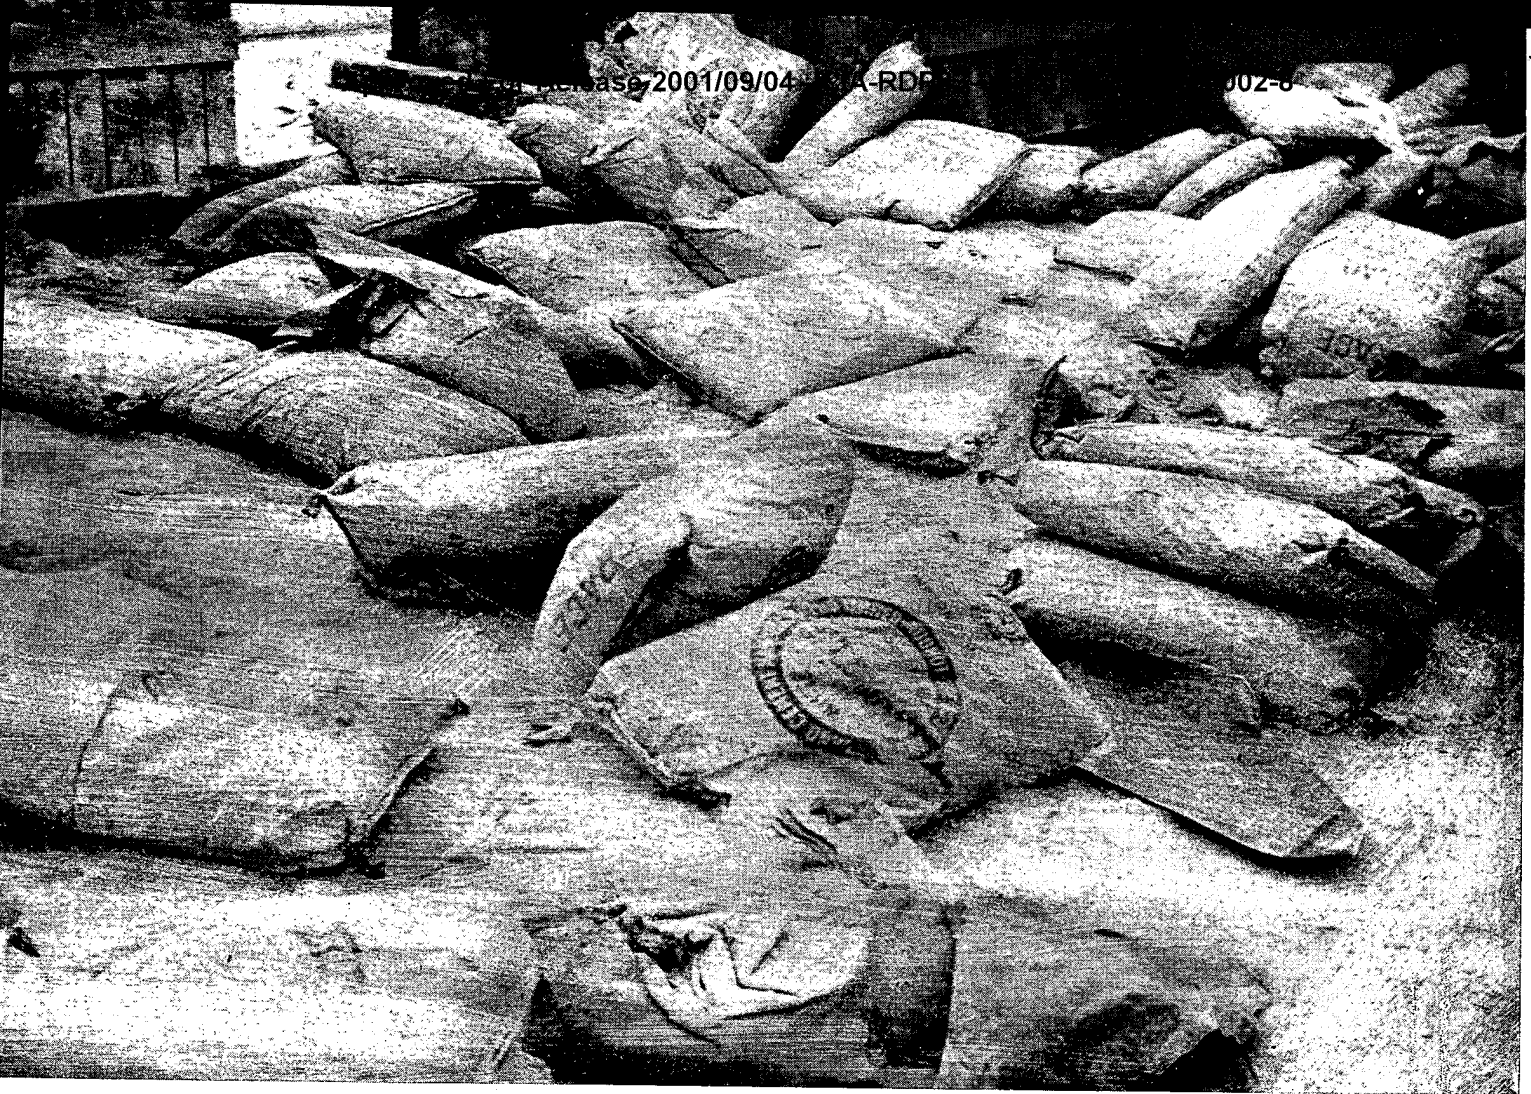
Before: Mishandled shipment of cement bags.

After: Handling of cement bags by pallets.

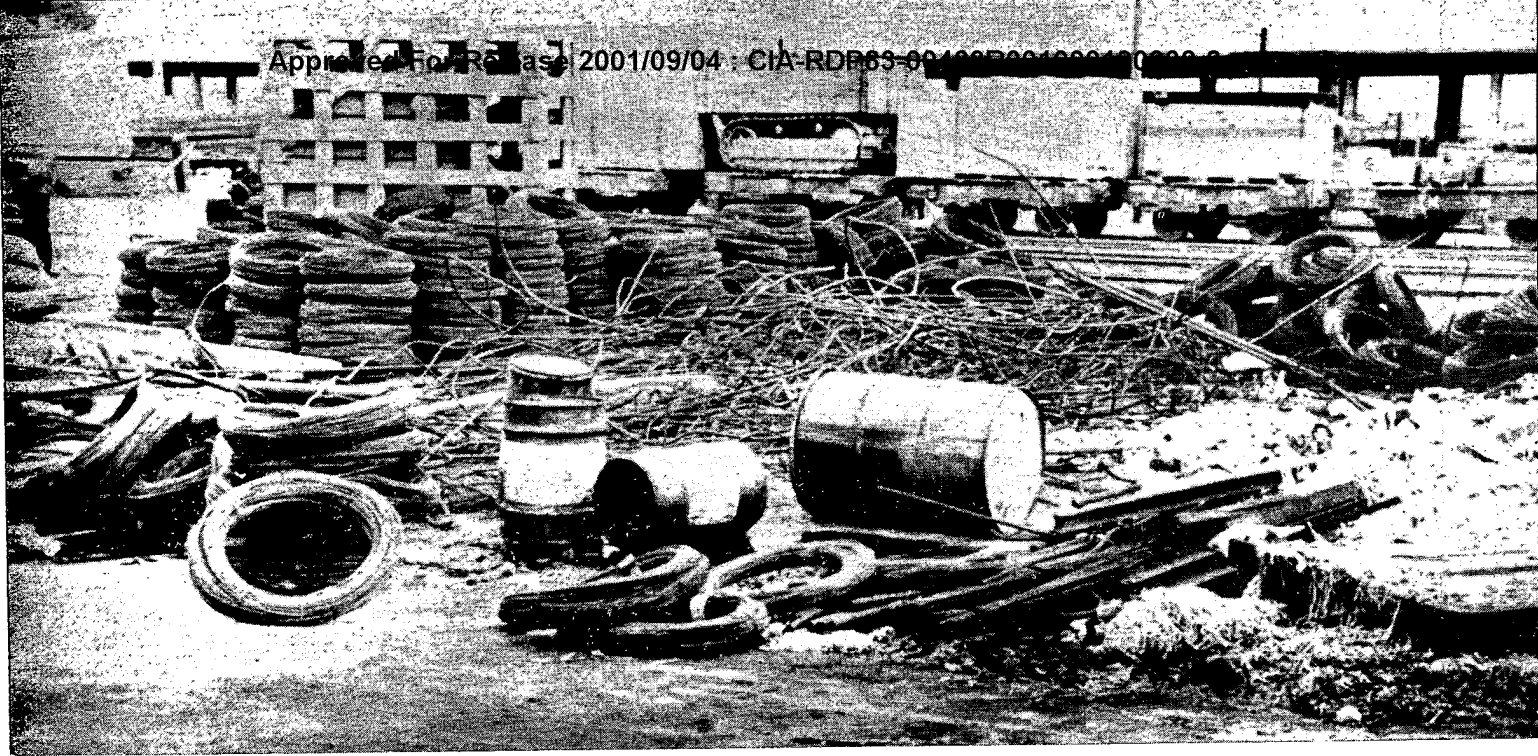
Before: View of cargo mishandled.

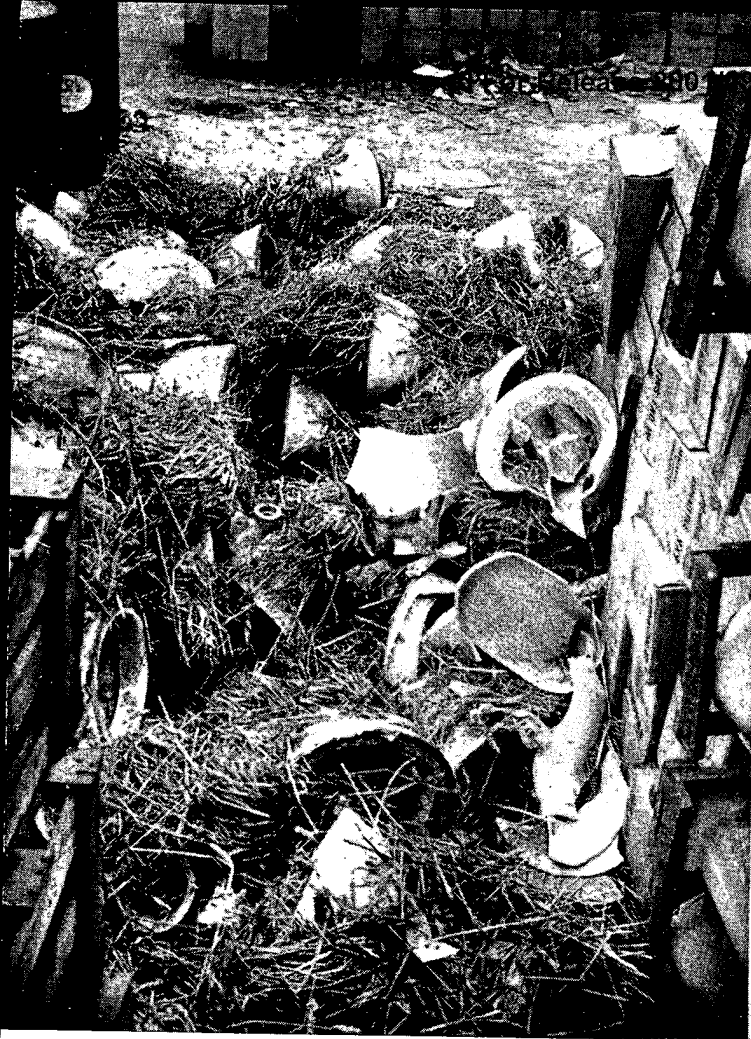
Before: View of cargo mishandled.

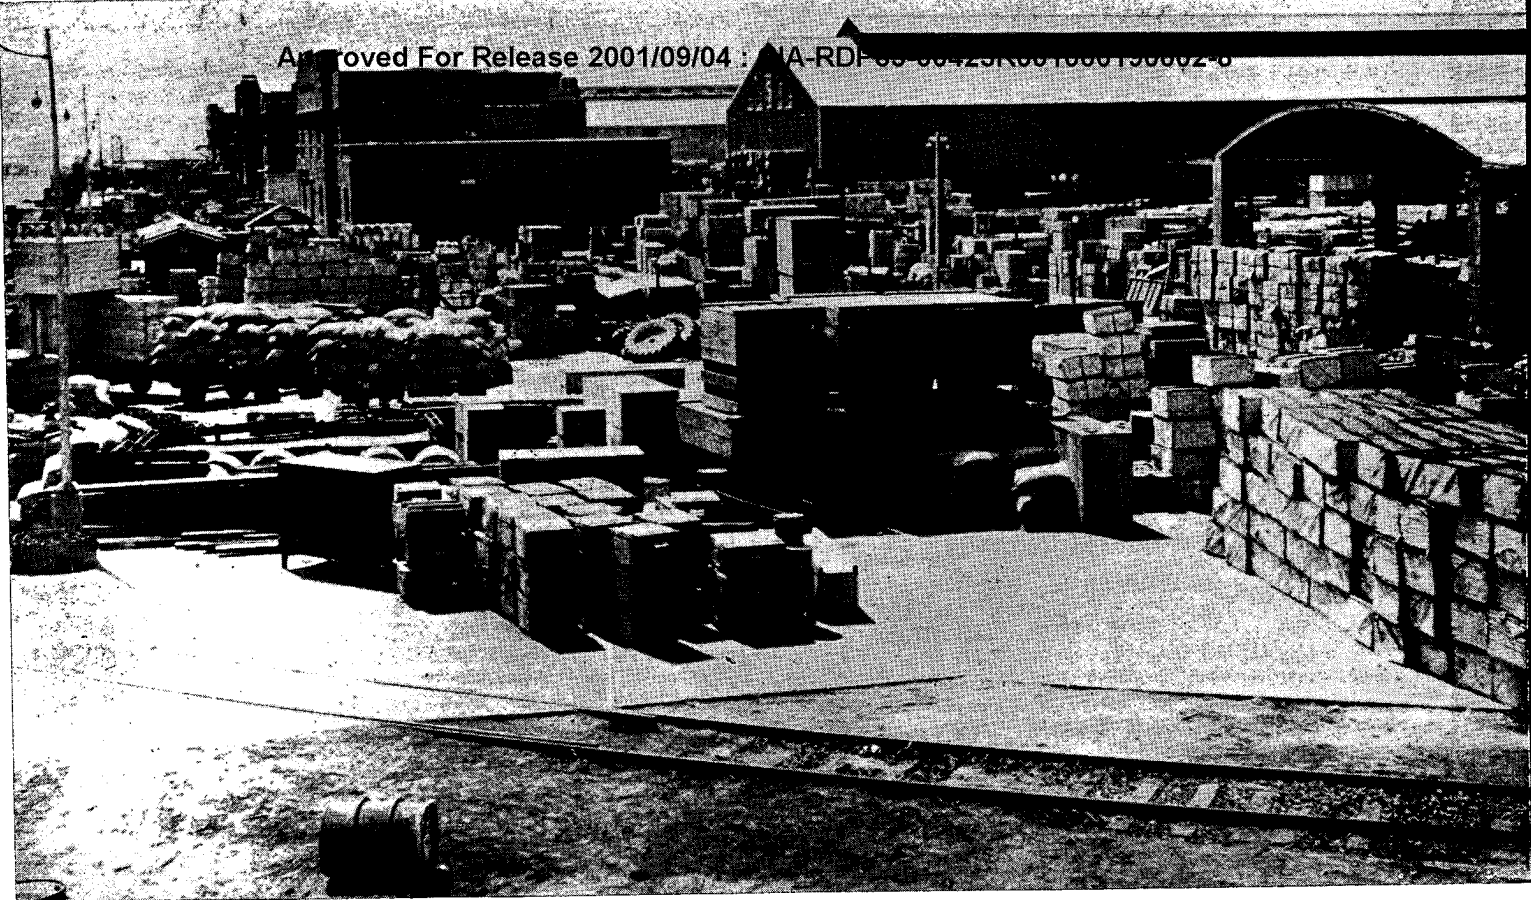
Before: Congestion in front of Main Buildings.

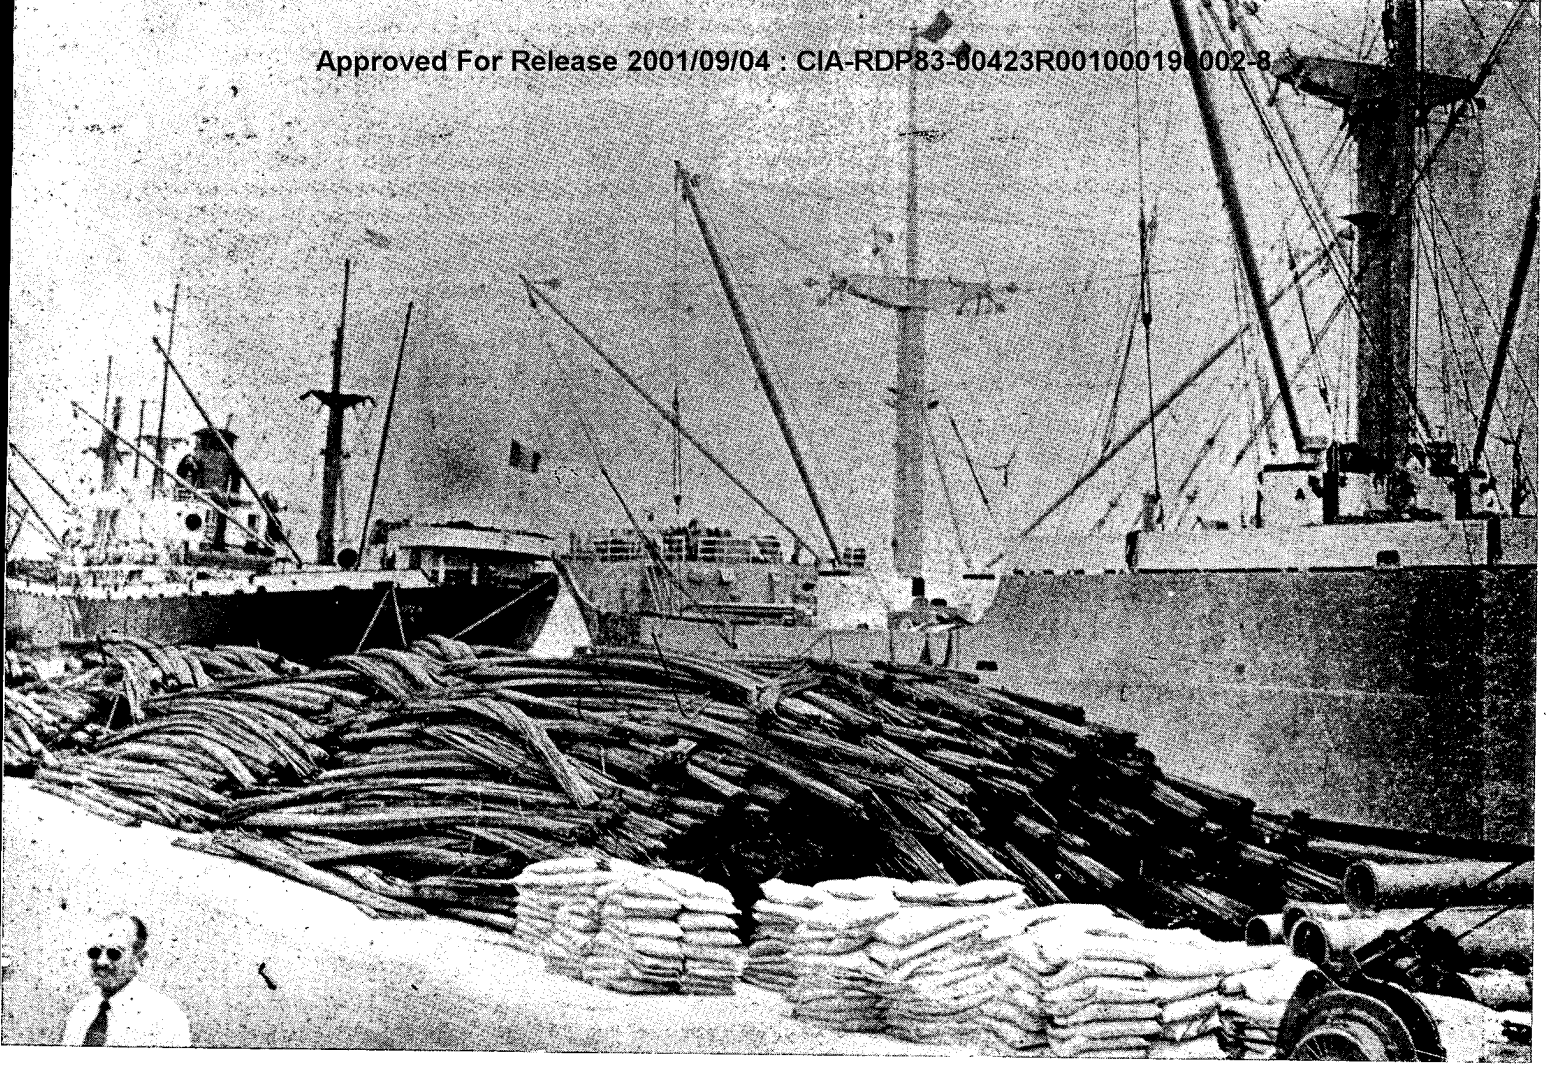
Before: Congestion on Long Wharf.

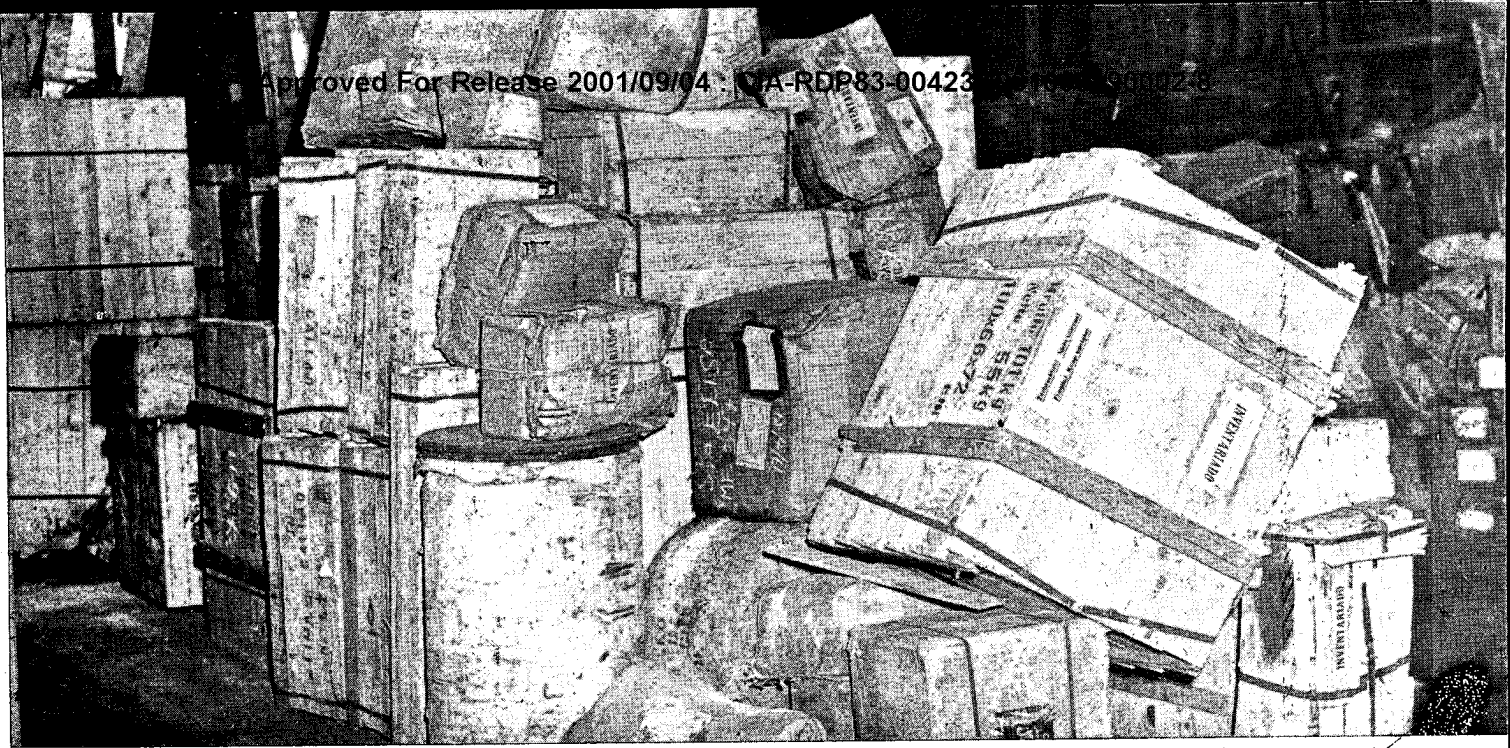
Before: Warehouse Operations. Cargo manhandled with considerable cargo damage and poor utilization of available storage space. In this type of operation it was difficult, if not impossible, to locate a given shipment.

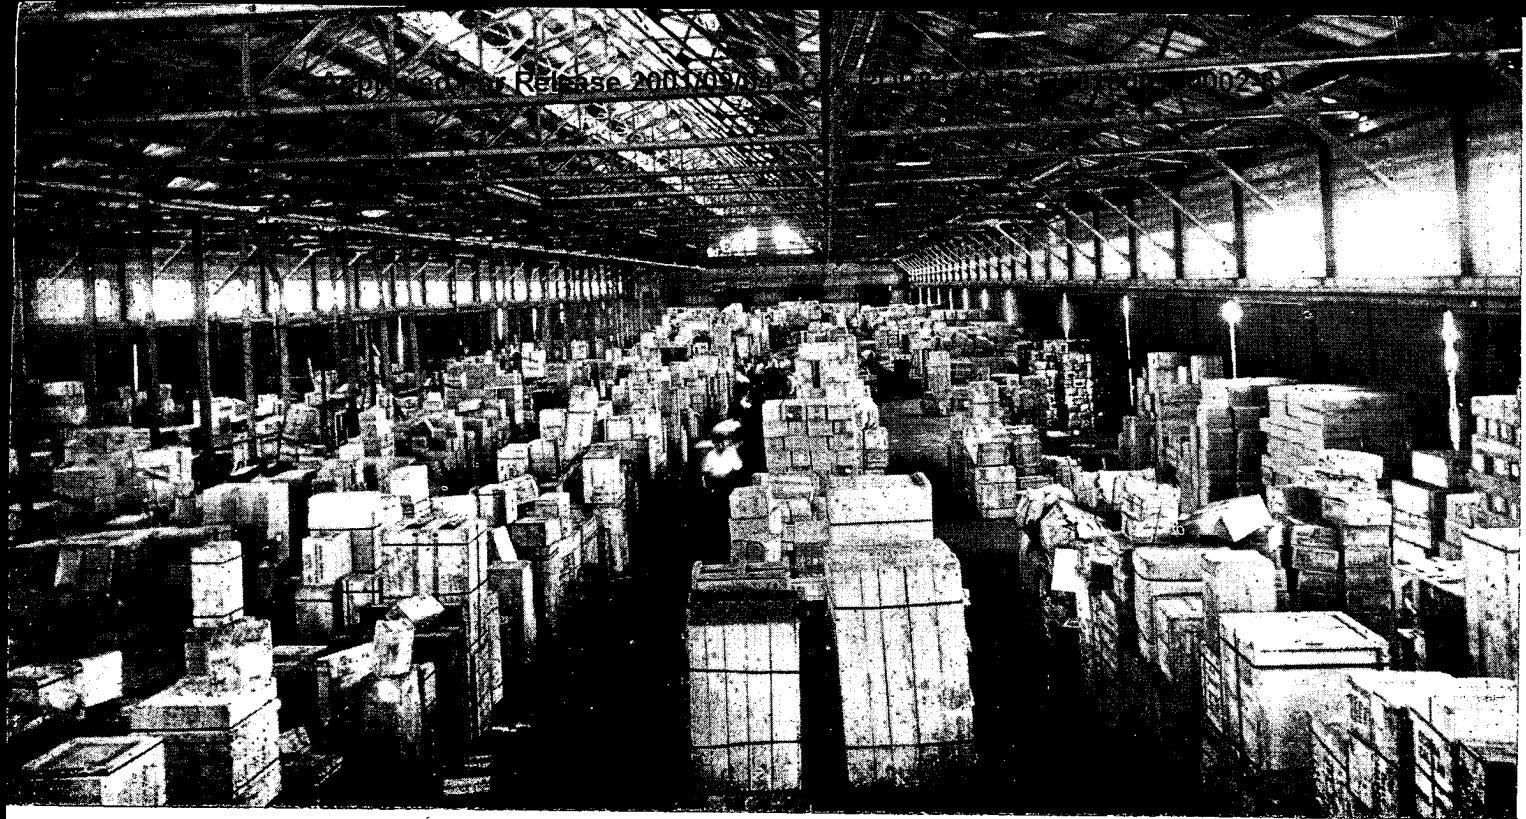
Before: Warehouse Operations. Poor space utilization — Manhandling — Cargo Damage — Impossible to locate given shipment.
