PHOTOGRAPHIC INTERPRETATION REPORT

HEN HOUSE ANTENNA
RADAR SITE 1
ANTIMISSILE TEST CENTER
SARY-SHAGAN, USSR
Declass Review by NIMA/DOD

NPIC/R-5158/64
December 1964

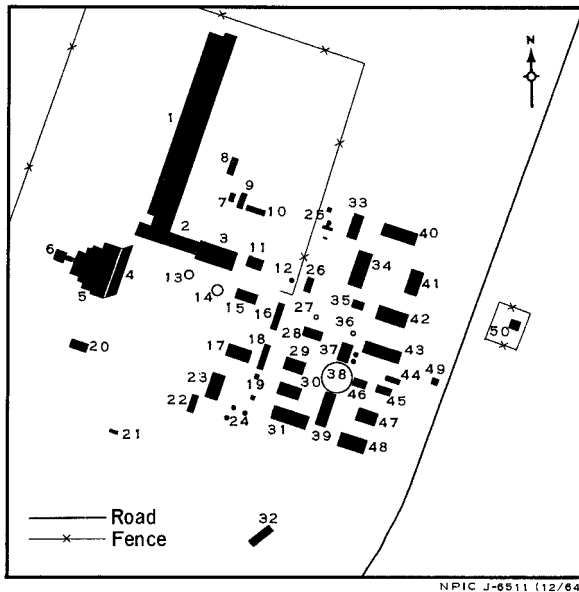
FIGURE 3. RADAR SITE 1.

TABLE 1. Key to Annotations on Figure 3

Item No	Description	Dimensions (ft, approx)	Remarks
1	Original HEN HOUSE structure	--	See Figures 6 and 7.
2	Original control bldg	--	See Figures 6 and 7.
3	Control bldg extension	--	See Figures 6 and 7.
4	Vertical screen	--	See Figures 6 and 8.
5	Triangular facility	--	See Figures 6 and 8.
6	Bldg at apex of triangular facility	--	See Figures 6 and 8.
7	Bldg	20 x 20	[redacted]
8	Bldg	100 x 55	[redacted]
9	Bldg	55 long	[redacted]
10	Bldg	110 long	[redacted]
11	Bldg	85 x 35 x 20 high	Flat roof. [redacted] probably completed by [redacted]
12	Probable bunker	--	Identifiable as a bunker on TALENT photography. Configuration details not discernible on current small-scale photography.
13	Probable buried tank	--	Circular excavation observed at site on TALENT photography. Served by buried conduit.
14	Possible buried tank	--	First observed as circular ground scar between [redacted] appeared earth covered by [redacted] Served by buried conduit.

15	Bldg	85 x 65 x 15 high	Probable gable roof. [redacted] appeared complete by [redacted]
16	Bldg	110 x 25	Gable roof. [redacted] dismantled between [redacted]
17	Bldg	130 x 45 x 10 high	Gable roof. [redacted]
18	Bldg	110 x 25 x 15 high	Gable roof.
19	2 bldgs	Each 20 x 20	
20	Bldg	55 x 35

Item No	Description	Dimensions (ft, approx)	Remarks
21	Unidentified facility, possibly a bunker	--	U/c between [redacted] Trail served. 25X1D
22	Hardstand or very low shed-type bldg	75 x 40	
23	Bldg	110 x 65 x 20 high	Probable gable roof. 25X1D
24	Several very small u/i structures	--	Appeared between [redacted] 25X1D
25	Three small u/i structures	--	[redacted] two appeared between [redacted] 25X1D
26	Bldg	35 x 25	Gable roof. 25X1D
27	Possible buried tank	--	Identifiable on TALENT photography; details not apparent on current photography.
28	Bldg	35 x 25	Gable roof.
29	Bldg	50 x 30 x 10 high	Gable roof.
30	Bldg	80 x 25 x 15 high	
31	Bldg	130 x 55 x 25 high	
32	Bldg	130 x 35	[redacted] 25X1D
33	Barracks-type bldg	110 x 45 x 15 high	Hip roof.
34	Bldg	155 x 40 x 25 high	
35	Bldg	25 x 25	Gable roof.
36	Possible buried tank	--	Identifiable on TALENT photography; details not discernible on current photography. 25X1D

37	Steam plant	--	One tall stack in [redacted] two stacks visible in [redacted] 25X1D
38	Apron for coal supply	--	
39	Bldg	140 x 35 x 10 high	Gable roof. Constructed between [redacted] 25X1D
40	Bldg	160 x 45	Flat roof. 25X1D
41	Bldg	100 x 25 x 10 high	Flat roof.
42	Administration/barracks-type bldg	135 x 30 x 10 high	Gable roof.
43	Administration/barracks-type bldg	155 x 55 x 20 high	Hip roof.
44	Bldg	30 x 30	
45	Bldg	30 x 30	
46	Bldg	50 x 30	
47	Barracks-type bldg	110 x 60 x 15 high	Hip roof.
48	Barracks-type bldg	125 x 55 x 25 high	Hip roof.
49	Bldg	20 x 20	
50	Bldg	20 x 20	Possible mast identified on TALENT photography. Fenced. 25X1D

One major building was removed between. Approximately 27 permanent-type buildings of various sizes and configurations now are contained in the support area. The tabulation in annotations for Figure 3 (Table 1) provides pertinent details on support facilities. of Radar Site 1 is shown in Figure 4. The construction chronology of support facilities and utility lines is shown in Figure 5.

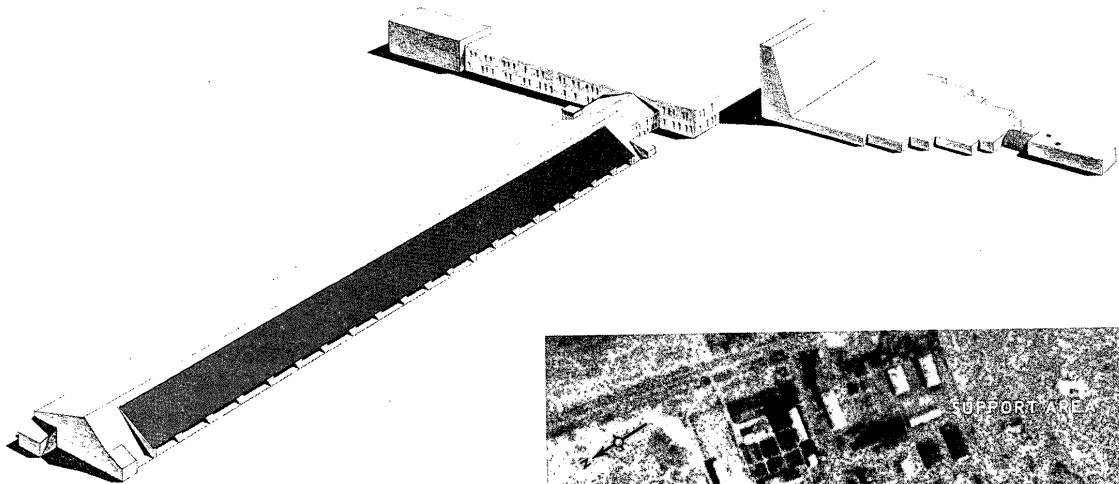
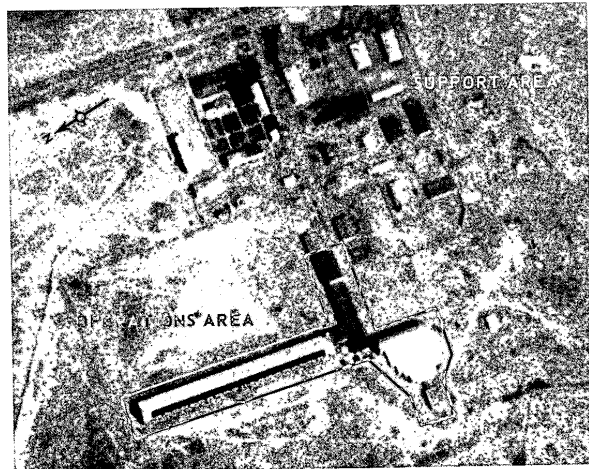
FIGURE 6. CONCEPT OF OPERATIONS AREA AT RADAR SITE 1, [REDACTED]

25X1D The HEN HOUSE antenna structure (Figures 6 and 7), first observed in [redacted] does not appear to have changed significantly through [redacted] 25X1D The structure measures 890 feet in length. Intensive review of the large-scale TALENT photography of [redacted] has 25X1D resulted in certain significant mensural changes, as depicted in Figure 7. The overall width of 25X1D the antenna structure including the shed is [redacted] feet, with the width from the rear wall to the ridgeline [redacted] and from the ridgeline to the front shed wall 45 feet. The height of the struc-

The original control building (Figures 6 and 7) observed in [REDACTED] measured approximately [REDACTED]. It is positioned at right angles to the south end of the antenna structure and is connected to it by a building 85 feet long by 65 feet wide. By [REDACTED] an extension was being added to the east end of the control building. Construction continued in [REDACTED] the extension appeared complete externally except for possible

TRIANGULAR FACILITY AND VERTICAL SCREEN (Figures 6 and 8)

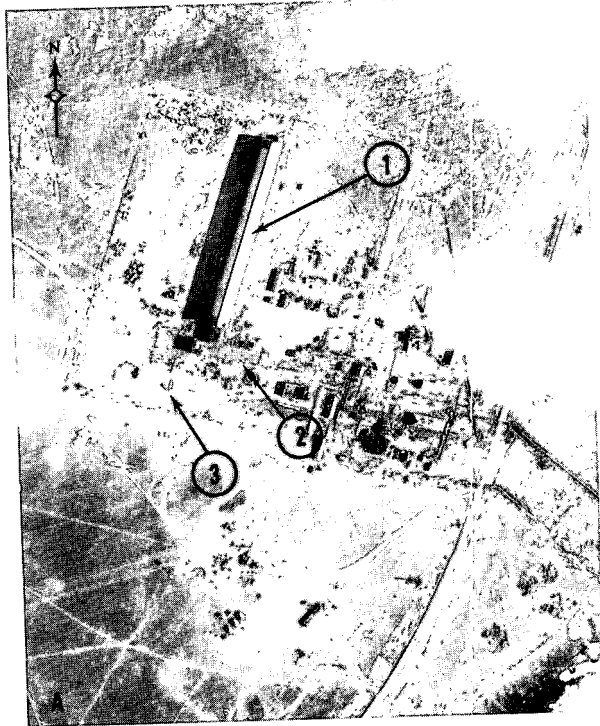
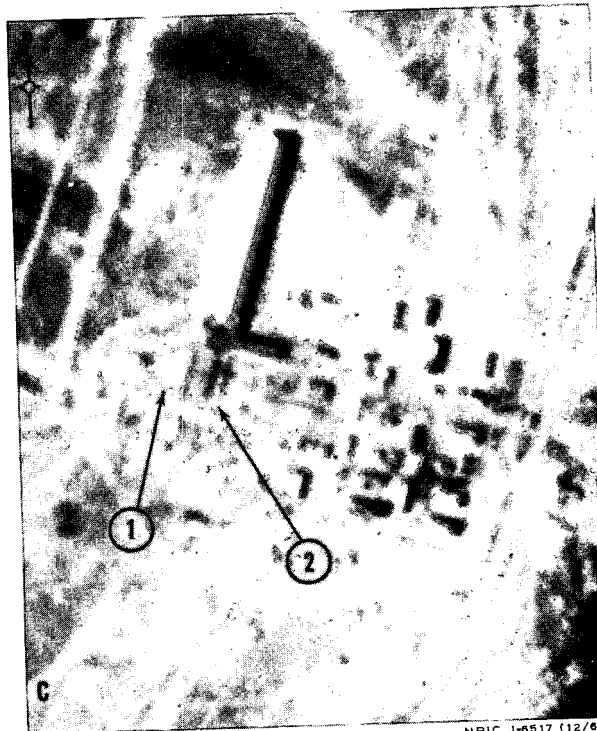
FIGURE 9. DEVELOPMENT OF THE OPERATIONS AREA OF RADAR SITE 1 [redacted]

25X1D
A. In [redacted] Radar Site 1 consisted of an antenna structure (1) with light-toned panels in the antenna face and a control building (2). Note initial earth scraping (3) to the southwest of the control building.

25X1D
B. By [redacted] a stepped light-toned triangular facility (1) with a low building (2) at its apex is under development. Construction activity (3) is noted to the east of the triangular facility.

C. Work continues on the triangular facility (1) and in the area (2) to the east of it in [redacted]

Development of the HENHOUSE antenna and other components of the operations area is depicted in Figures 9 through 11.

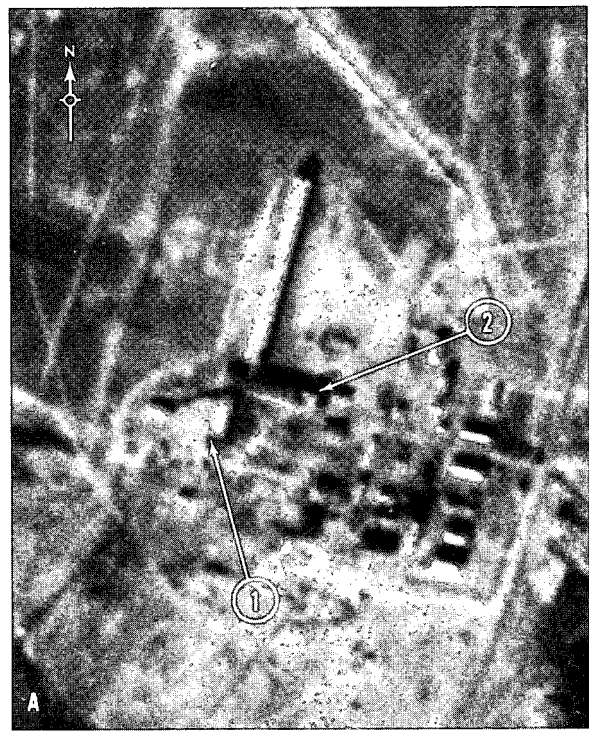
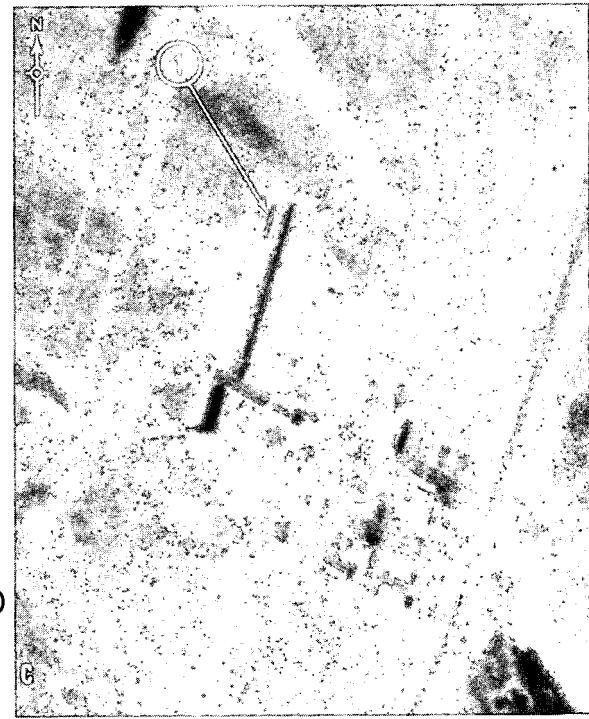
FIGURE 10. DEVELOPMENT OF THE OPERATIONS AREA OF RADAR SITE 1 FROM [redacted] 25X1D

A. On [redacted] 25X1D photography work is noted on the probable base (1) for a vertical screen to be erected and on an extension (2) to the control building.

B. The vertical screen (1) at the base of the triangular facility (2) and the extension (3) to the control building appear complete or nearly complete externally on small-scale photography of [redacted] 25X1D

C. A segment (1) of the HEN HOUSE antenna face approximately 1,900 feet long appears dark in tone on photography of [redacted] 25X1D

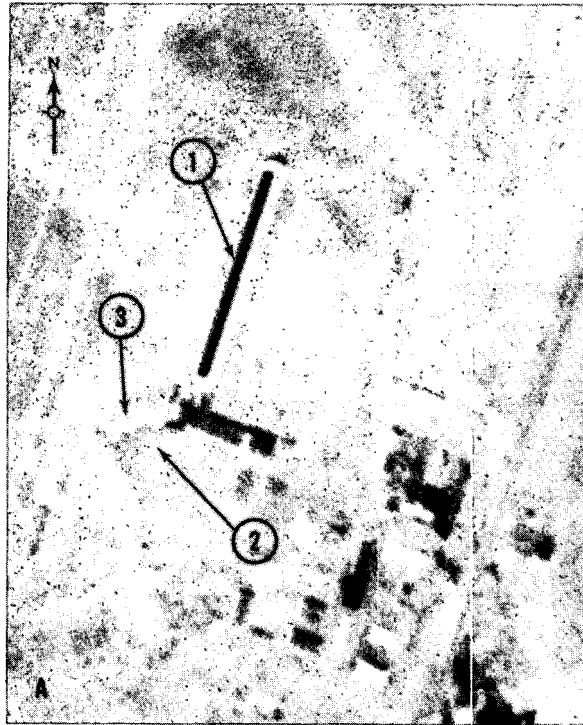
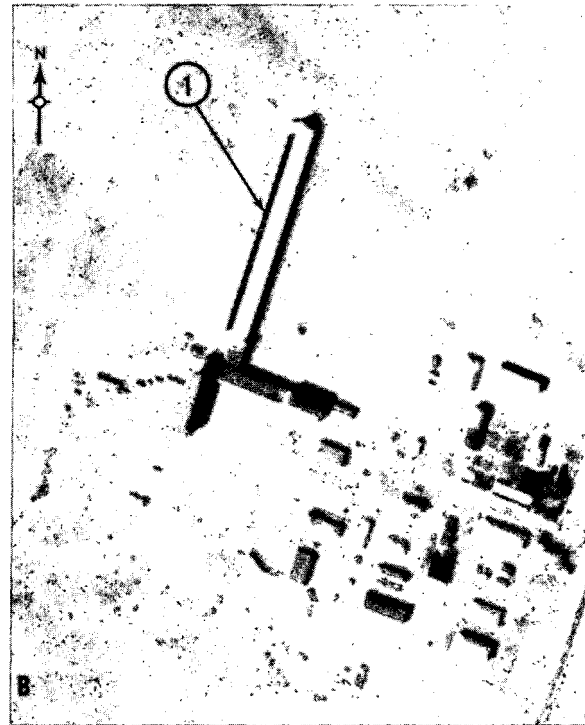
FIGURE 11. DEVELOPMENT OF THE OPERATIONS AREA OF RADAR SITE 1 FROM [REDACTED] NPIC J-6519 (12/64) 25X1D

25X1D A. On photography of [REDACTED] the entire antenna face (1) appears black. The vertical screen (2) and triangular facility (3) are barely visible.

B. The antenna face (1) remains black on the latest available coverage of [REDACTED] 25X1D

off the vertical. The antenna face appeared light-toned on [REDACTED] photography as well as on subsequent available photography when the face was discernible until [REDACTED]. At that time approximately 190 feet along the northern end of the antenna face appeared dark. One year later, on [REDACTED] coverage, and on subsequent missions the entire antenna face appeared black. [REDACTED] the most recent coverage included in this report, the antenna face was not discernible.

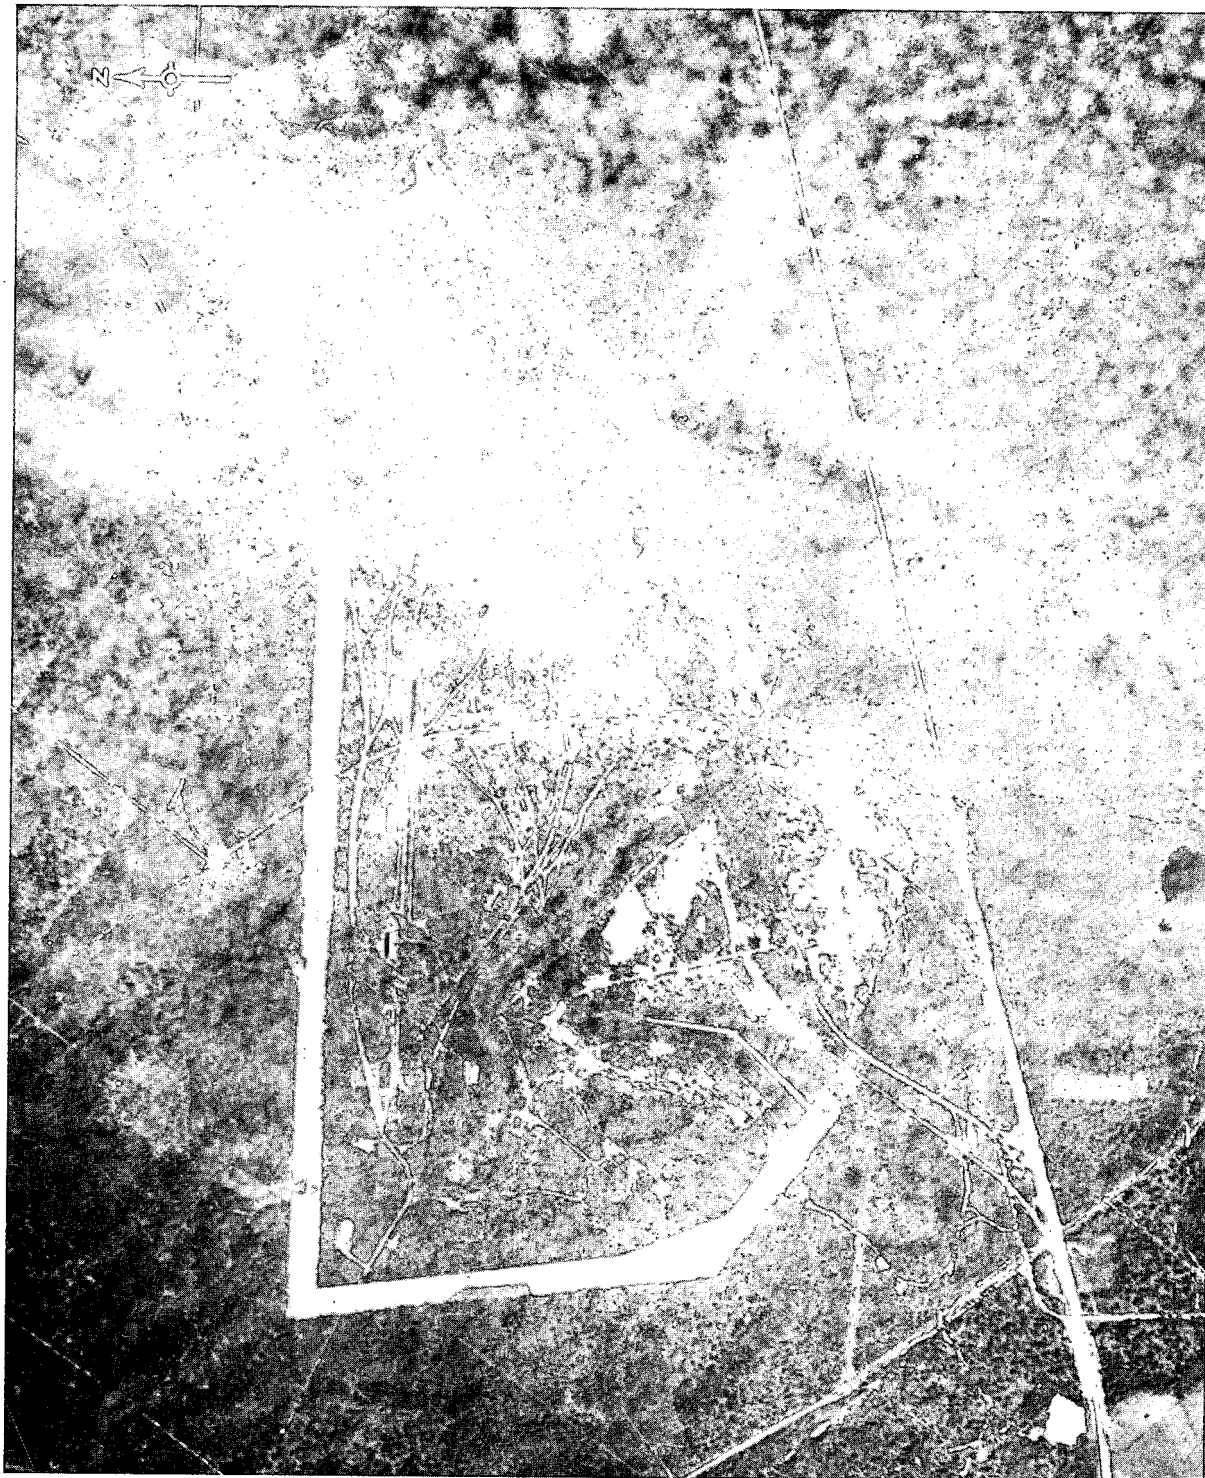
FIGURE 2. RIGA ARMY AMMUNITION DEPOT CEKULI PUG, RIGA, USSR, [REDACTED]

The depot contains 2 barracks, 2 administration buildings, 31 ammunition storage build-

ings (6 built into the side of a hill), 24 support buildings, 1 bunker, 8 possible bunkers, and a possible cave (Figures 2 and 3). The natural terrain provides blast protection.
