CIA/PIR-67227

CIA IMAGERY ANALYSIS DIVISION

SELECTED MILITARY INSTALLATIONS

CHANG HSIN TIEN (PEI-PING AREA), CHINA

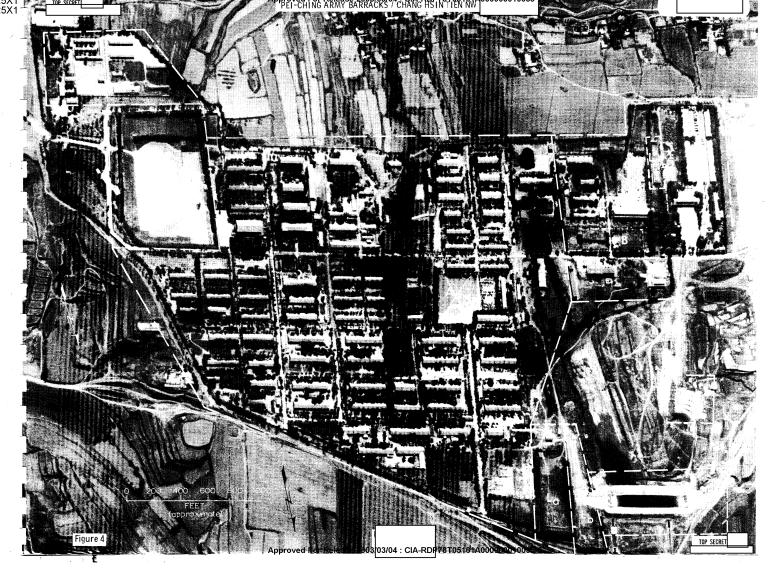
Ec. General support area (Figure 5)

A large miscellaneous area containing an athletic field, basketball court, gardens, 10 storage/support buildings, 5 possible barracks, and one possible messhall building.

Ed. General support area (Figure 5)

This area contains two support buildings and an empty swimming pool.

Id. Subcaliber firing range (Figure 5)

A subcaliber firing range with shed covered firing positions and a maximum range of approximately 170 feet. The shed covering the firing positions has an addition near the center that is possibly used for storage and support.

Subcaliber firing range (Figure 5)

A subcaliber firing range with shed-covered firing positions and an approximate length of 985 feet.

Li. Subcaliber firing range (Figure 5)

A subcaliber firing range with 2 small support buildings, probable moving target runs at approximately 660 and 1,700 feet, and numerous other possible stationary and moving targets at varying distances.

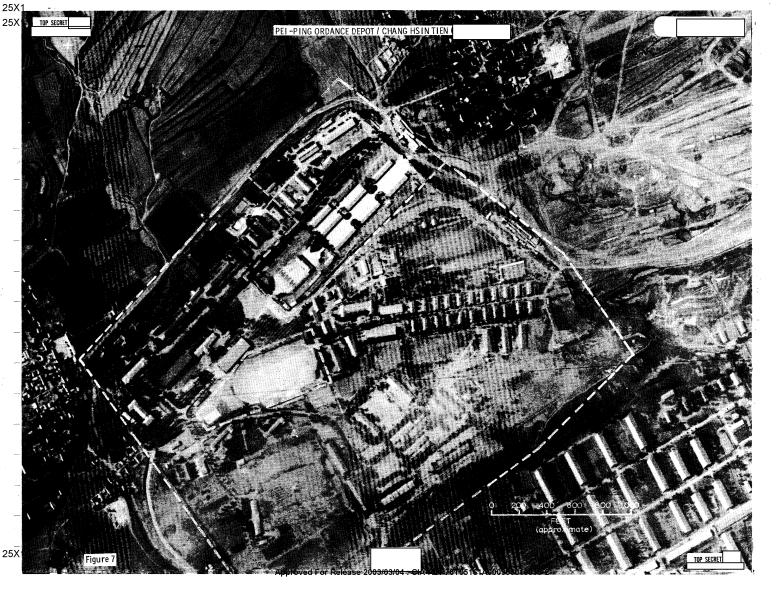
- Billeting and support area (Figure 7)
  - 30 Possible barracks buildings
  - 4 Multistory probable barracks buildings
  - 3 Probable messhall buildings
  - 3 Probable administration buildings
  - 46 Miscellaneous storage/support buildings and sheds

- Vehicle storage and maintenance area (Figure 7)
  - 9 Vehicle storage and maintenance buildings 6@ 180' X 40' 2@ 175' X 50' (Drive-through with roof monitor)....l@ 120' X 50' 4 Probable vehicle storage/maintenance building......2@ 125' X 40' 1@ 150' X 50' 1@ 245' X 50'
  - 16 Small support buildings and sheds
- 6 Vehicle maintenance racks

Personnel training facilities (Figure 7)

This area contains an athletic/parade field and a probable basketball court.

indicates that Comparative photographic coverage from few changes have occurred at this installation during that time period. The medium level of activity has remained relatively constant during the same time period. The single most significant pattern found in this installation is in area B, Figure 7---this area contains a typical tank/ assault gun storage and maintenance area.

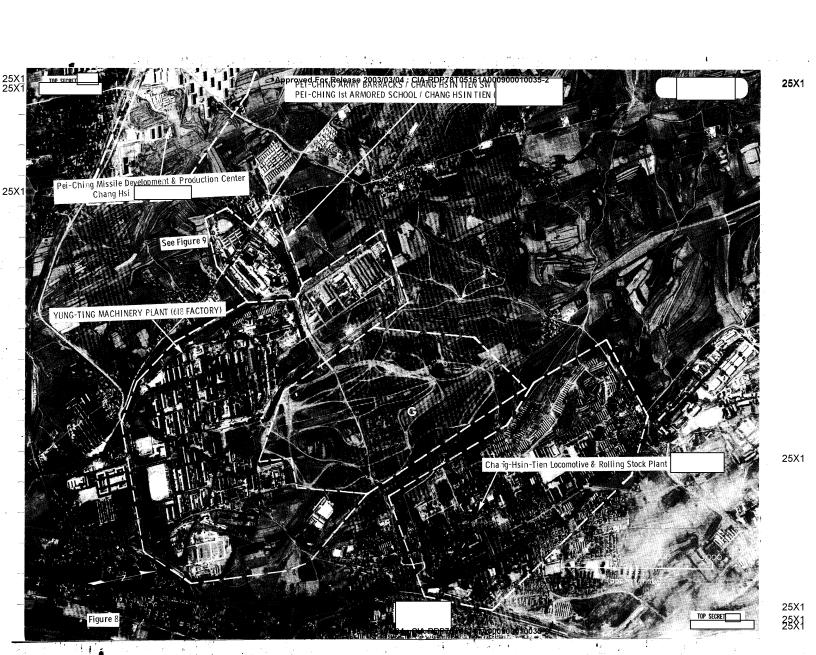
Tracked vehicle test and driver training area (Figure 8)

This area contains an active tracked vehicle test/driver training course.

The Pei-Ching Army Barracks/Chang Hsin Tien and the Pei-Ching lst Armored School/Chang Hsin Tien are located adjacent to the Yung-Ting Machinery Plant, and it is also located in close proximity to the Pei-Ching Missile Development Center and a locomotive plant (See Figure 8). The close areal relationship of the army barracks amd armored school to the Yung-Ting Machinery Plant indicates that the machinery plant may be engaged in the modification or production of armored equipment.

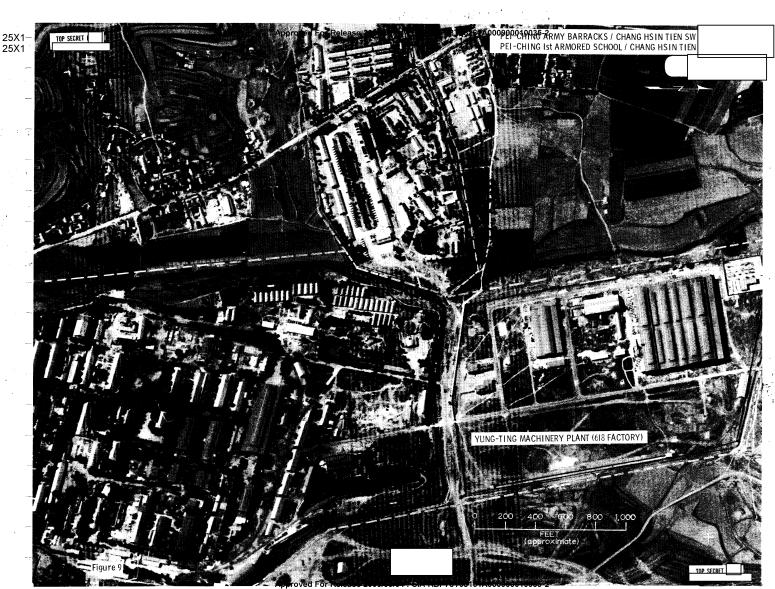
- Billeting area (Figure 9) Aa.
  - 10 Probable barracks buildings
  - l Possible messhall building
  - 10 Small storage/support buildings and sheds
  - 2 Probable basketball courts
  - l Parade/athletic field
- Ab. Billeting area (Figure 9)
  - 7 Probable barracks buildings
  - 1 Probable messhall building ("L" shaped)
  - 1 Storage/support building
- В. Vehicle/equipment storage and maintenance area (Figure 9)
  - 9 Vehicle/equipment storage and maintenance buildings

- 4 Small support buildings/sheds
- 4 Vehicle maintenance ramps Vehicles--49 tanks/assault guns 17 trucks
- Ε. General support area (Figure 9)

This area contains approximately 30 buildings of varying sizes and shapes. The building functions probably include storage, support, administration, messing, classrooms, and possibly limited billeting.
