**Ground Force  
Facilities**

*Basic Imagery Interpretation Report*

**Kai-yuan Army Barracks Northwest AL-4**

**China**

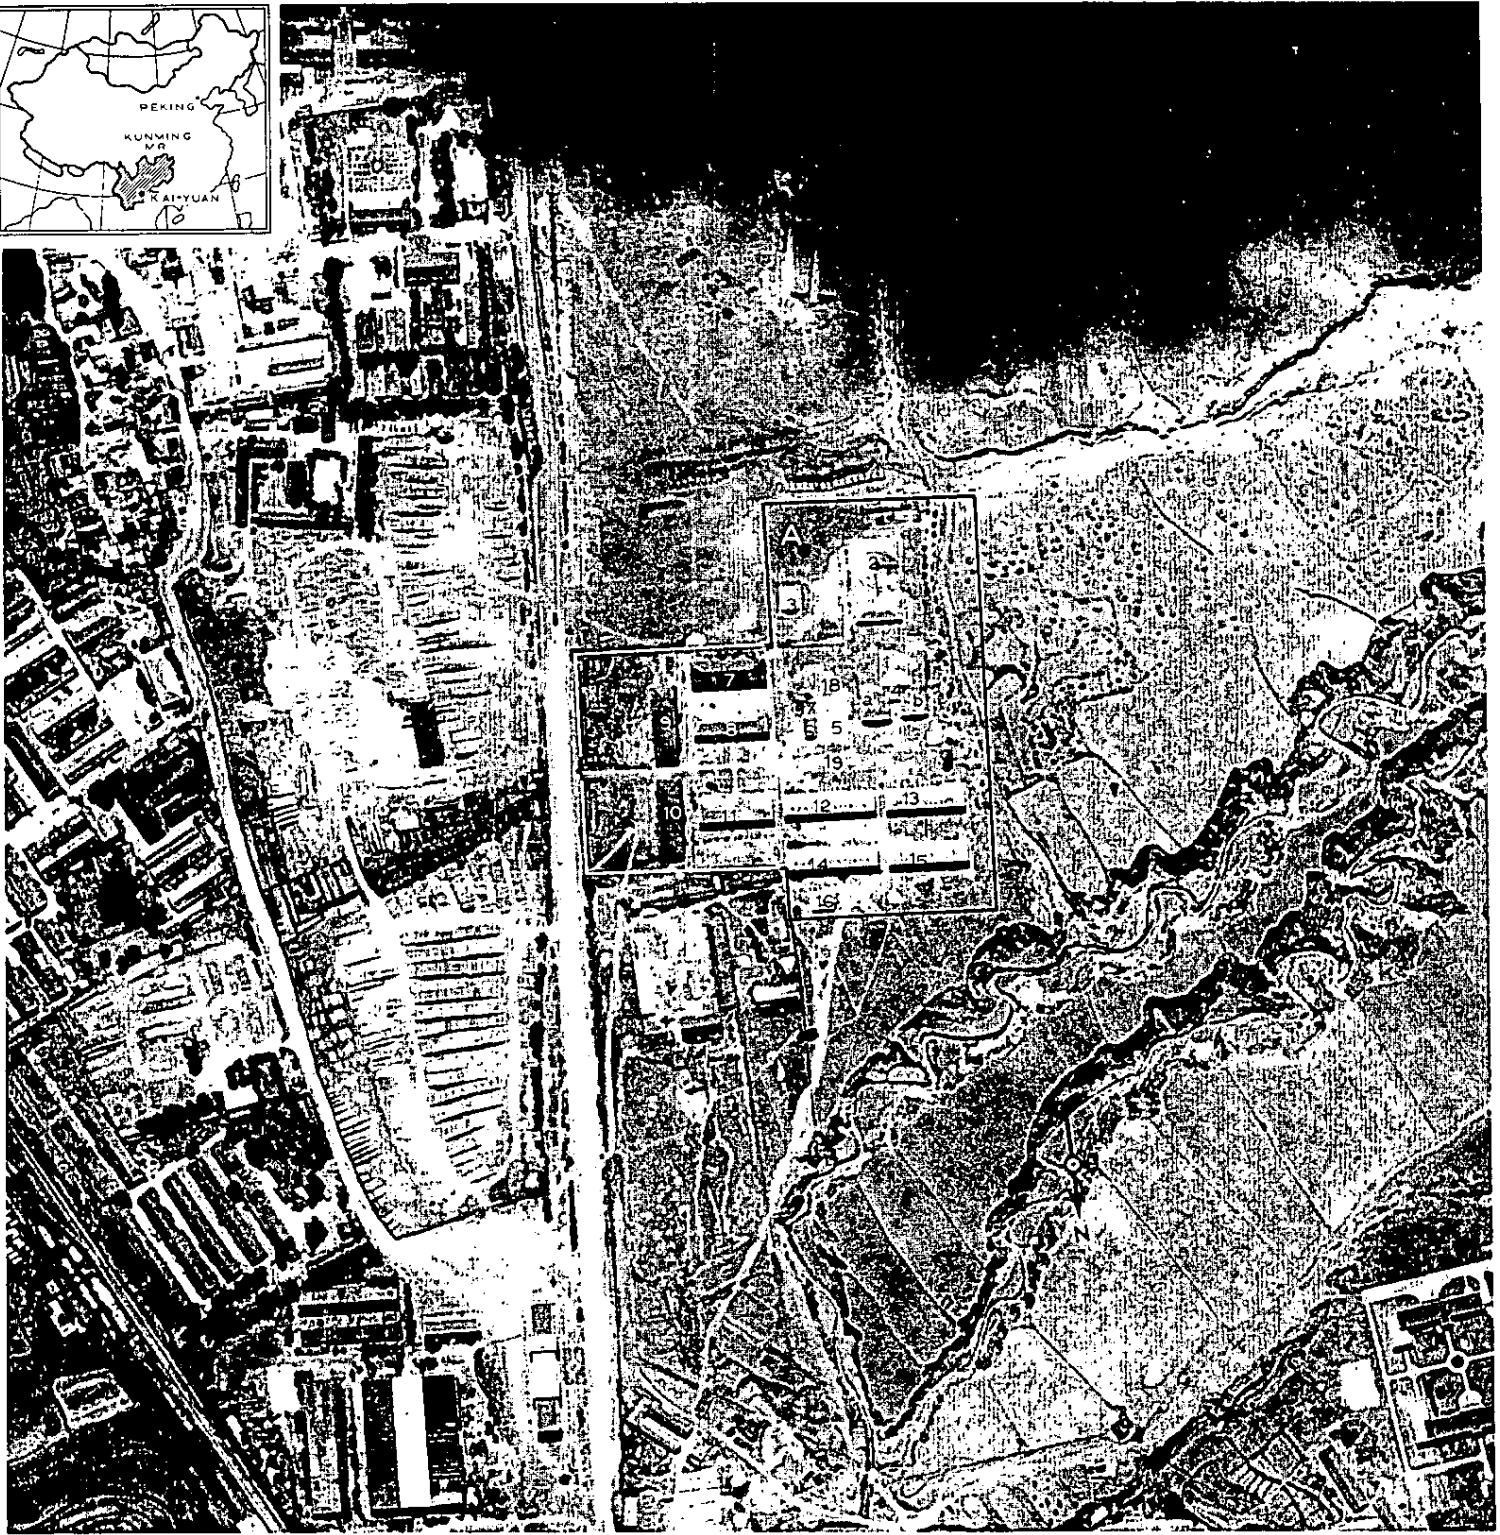
KAI-YUAN ARMY BARRACKS NORTHWEST AL-

- 4 Barracks (two story) (12,14)
- (two story) (13,15)
- 1 Messhall (4) Section a
- Section b
- 1 Administration building (2)
- 3 Administration/support buildings(7,8,11)
- 6 Support buildings(6,9,10,17-19)
- 2 Latrines (3,16)
- 1 Animal pen (1)
- 1 Basketball court (5)
