SUBJECT 1. Observations of Naval and Merchant Vessels in Novorossiysk 2. Navigational Data and Merchant Vessels NO. PAGES 1 in Odessa 3. Naval Vessels with Numerous Antenna REFERENCES DATE OF INFO. PLACE & DATE ACQ SOURCE EVALUATIONS ARE DEFINITIVE. APPRAISAL OF CONTENT IS TENTATIVE. Att. No. 1: A report giving observations of naval and merchant vessels in Novorossiysk six or seven light vessels, perhaps corvettes, at the naval pier. one of these vessels, which put out to segont antennas (each about seven meters high) placed along the full length of the hull on both sides; and there were three other mast antennas on the bridge. The corvette-like vessels had radar, one 76-mm gun forward and another aft, several machine guns, a lattice mast, a single stack, a square stern, a flush deck, no markings, and a hull about 300 feet long, submarine less than 120 feet long, which left Novorosiysk (no further information). Attached to the report is a sketch of the port showing berthing locations and port installations, and a disbursements account for the vessels in Odessa The report lists merchant vessels in the 50X1 port, and devotes six lines to port controls. Attached to the report is a ske

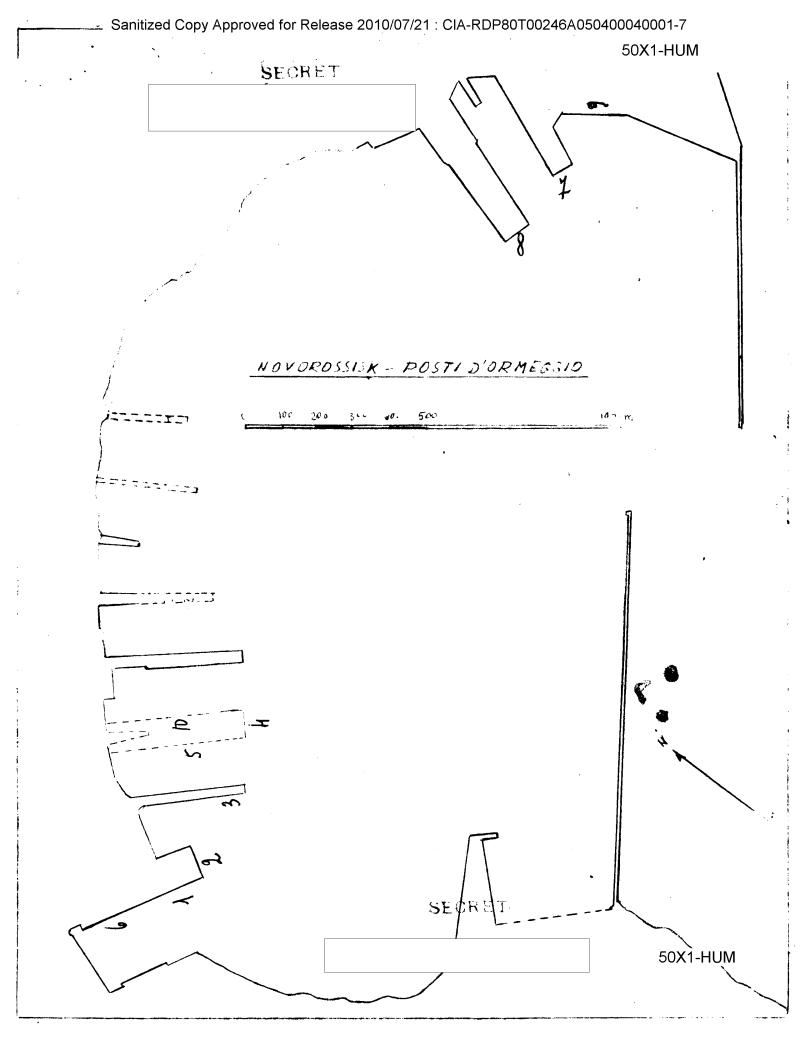
(4), which loaded barley and oats for I	REST.
A floating dock, about 1,000-ton capacity (5), with a	tug in it.
The Sergio Laghi was also in port	50X1-HUM
There were always ships in the roadstead, quite often	tankers, waiting
for berths.	
Naval	
At the naval quay (6) were 6-7 light vessels, perhaps	corvettes,
represented by a sketch [see original]. The	hese vessels 50X1-HUM
had radar, a 76-mm gun forward and another astern, several	machine guns,
a lattice mast, single funnel, and the hull was about 100 m	
square stern One of these had about 20 ma	50X1-HUM
each about 7 meters high, placed along the full length of t	he deck on both
sides. There were three other mast antennas on the bridge,	probably for
the radio. this last mentinned vesse	l put out to 50X1-HUM
sea every evening and returned to port the following morning	g•
On the day of his arrival, a small submarin	e leaving the 50X1-HUM
port. It was not over 40 meters long and had no	r armament.

Sanitized Copy Approved for Release 2010/07/21 : CIA-RDP80T00246A050400040001-7 50X1-HUM Port facilities, etc. (numbers enclosed in parentheses correspond to those on attached sketch) The cement pier (7) has facilities for berthing on both sides, and is built of stone, rising about 2 meters above water level. The coal pier (8) has a large warehouse and heavy-capacity cranes. The small shipyard (9), work being done on 50X1-HUM the hulls of several unidentified small vessels. The grain pier (10) has a large masonry building and 3-4 large cranes running on rails. The lumber pier has no cargo-handling equipment. 50X1-HUM

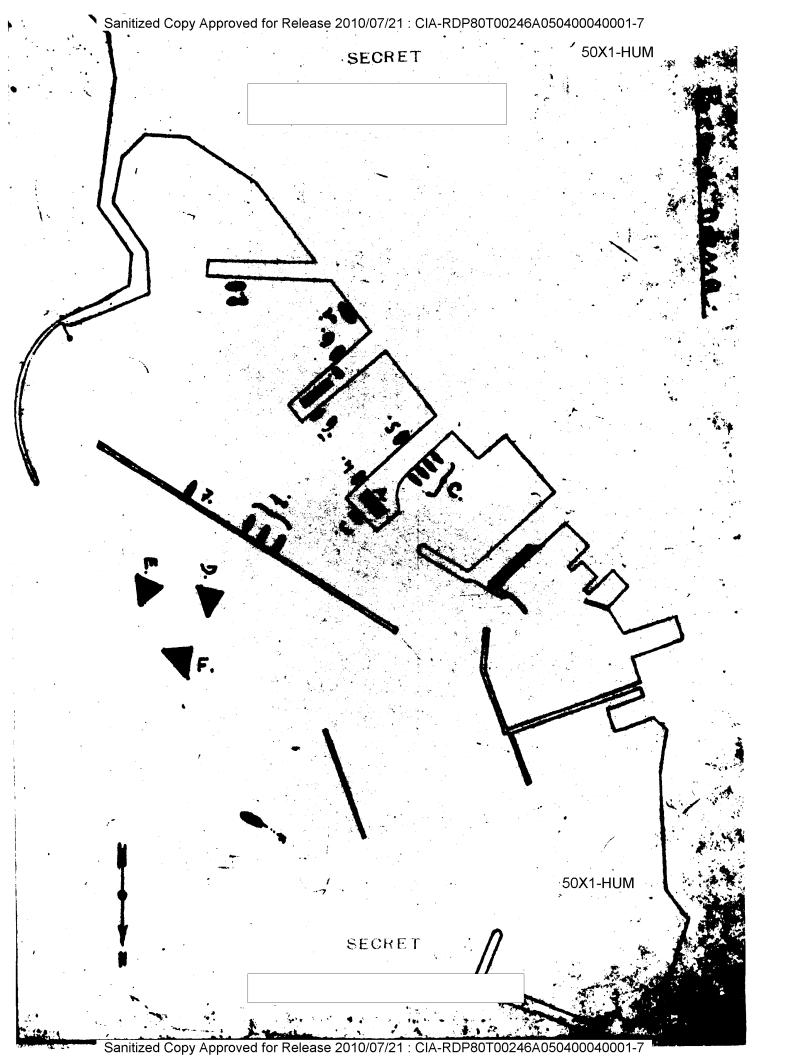
50X1-HUM Sanitized Copy Approved for Release 2010/07/21 : CIA-RDP80T00246A050400040001-7	,
SECRET	
North and a second a second and	
Naval and merchant vessels in port	
<u>Naval</u>	
Three small Soviet naval motor tankers were idle at berth (1).	
From vessel's berth (9), the masts of 3-4 small naval	50X1-HUM
vessels in the port area marked blue on sketch.	50X1-HUM
Merchant	
	7
	50X1-HUM
Thefreighterperthed (3) with a cargo of citrus fruits	
from PALERMO.	
A 10,000-ton Soviet freighter (4) was unloading cargo in medium-size	
boxes.	
An old Soviet freighter of about 6,000-7,000 tons (5) was unloading	
cargo in medium-size boxes.	
An old Soviet freighter of about 6,000-7,000 tons (5) was unloading	
general cargo on forklifts which carried the cargo into a warehouse (A).	
A new 10,000-ton Yugoslav motorship (6) was loading coal.	
A new Soviet Standard-type tanker of about 10,000 tons (7), fully	50V4 LIINA
	50X1-HUM

- Sanitized Copy Approved for Release 2010/07/21 : CIA-RDP801	Γ00246A050400040001-	7 -HUM
An old 20,000-ton Soviet transatlantic liner, tw	/ /o-funnelled, painted	
white (8), left port without passengers at the same t		el.50X1-HUM
Port facilities (numbers and letters in parentheses of		
attached sketch)		
Cargo warehouse (A) is a masonry building where		50X1-HUM
tea, sugar, and lemons stored on a previous visit.		
A masonry shed (B) is used for deposit of citrus	fruits.	
Four old barges (C) are used to transport goods	inside the harbor.	
Three buoys (D, E, and F) are placed in a triang		
from the outer breakwater, perhaps to mark a wreck.		
While berthed at (2), vessel was bunker	ed with 61 tons of	50X1-HUM
fuel oil in about 2 hours by a barge equipped with 20		
with 30 tons of fresh water in about 2 hours from an o		
equipped with a 10-cm hose.	50X1-	HUM
Miscellaneous information		
new port is being constructe	ed south of Cape
