CENTRAL INTELLIGENCE AGENCY
INFORMATION REPORT

SUBJECT Port of Odessa

Port of ODESSA

PORT of ODESSA
(March 1950)

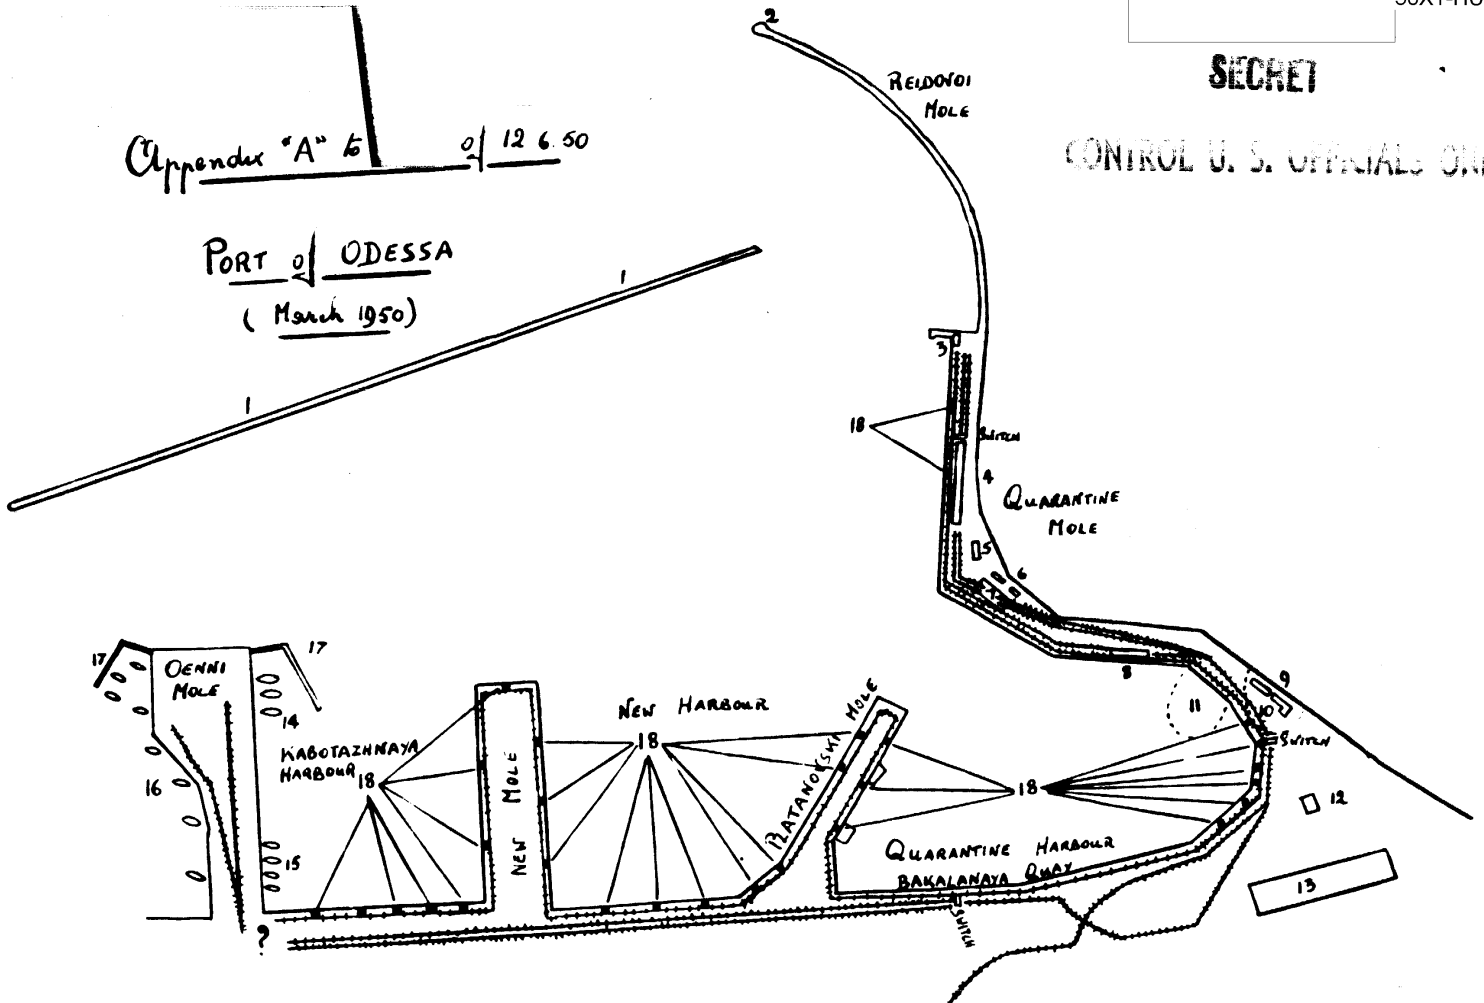
Appendix "A" to 2/12/65

3. Description of the Port. (The numbers refer to the sketch of the port, attached as Appendix A to this report.

- No. 1. Breakwater. The breakwater is made of concrete blocks and has a width of 3,5 to 4 metres. It had been damaged by bombing and was out in several places; cracks due to explosions were noticeable. There is a permanent navigation light flashing green every second. The Southern mole of the breakwater is suitable for mooring and large bollards have been fitted along the whole length. About 9 ships, mainly small tankers, but including the Polish tanker KARPATIA (para.2(c)(viii)) and the Russian cargo vessel GENERAL CHERNIKOVSKI (para 2(b)(i)) were moored at this position.

- No. 2. VORONISOV Light, located at the end of REIDOVOL Mole, flashing red every second.
- No. 3. Signal Station, located at the end of the QUARANTINE Mole.

- No. 4. Silo No. 1. This building is about 60 metres long and 25 metres wide. It is of wooden construction with a zinc roof; it gives the impression of being badly in need of repairs (For railway services see para. 4 below). On the seaward side are 12 tubes with a diameter of 0,50-0,60 metres. When taking grain into the silo each tube handles 50-60 tons per hour; their capacity when loading ships is 60-70 tons per hour each. Electric power of 330 volts is used in the silo installations.

- No. 8. Silo No. 2. This is a concrete construction about 75 metres long and 25 metres wide with a wooden projecting gallery about 50 metres long and 20 metres high supported by metal girders. The silo is an old construction showing many cracks in the concrete walls. The gallery, which has a tar-paper roof and many windows, is also in poor condition. There are large holes in the tar-paper and most, if not all the windows are smashed. Loading into the silo takes place from railway wagons (see railway lay-out para. 4 below). There are openings in the side of the building through which the railway wagons are discharged. It is believed that the grain is then brought to the storage lofts by conveyor belts. It was noticed that wheat was unloaded on the QUARANTINE harbour side and barley and maize on the opposite side. The projecting gallery has 4 tubes for loading ships, situated at 10 metre intervals. The grain is brought to the tubes by conveyor belts. Electric power of 330 volts is used in the silo installation. During March, loading at Silo No. 2 had to be discontinued on several occasions as supplies of grain arriving from BRAILA/RUMANIA were insufficient. The grain arrived in ODESSA in railway wagons of 10, 15 and 20 tons.

No. 11. At this position were about 10 Russian ships undergoing repairs. Their carrying capacity ranged from 4,000 to 10,000 tons.

No. 18. Twenty-nine 330 volt Electric Travelling Cranes.

Most of the cranes are old and in poor condition. On the QUARANTINE Mole, the two cranes operating between the Signal Station and Silo No. 1 are marked No. 4 and No. 5. Their capacity is 10 and 15 tons respectively.

4. Railway Facilities (see Sketch, Appendix A).
