CIA/PIR-61094

ALGERIA SAM SEARCH

This report presents the result of searches within a 25 nautical mile (nm) radius of six locations (Figure 1-4) in Algeria, for evidence of SAM launch site construction, storage sites, training facilities, or SAM-associated equipment. The six locations are:

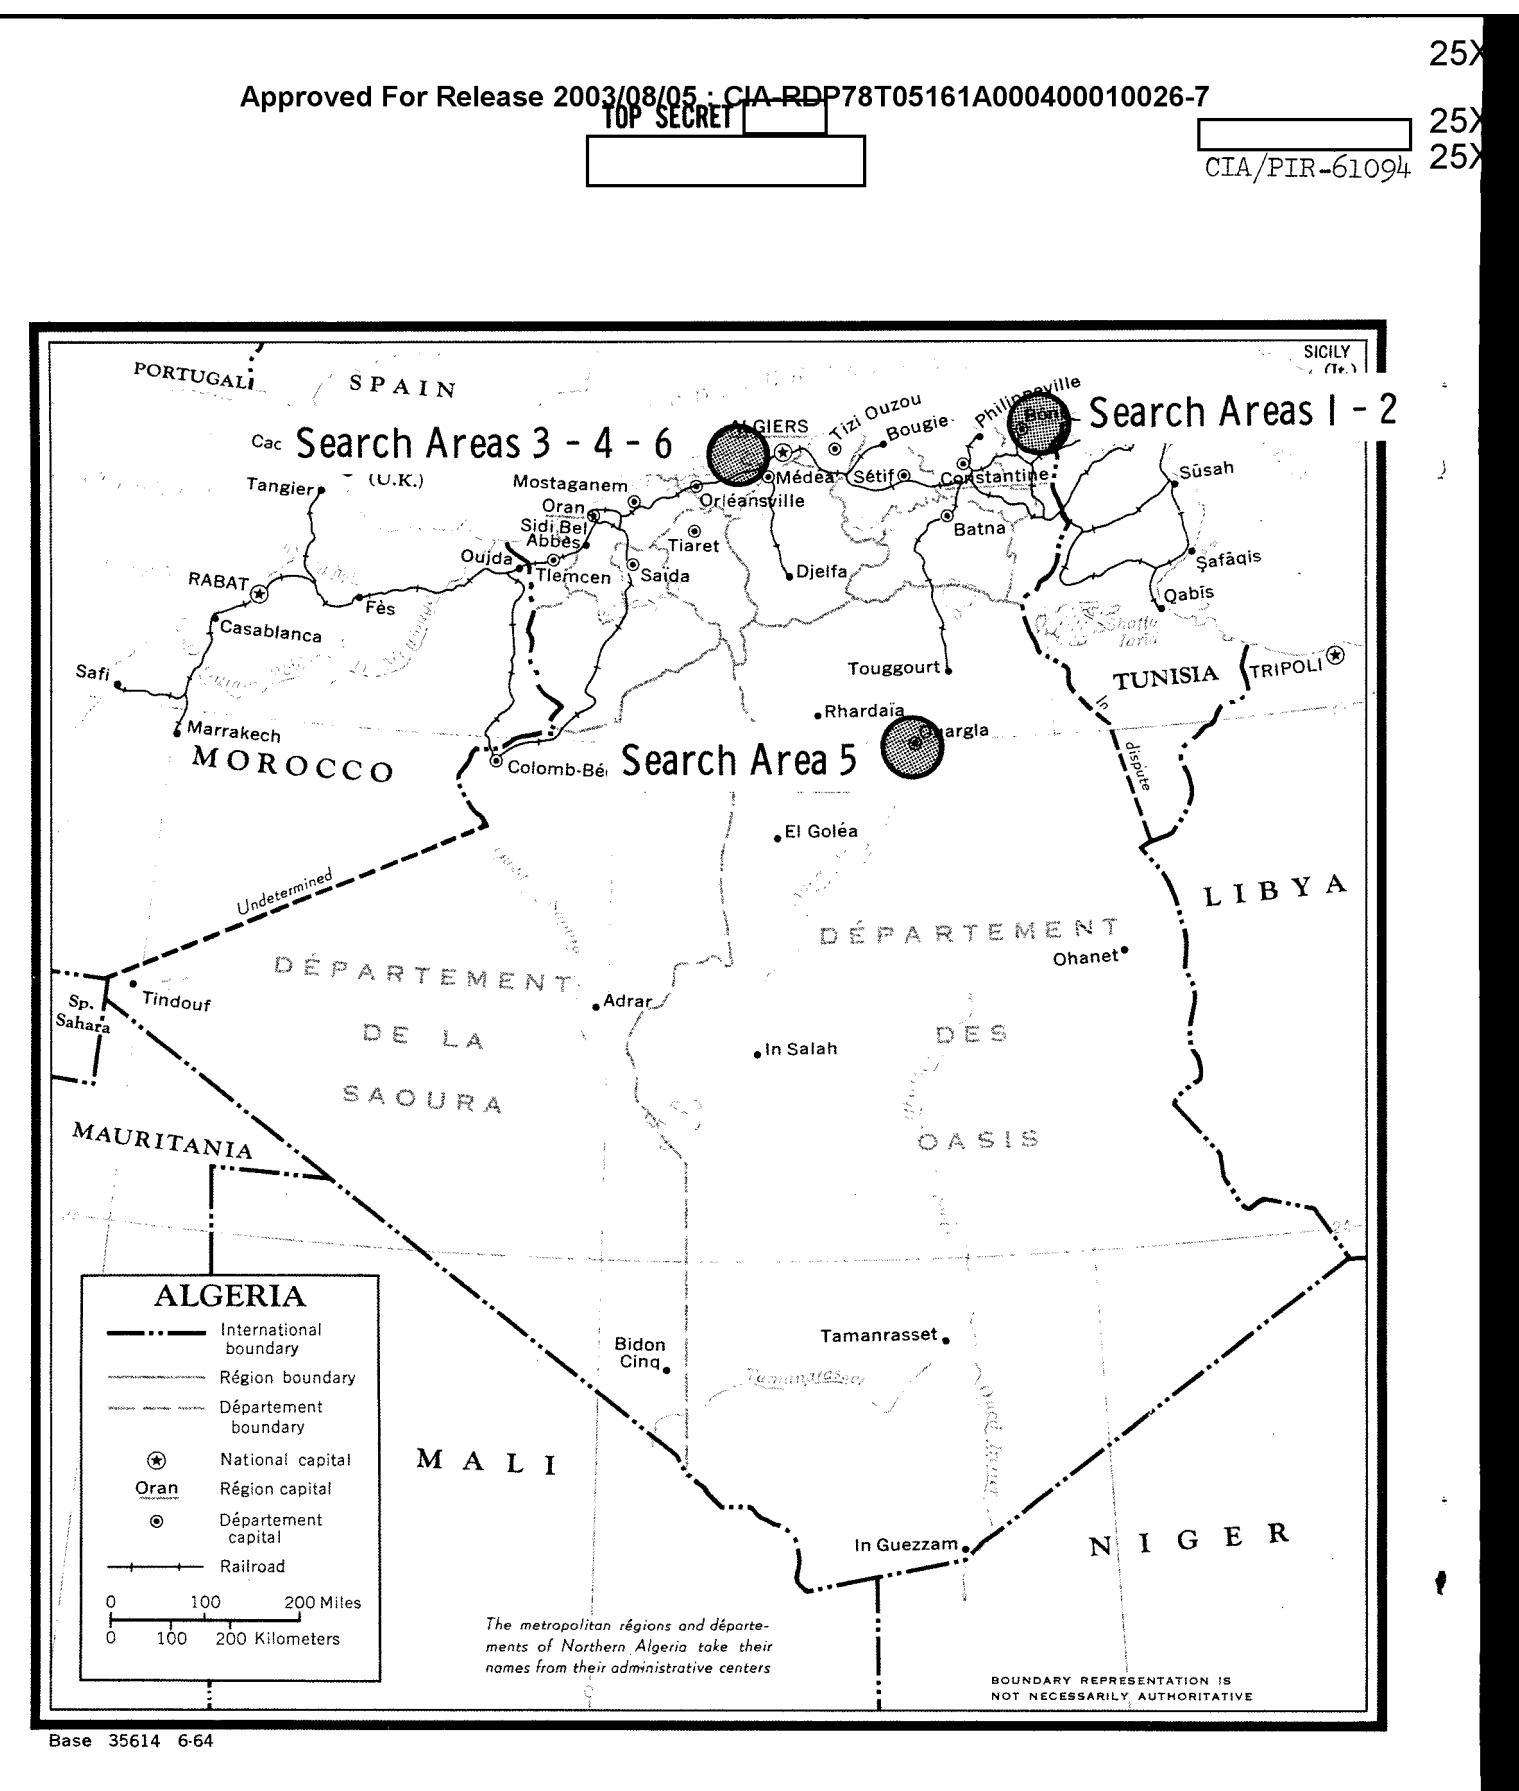
Search Areas

1. Cap Rosa (36-57N 008-14E)

2. La Calle (36-53N 008-26E)

3. Tipasa (36-36N 002-27E)

4. Cherchel (36-36N 002-11E)

5. Ouargla Airfield (31-57N 005-25E)

6. Four nm south of Zurich (36-28N 002-19E)
