8 25X1 SECRET TOP 1a. JOINT PHOTOGRAPHIC INTELLIGENCE REPORT TYURA TAM MISSILE TEST CENTER, USSR A COMPARISON OF 1957, 1959. 4539NC632CE AND 1960 PHOTOGRAPHY PIC/JR-8/61 August 1961 Published and Disseminated by NATIONAL PHOTOGRAPHIC INTERPRETATION CENTER 25X1 TOP SECRET

PIC/JR-8/61

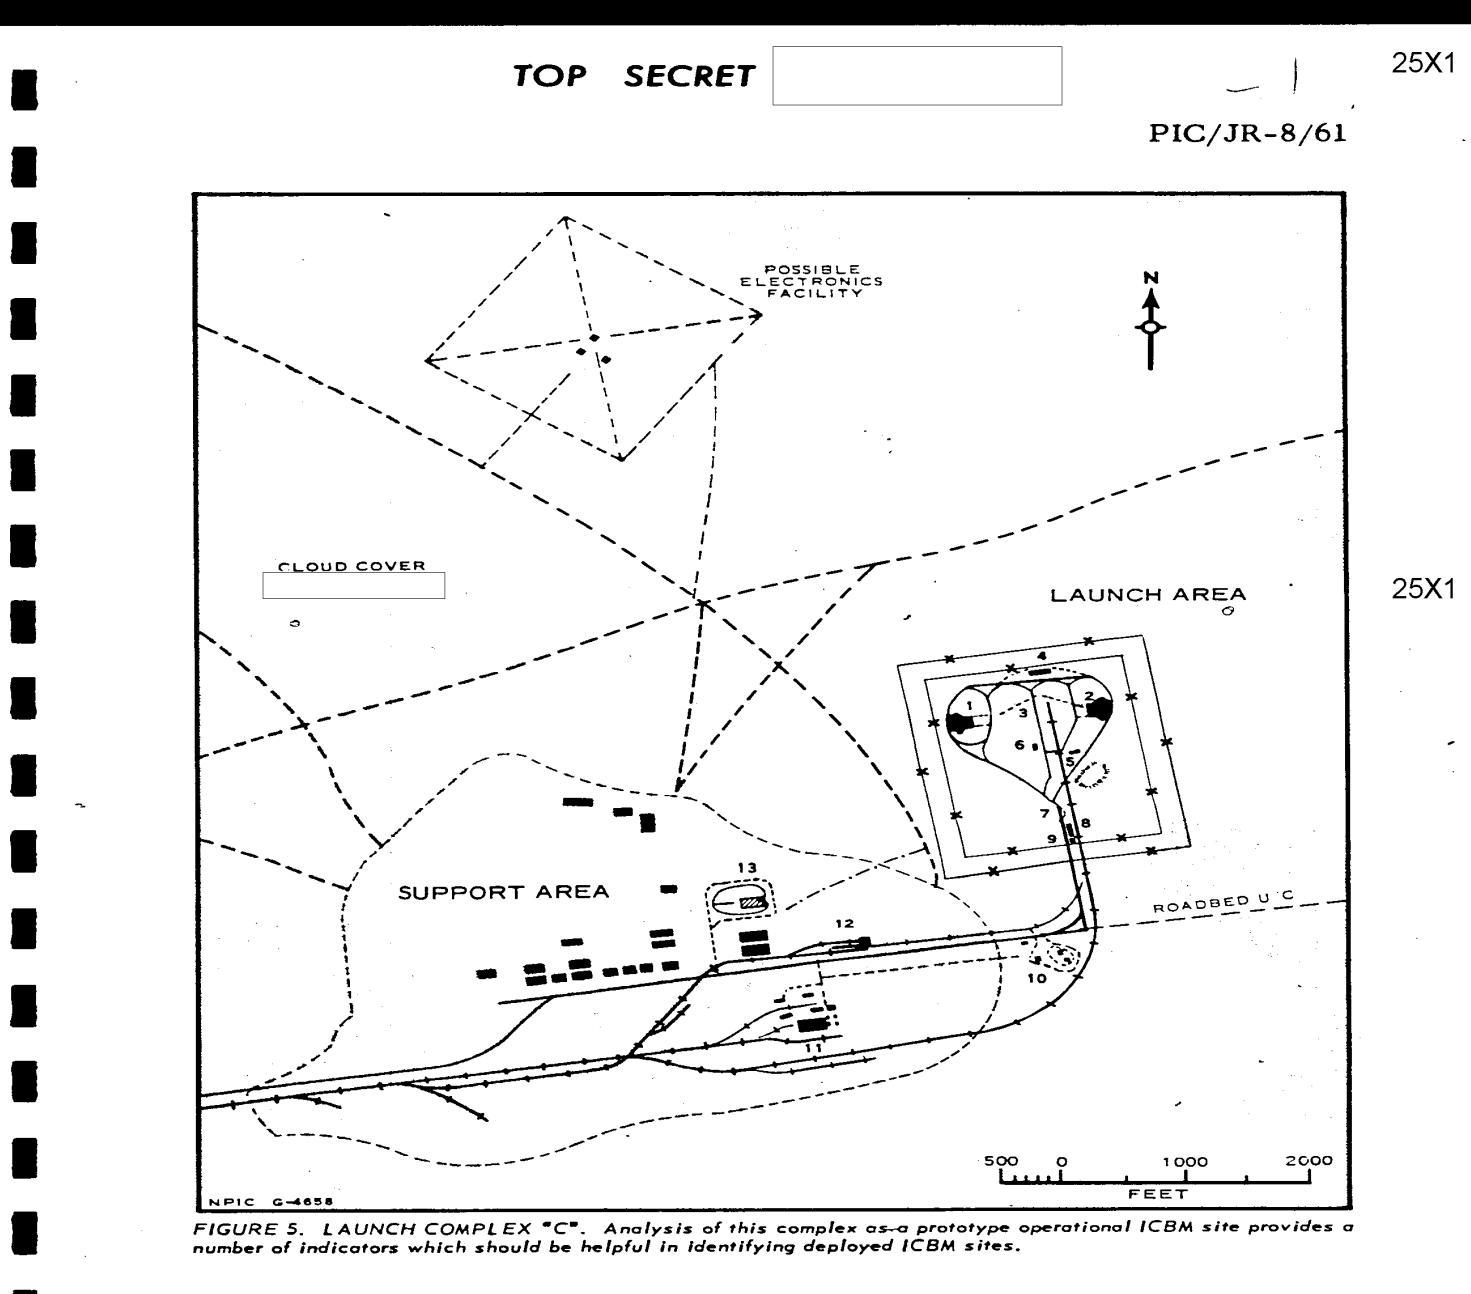
A detailed description of facilities within the Launch Area follows (item numbers are keyed to Figure 5).

1 and 2 -- Launch Sites 1-C and 2-C. The two launch sites are now apparently complete and are nearly identical. Each launch pad is octagonal, and measures approximately 180 by 120 feet, with the long axis oriented generally north-south. The loop road passes along the outside of each pad. The vehicle stalls, under construction in cannot be clearly distinguished from the launch pads themselves, but appear to have been roofed at the same level as the surface of the pads, providing a uniform surface. Two major differences between the two launch sites are First, Launch Site 1-C appears uniformly darker in tone than evident. Site 2-C, suggesting that the two sites are in a different stage of final construction. Second, the secondary service roads which probably provide access to the vehicle stalls for each launch site are aligned differ-Although each road intersects the upper portion of the primary ently. loop service road at about the same relative distance from the launch site it serves, the road serving Launch Site 1-C returns to the loop road after passing the vehicle stalls, whereas the road serving Launch Site 2-C turns to the west after passing the service stalls, then passes just north of the two buried tanks, and intersects the central secondary road. This differ-

<u>3 -- Control Bunker</u>. This bunker, which measured 60 by 45 feet on the ______ photography, has now been buried. Its top appears to be nearly flush with the surrounding terrain, and its outlines are no longer distinct. The cable ditches shown on the April photography connecting the control bunker to the launch sites have now been filled in.

<u>4</u> -- Possible Missile Ready Building. This building, 160 by 45 feet, under construction in ________ ow appears complete. Although the building is north of the main loop service road, a second road, faintly visible, passes through the building and intersects the main road north of each launch site. The building appears to be of ample size to hold at least one missile; the width of the road passing through it suggests that only one missile would be handled in the building at any time. The building could perform one or more of several functions: it could be used for minor recycling of a missile which had previously been on a launch pad;' or, if a rapid refire capability were desired, two missiles could be emplaced at the launch sites while a third missile was stored in the building.

<u>5</u> -- Two Semiburied Tanks. It was concluded in PIC/JR-17/60 <u>3</u>/ that these tanks, were to be used for water storage. It is also possible that these tanks may be used for fuel storage. Their proximity to the rail line suggests that fuel could be easily transferred from rail tank cars to the tanks.

<u>6 -- Unidentified Structure.</u> This structure, approximately 60 by 45 feet, has been built in an area which had been graded on the ________ photography. It is possible that the four cylindrical tanks, each measuring and lying at random along the rail track in ______ have been installed in a bank at this point. Their central location within the Launch Area and their proximity to the circular semiburied tanks suggests that they may be LOX tanks and that a similar transfer method may be employed for both fuel and oxidizer.

The Complex contains two major components: (1) a double-fenced Launch Area containing two "soft" road-served launch pads, and (2) a Launch Support Area containing an Assembly and Checkout Facility, a Possible Warhead Handling Facility, and an Administration and Housing Area. A third component, a Possible Electronics Facility, has been added since (see Figure 5).

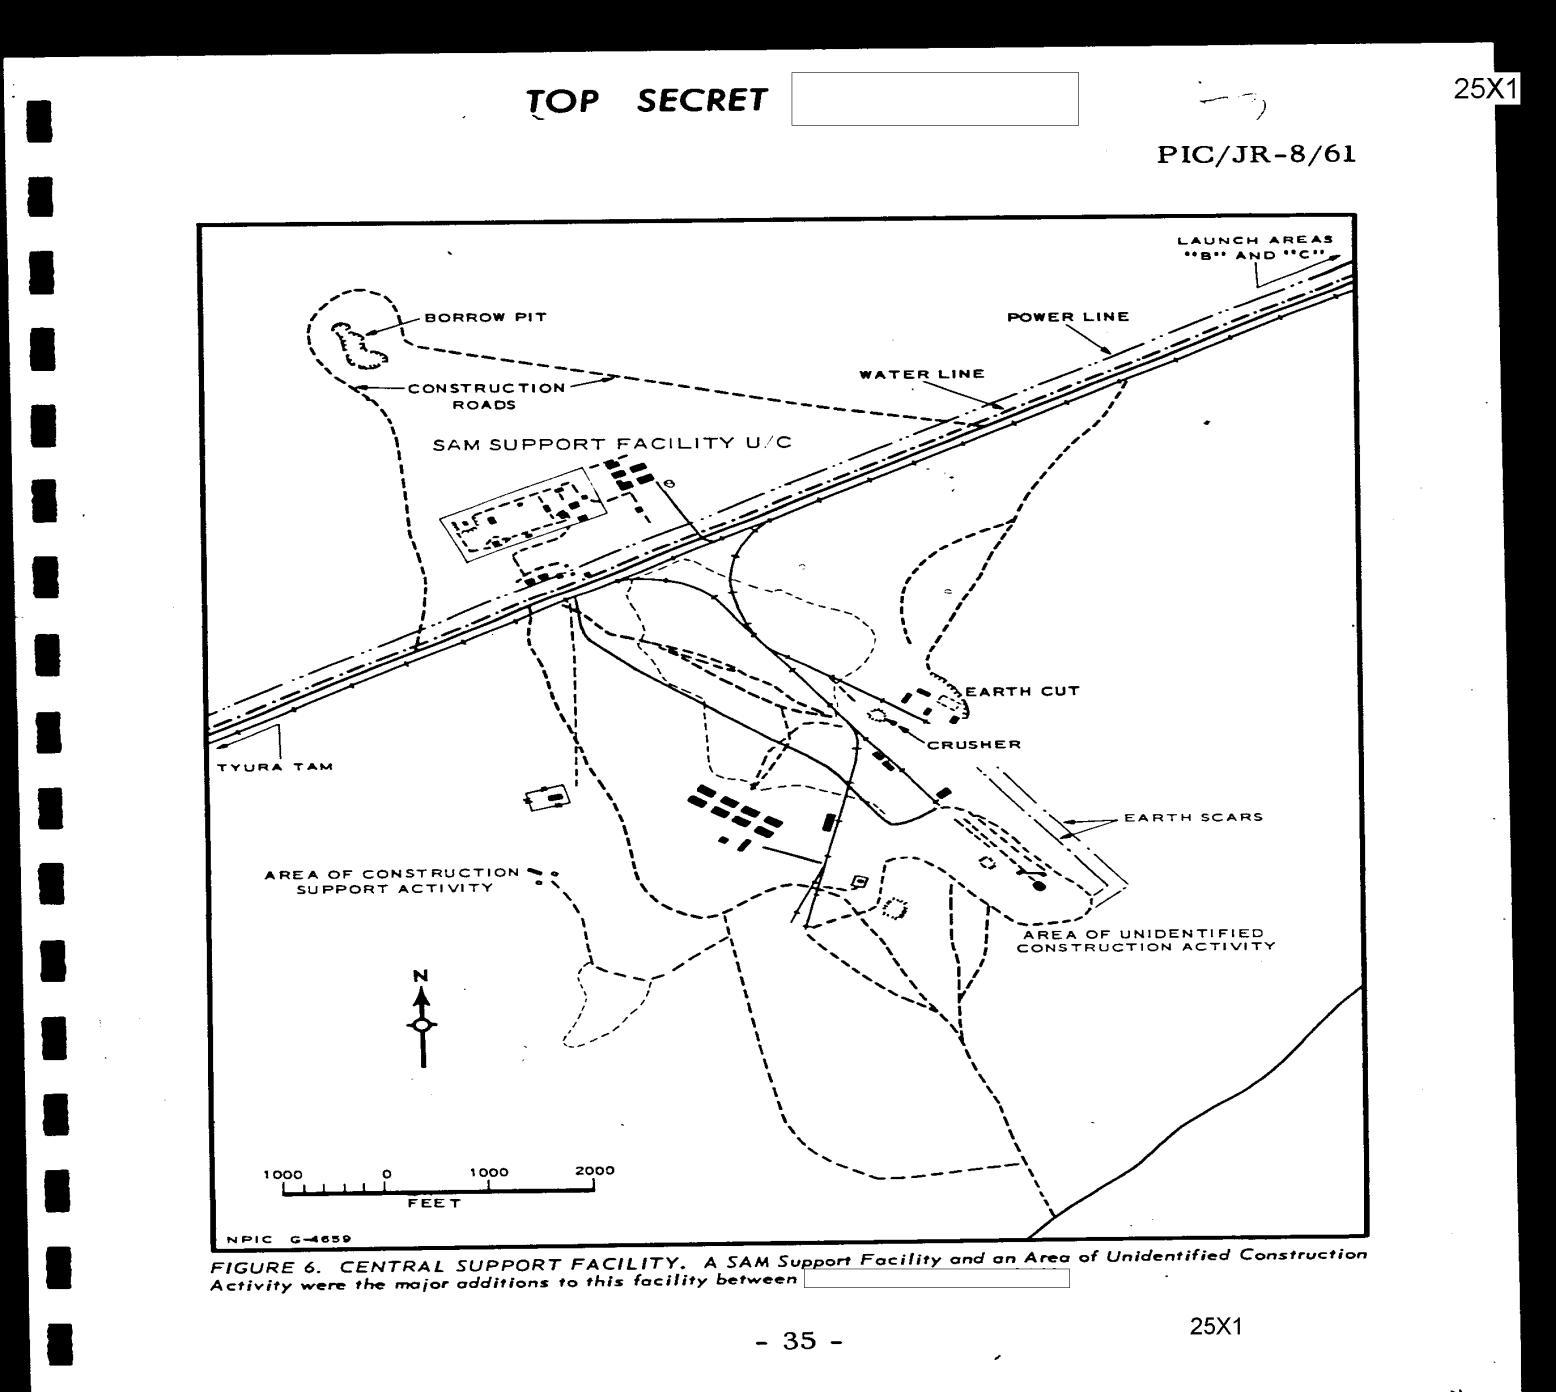
A SAM Support Facility (see Figure 6) is under construction near the center of the oval pattern of SAM sites, at 43-53-30N 063-26-00E. The facility is similar in size, road layout, and number and type of buildings to other SAM support facilities found elsewhere in the USSR and East Germany. One feature found at the Tyura Tam site which is not evident at other sites is the presence of five barracks-type buildings immediately adjacent to the Support Facility. However, most other SAM support facilities have been constructed at or near existing antiaircraft artillery barracks or other military installations. Since no such facility exists at the Test Center, it is probable that this group of buildings is used to house personnel associated with the SAM defense system.

The SAM Support Facility is enclosed by a single fence, measuring about 1,500 by 600 feet. The interior road net skirts the inside of the fence, and at least nine buildings, including one revetted bunker, are vi-

Area of Construction Support Activity. The expansion of the construction support facilities noted since ______ appears to be commensurate with the expansion of range facilities during that period. New facilities (shown in green on Figure 6) include two new rail spurs. One of these has been added to the original rail spur near its north end to form a wye (which, incidentally, provides the only point north of Tyura Tam village where rolling stock can be turned around). The second spur branches off the original spur to the southwest, for a distance of 2,500 feet. A third, shorter, spur, 850 feet long, branches off the second spur near its midpoint. This spur may serve as a storage spur for construction material.
