PHOTOGRAPHIC INTERPRETATION REPORT

SOVIET MILITARY ORDER OF BATTLE MOSCOW MD

VLADIMIR ARMY BARRACKS
AND

TRAINING CENTER
(56-07N 040-21E)

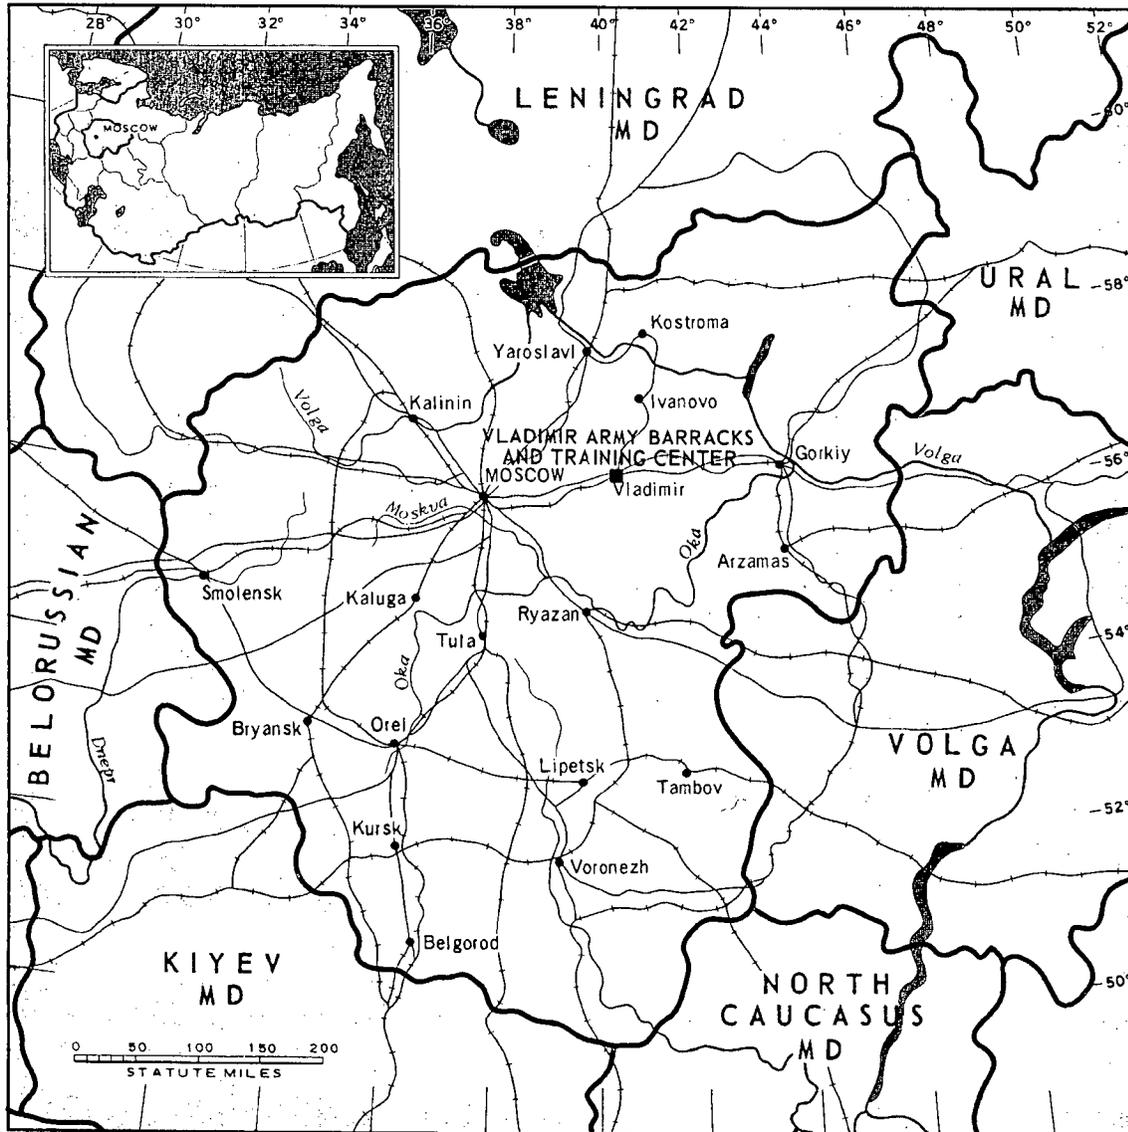
FIGURE 1. LOCATION OF VLADIMIR ARMY BARRACKS AND TRAINING CENTER.

Vladimir Army Barracks and Training Center is located in the western section of Vladimir (Figure 1). Associated driver-training courses and a vehicle park are 7 kilometers (km) west of the barracks area and an associated ammunition storage area is 5 km west-southwest of the barracks.

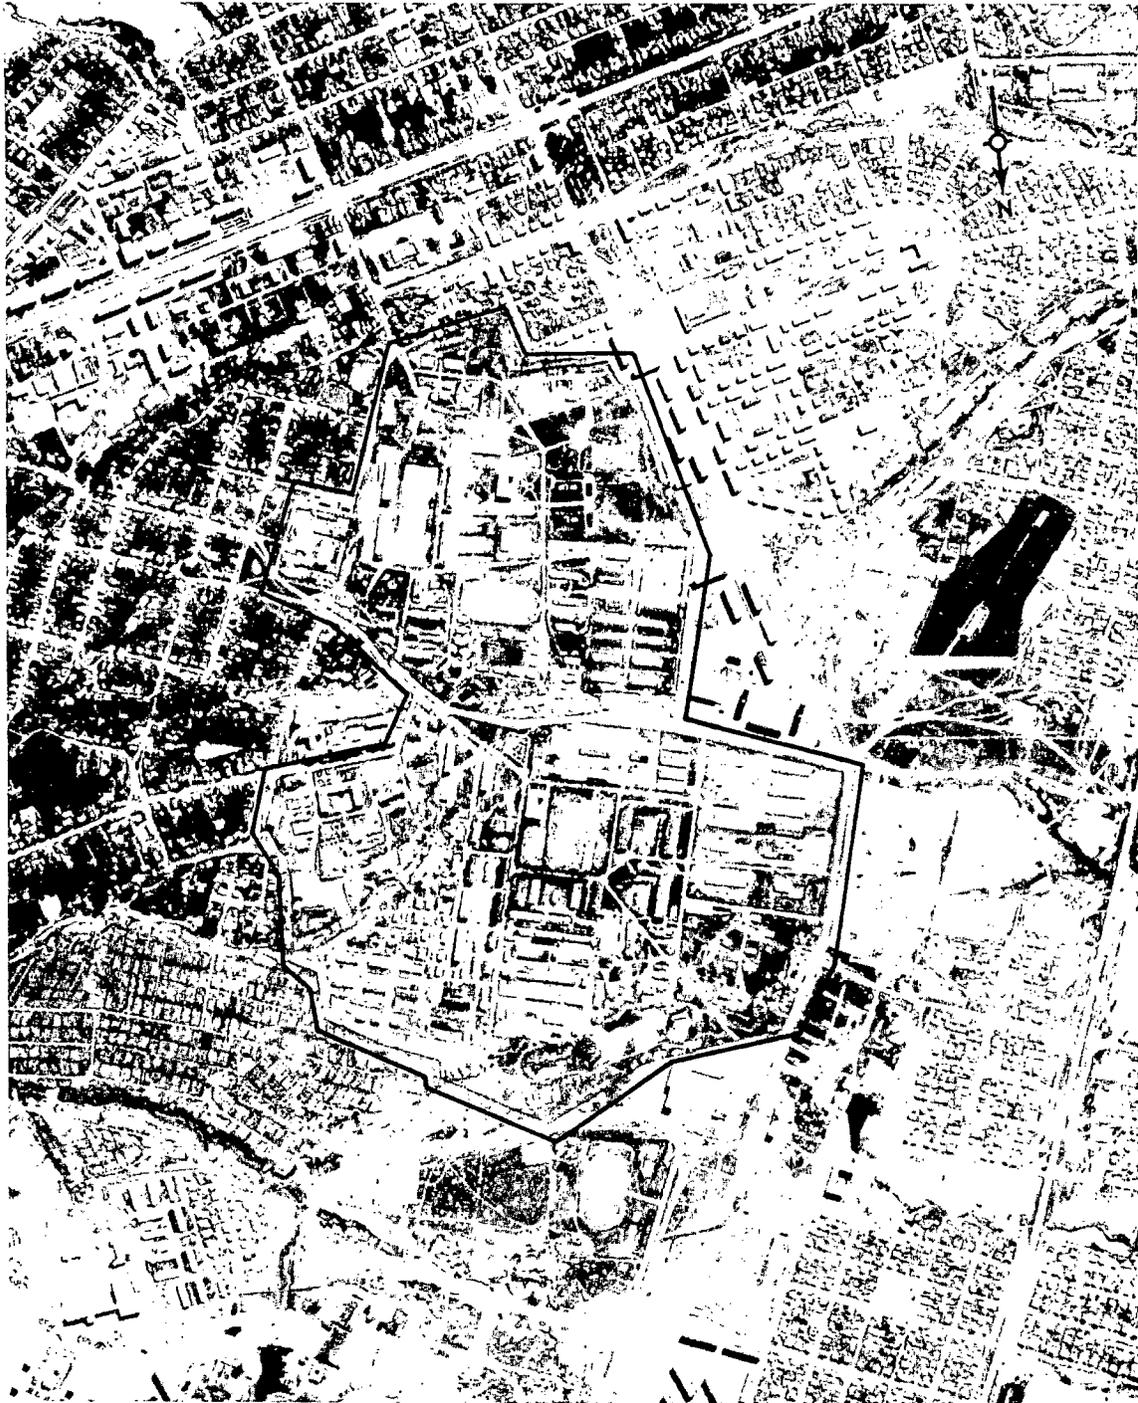
FIGURE 2. VLADIMIR ARMY BARRACKS AND TRAINING CENTER, VLADIMIR, USSR, JUNE 1964.

The barracks area covers approximately 336 acres and contains 3 administration/classroom buildings, 6 administration buildings, 18 barracks, 4 barracks/quarters, 28 officers/dependents quarters, 63 storage buildings, 96 support buildings, 1 vehicle maintenance building, 4 vehicle sheds, 2 athletic fields, a possible prison with 1 prison barracks, 2 storage buildings, and 3 support buildings (Figures 2 and 3).

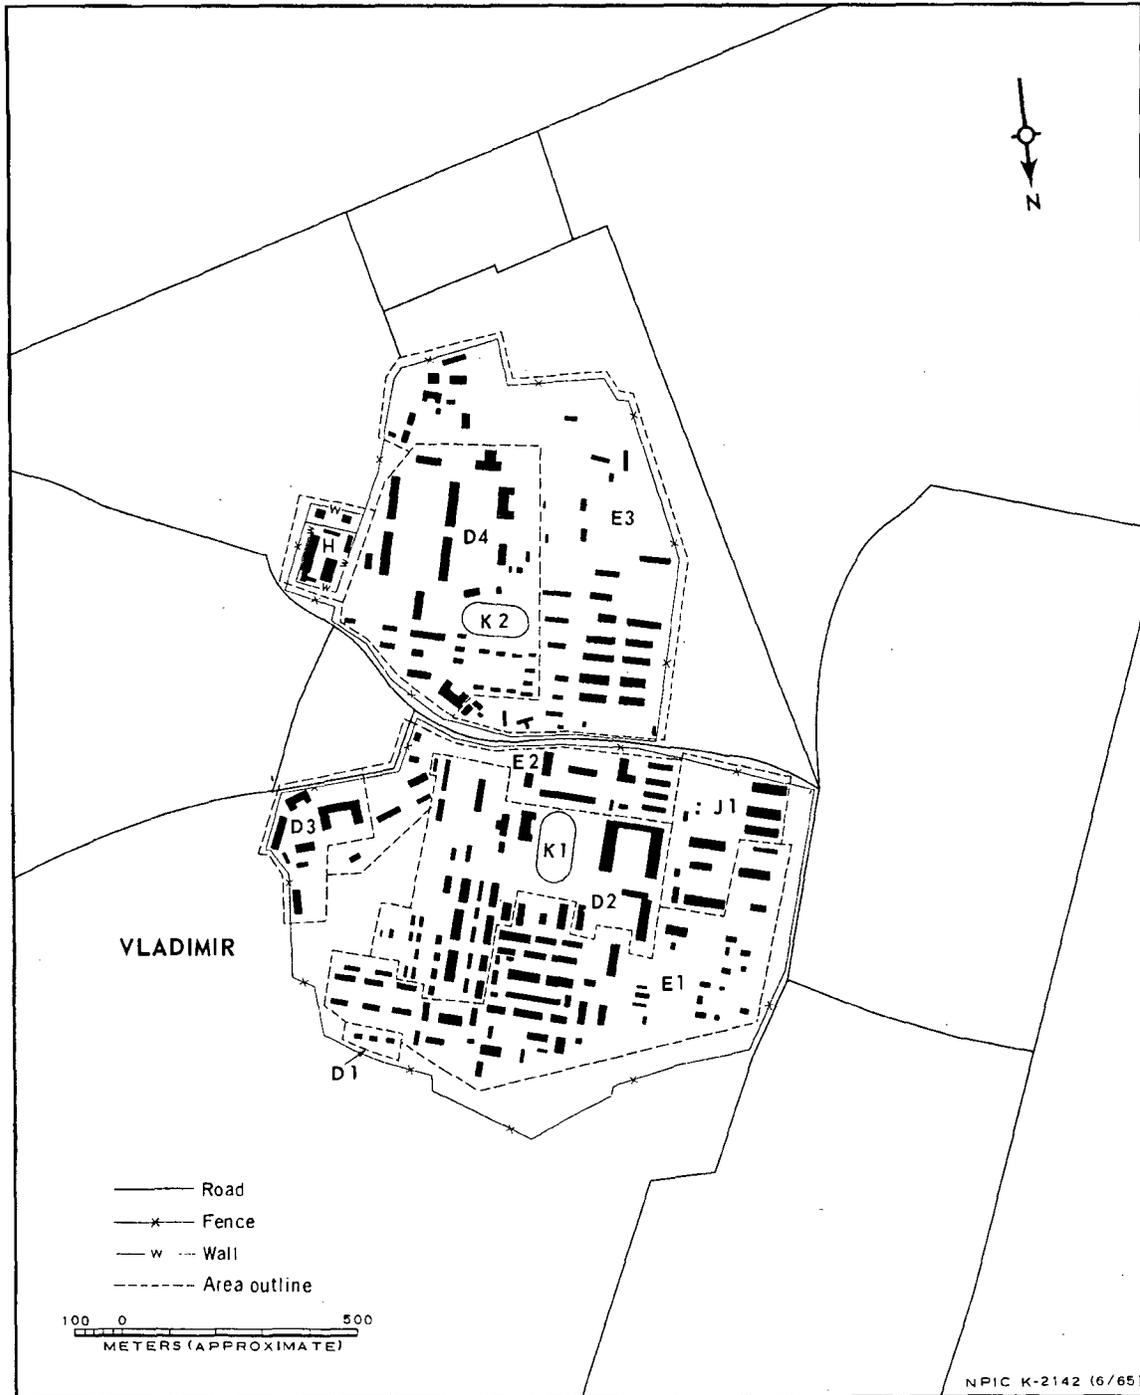
FIGURE 3. VLADIMIR ARMY BARRACKS AND TRAINING CENTER. Sketch compiled from [redacted] June 1964.

Area D1 contains 3 officers/dependents quarters.

Area D2 contains 2 administration/classroom buildings, 2 administration buildings, 8 barracks, 4 barracks/quarters, 13 officers/dependents quarters, 2 storage buildings, and 8 support buildings.

Area D3 contains 1 administration/classroom building, 1 administration building, 2 barracks, 1 storage building, and 2 support buildings.

Area D4 contains 3 administration buildings, 8 barracks, 12 officers/dependents quarters, 3 storage buildings, and 9 support buildings.

Area E1 contains 28 storage buildings and 38 support buildings. Two buildings were removed from this area between September 1962 and September 1963.

Area E2 contains 10 storage buildings and 7 support buildings.

Area E3 contains 19 storage buildings and 26 support buildings.

Area H, a walled area, is a possible prison area containing 1 possible prison barracks, 2 storage buildings, and 3 support buildings.

Area J contains 1 vehicle maintenance building, 240 by 50 feet, 4 vehicle sheds, three 240 by 50 feet and one 270 by 50 feet, and 6 support buildings. Vehicles and equipment were observed in this area on June 1964 coverage.

Areas K1 and K2 are athletic fields.
