PHOTOGRAPHIC INTERPRETATION REPORT

SOVIET MILITARY ORDER OF BATTLE BALTIC MD

STORAGE AREA
(55-53N 026-32E)
DAUGAVPILS, LATVIYSKAYA SSR, USSR
BAL TIC MD

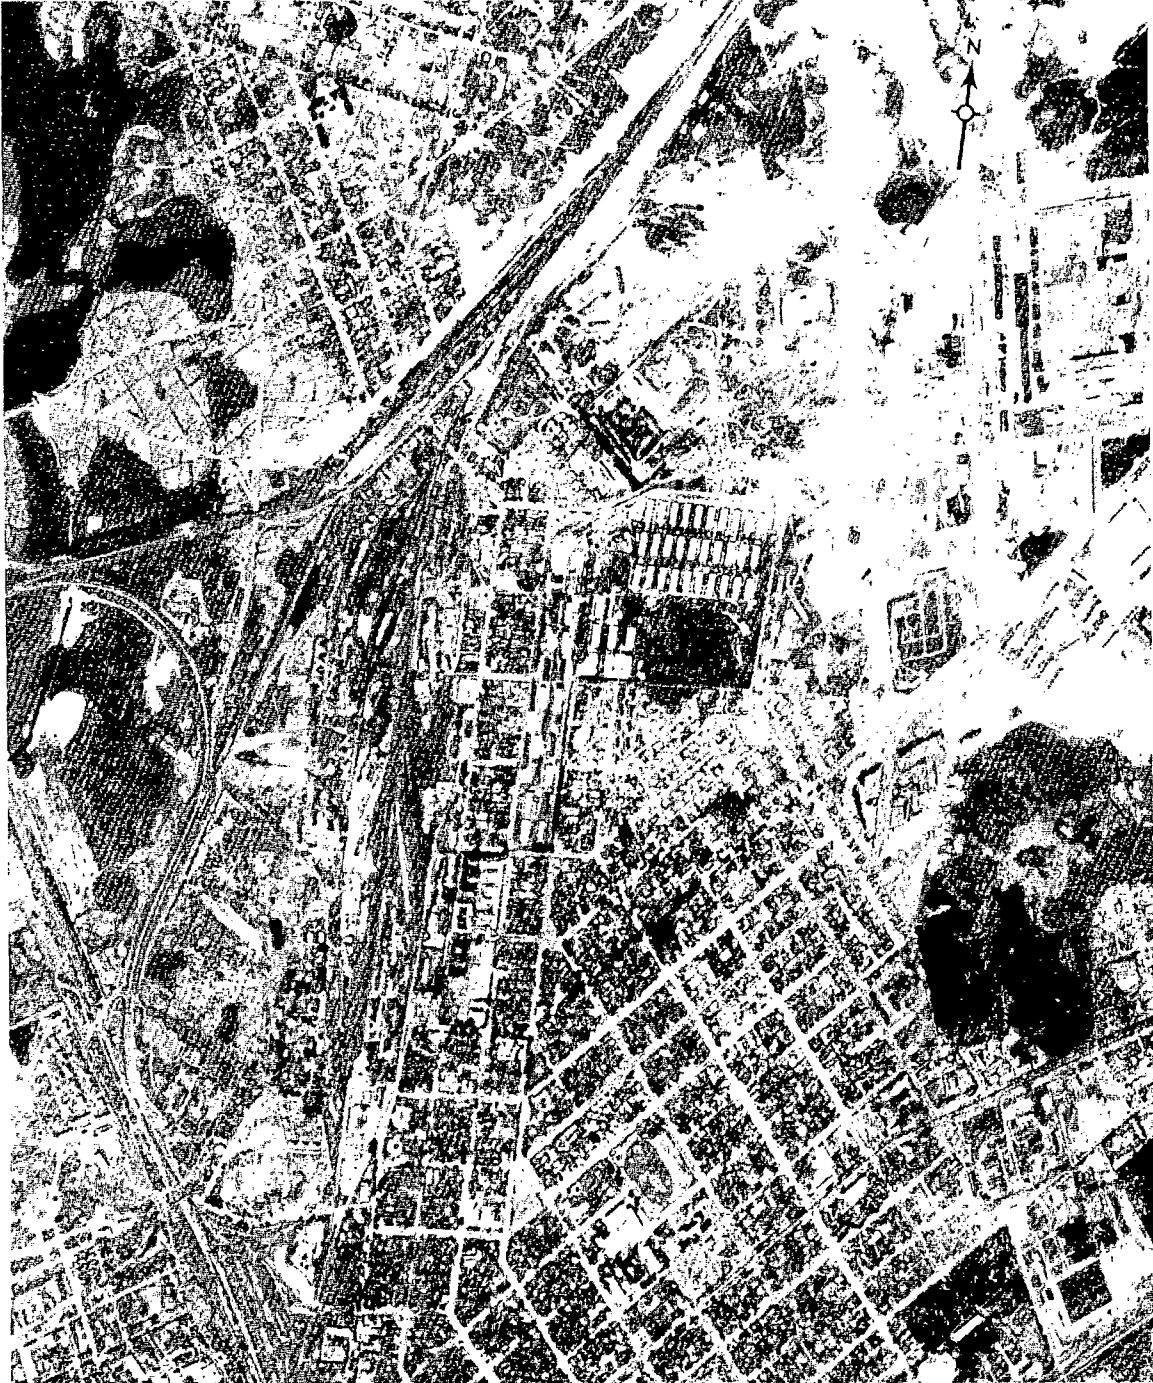
FIGURE 2. STORAGE AREA, DAUGAVPILS, USSR, JUNE 1964.

The installation covers approximately 250 acres and contains 7 administration buildings, 9 barracks, 90 storage buildings, and 19 support buildings (Figures 2 and 3).

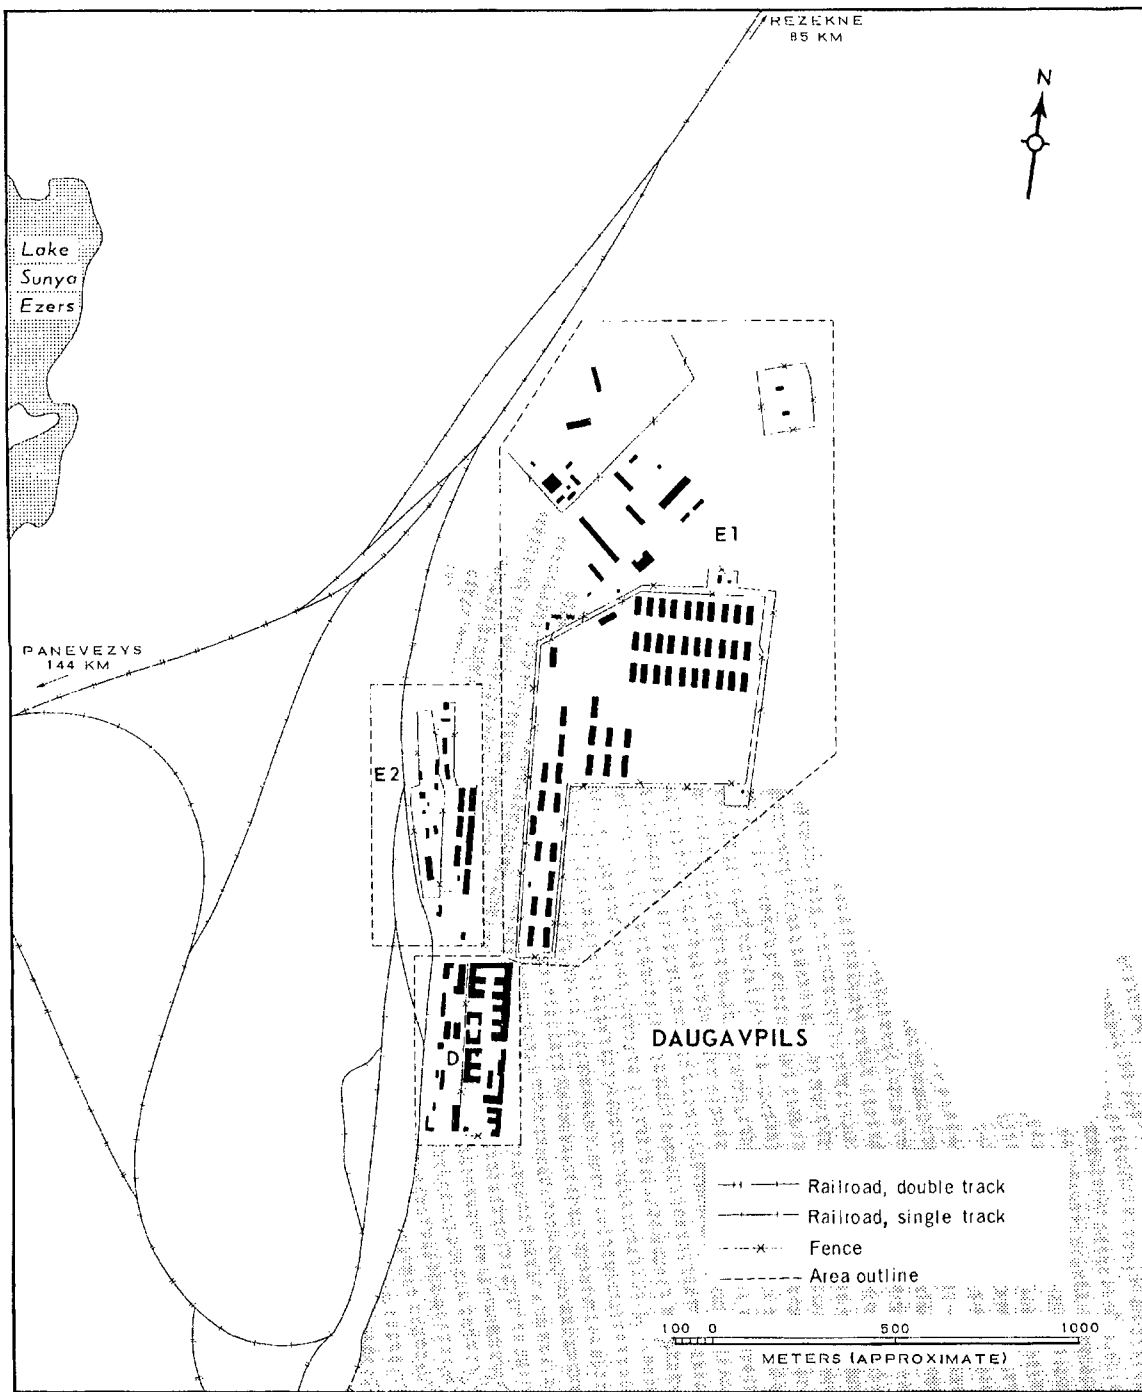
FIGURE 3. STORAGE AREA. Sketch compiled from [] June 1964.

Area D contains one administration build-

ing, 9 multistory barracks, 7 storage buildings, and 3 support buildings.

Area E1 contains 5 multistory administration buildings, 66 storage buildings, and 12 support buildings.

Area E2 contains one administration building, 17 storage buildings, and 4 support buildings.
