## FINAL REPORT

REPORT NO. 5490  
August 20, 1959

FINAL REPORT  
for  
AERIAL EQUIPMENT PROGRAM  
under  
SC 21-54

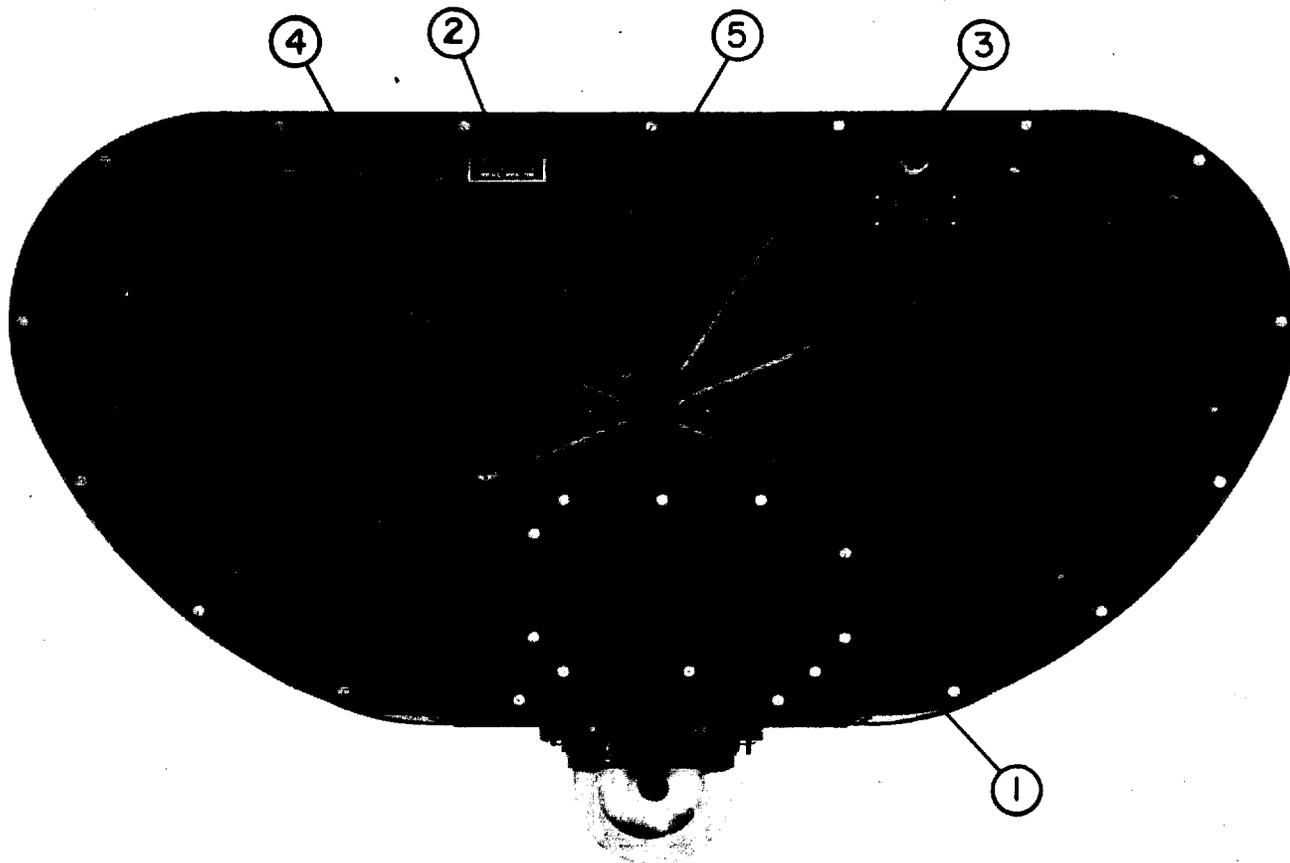
Figure I. Mark IA Tracking Camera, Showing Forward Cover

| 1. Access Cover for Change Gears | 4. Dry Gas Supply Hose Connection |
| 2. Desiccator | 5. Vacuum Pump Hose Connection |
| 3. Receptacle | |

The resulting panoramic camera, often referred to as the Data Camera or Tracking Camera, proved to be a very useful and important instrument. The unit employed scanning principles to obtain successive 180° panoramic photographs and had the capability of a 60% stereo overlap. It was fully automatic in operation and had a film capacity large enough to provide horizon-to-horizon photographic coverage for a complete mission. Completely self contained and requiring only a 28-volt dc power source, it weighed less than 53 pounds fully loaded. No special accessories were needed; image motion compensators, intervalometers, aperture controls and other devices necessary to obtain sharp, clear images were built into the instrument. The entire field was scanned through a small 5-inch diameter dome. The resulting photograph, on 70mm film, had a 2.47 by 9.425-inch format. Data presentation which appeared on each frame consisted of a level and time indicator.

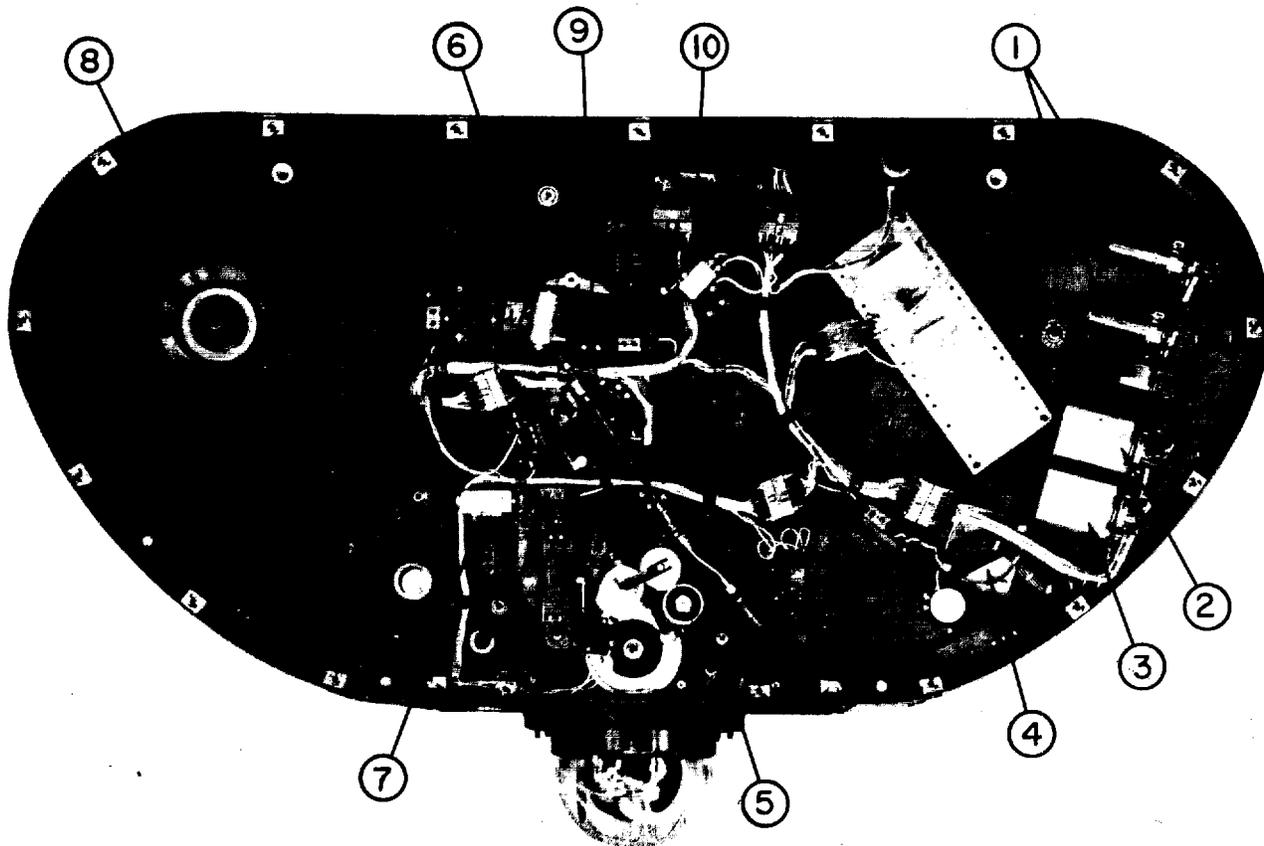
Figure II. View of Camera Showing Electrical and Mechanical Components

| 1. Thermal Relay (H802, H803) | 6. Metering Solenoid (L804) |
| 2. Relay (K811) | 7. Scan Solenoid |
| 3. Relay (K810) | 8. Take-up Clutch |
| 4. Latching Relay (K812) | 9. Drive Shaft for Programmer Mechanism |
| 5. Aperture Programmer Gear Assembly | 10. Metering Cam Switch (S806) |

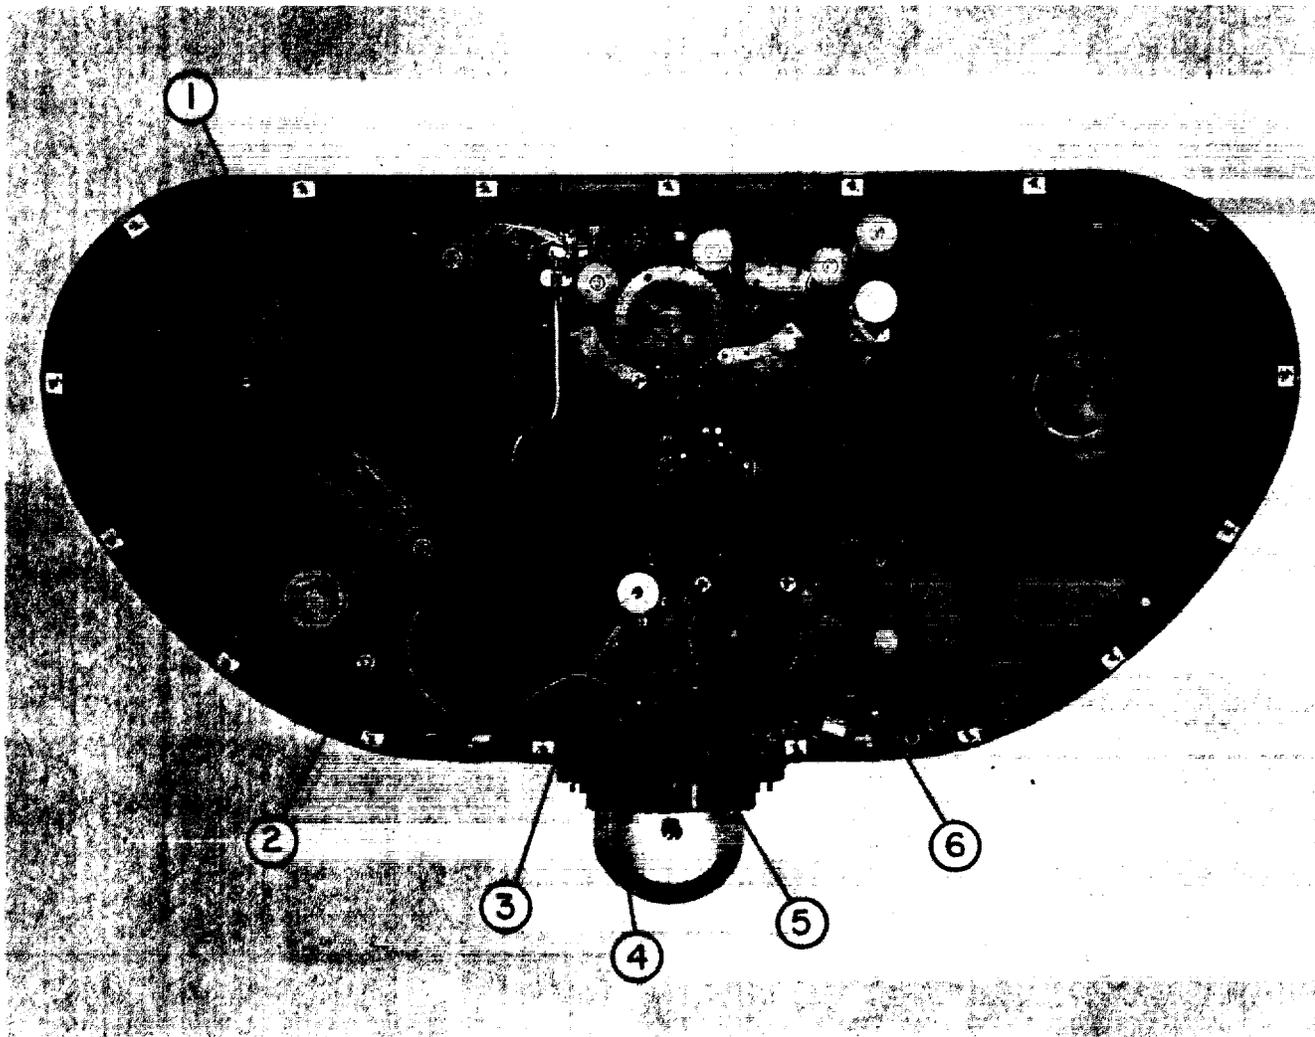
Figure III Film Compartment of Camera With Film and Spools Removed

1. Brake Tension Adjustment

2. Clock Dimmer (R830)

3. Aperture Cam

4. Retracting Lever

5. Filter Selector

6. Sprocket Gate

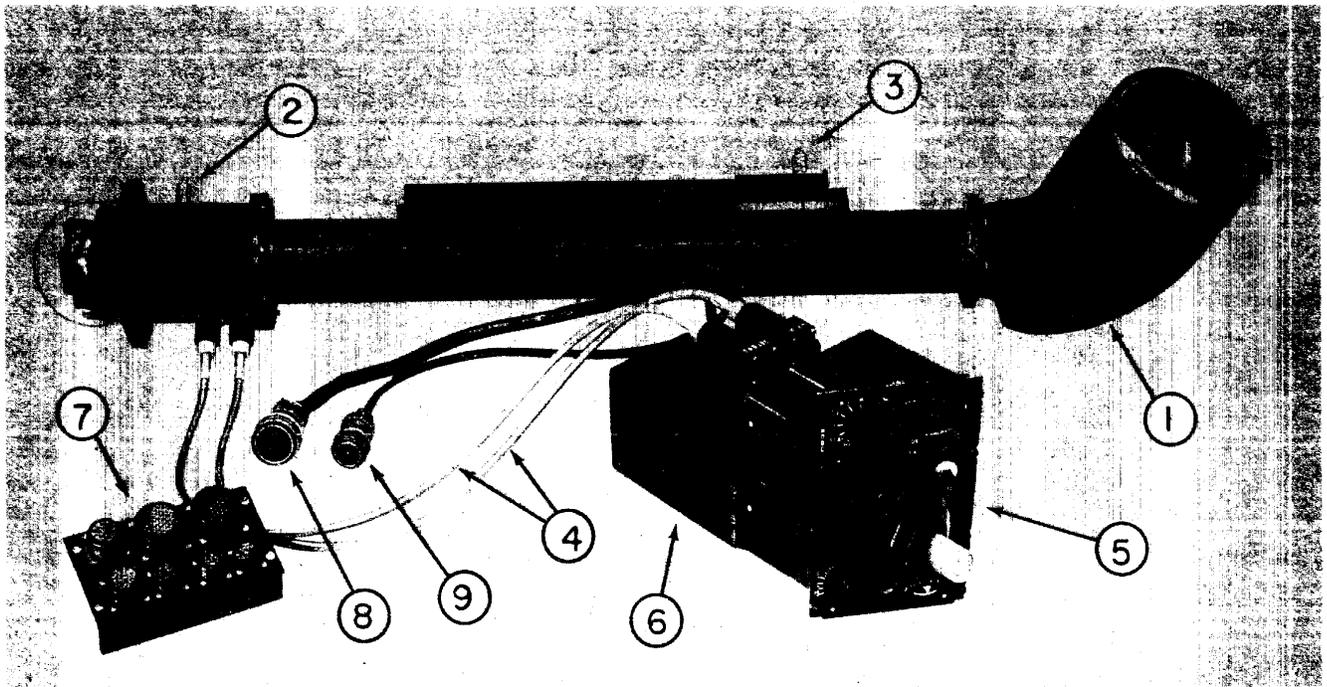
Figure VI. Periscope, Hand Control and Junction Box

| 1. Scanning Periscope (Driftsight) | 4. Flexible Shafts | 7. Junction Box |
| 2. Desiccation Fitting | 5. Hand Control | 8. Hand Control Cable |
| 3. Desiccation Fitting | 6. Memory Unit | 9. Memory Unit Cable |

The need for a viewing device was readily solved by developing a suitable scanning periscope. The need for a control unit, however, proved more of a problem. Due to the difference in complexity of the control functions (the C configuration required a more complex control than the A or B configurations) the original plan was to provide two different hand control units. The first hand control, which would be employed with either the A or B configurations, was to be a relatively simple device. Basically it would permit a selection of the various modes of operation of these configurations, as well as direct the line of sight of a periscope type viewing device.

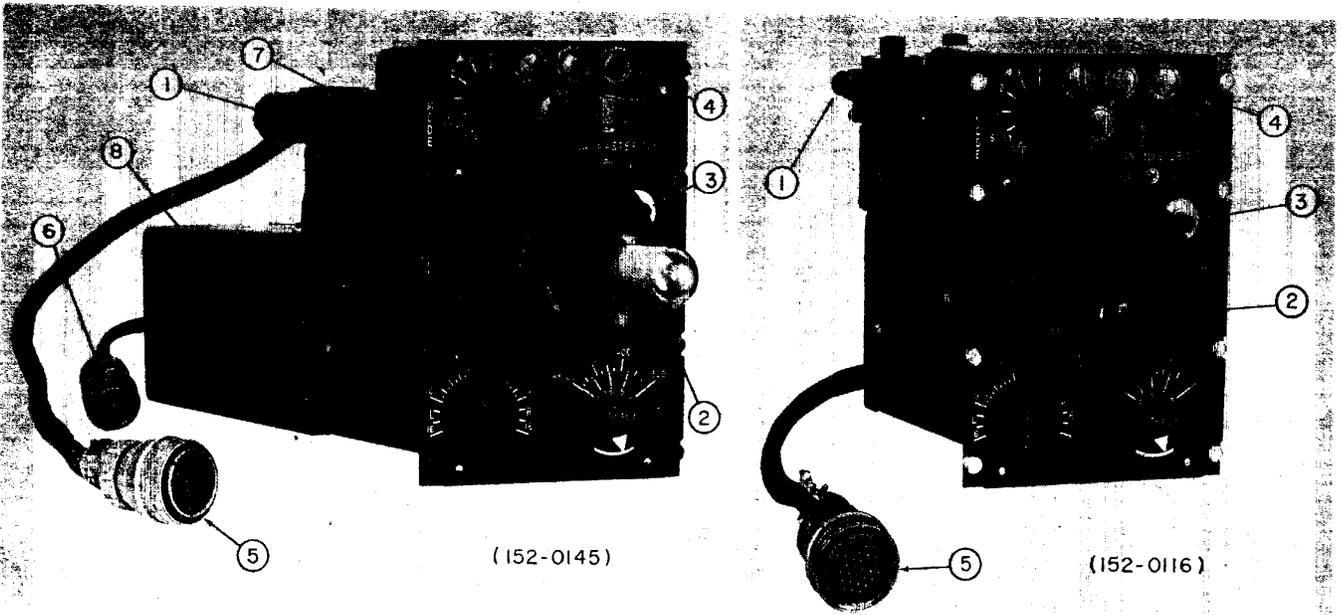
Figure VII. Hand Control

| 1. Periscope Cable Adapters | 4. Press-To-Test Lamps | 7. A + E Boresighting Clutch |
| 2. Control Handle | 5. Hand Control Connector | 8. Memory Unit |
| 3. Store Button | 6. Memory Unit Connector | |

information to and partially controlled the equipment configurations, as indicated earlier. It was a panel mounted tracking control consisting primarily of a number of gear drive mechanisms and electrical components. It was equipped with both a master ON-OFF switch for energizing related equipment in the over-all system and an OFF-STANDBY-MODE selector switch for turning the automatic tracking feature off, placing it on standby, or selecting any one of three modes of operation. A control handle on the unit provided direct azimuth and elevation control of the periscope line of sight, and a switch permitted changing power (magnification) of the periscope by electrical drive. Adjustments for V/H and for correction of drift were included, as well as a storage switch for energizing the Memory Unit when attached. Finally, several test lamps for fault-proof checking of related equipment were incorporated in the device.

The problem areas which arose were somewhat representative of those encountered in other hardware areas by prime and sub-contractors alike. The design of the Hand Control, for example, was handled by Perkin-Elmer and the manufacturing sub-contracted to H. O. Boehme Company. Scheduling permitted only limited testing and, in general, functional operation was good. When placed in the final operational environment, however, several problem areas arose. High cable friction in the connecting cables between Driftsight and Hand Control resulted from the unusually cold environment, and it was necessary to reroute the connecting cables and substitute more suitable (dry molykote impregnated) cables for the final operation environment. Failures of the protective rubber boot became frequent due to sensitivity of the rubber to the ozone environment. During retrofit program the boots were replaced with specially dipped neoprene ones.

lacked adequate means for accurate boresighting due to the lack of knowledge during the design stage of the difficulties of access to the equipment when installed in the vehicle. A subsequent retrofit program made it possible to incorporate a cone-clutch coupling for accurate, convenient, boresighting of those Hand Controls to be used with the C configuration.

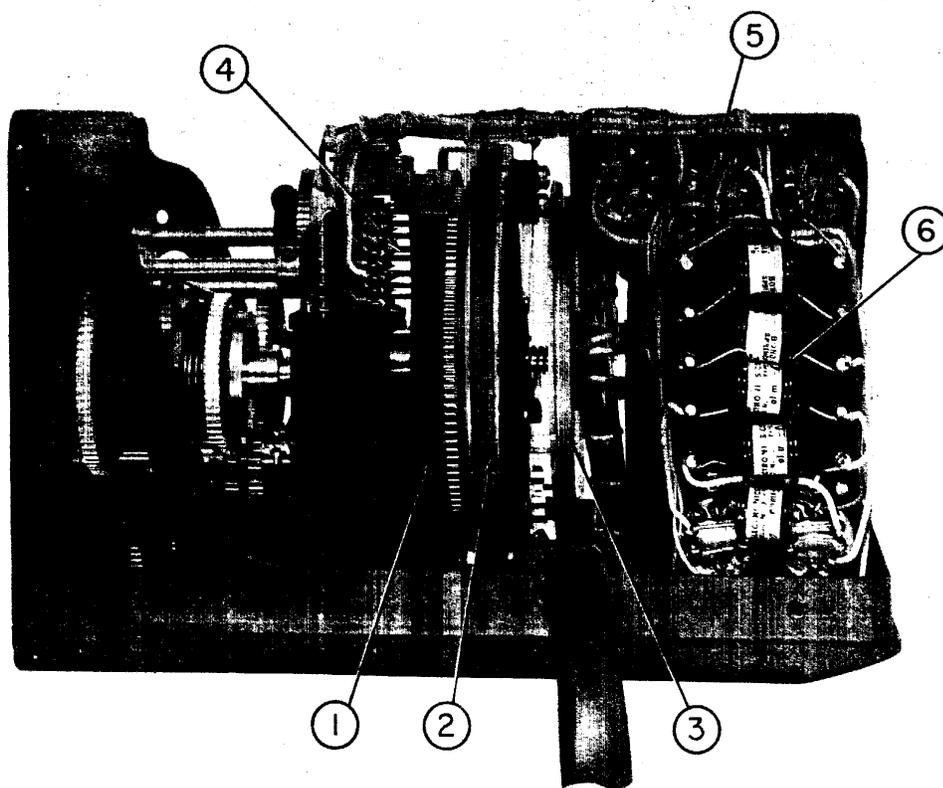
**FIG. VIII.** Memory-Computer Unit, Covers Removed

| 1. Pin Disc | 4. Code Read-out contacts |
| 2. Punch disc | 5. Relays |
| 3. Code disc | 6. Resistors |

The memory-computer unit was mounted directly below the Hand Control from which it received directional information. It was a coding device combining both computing and storage functions in a single unit. It employed the synoptic coding principle, converting information from shaft rotations to pin positions. It was able to store and read-out information with

an accuracy of about plus or minus .25% of full scale.

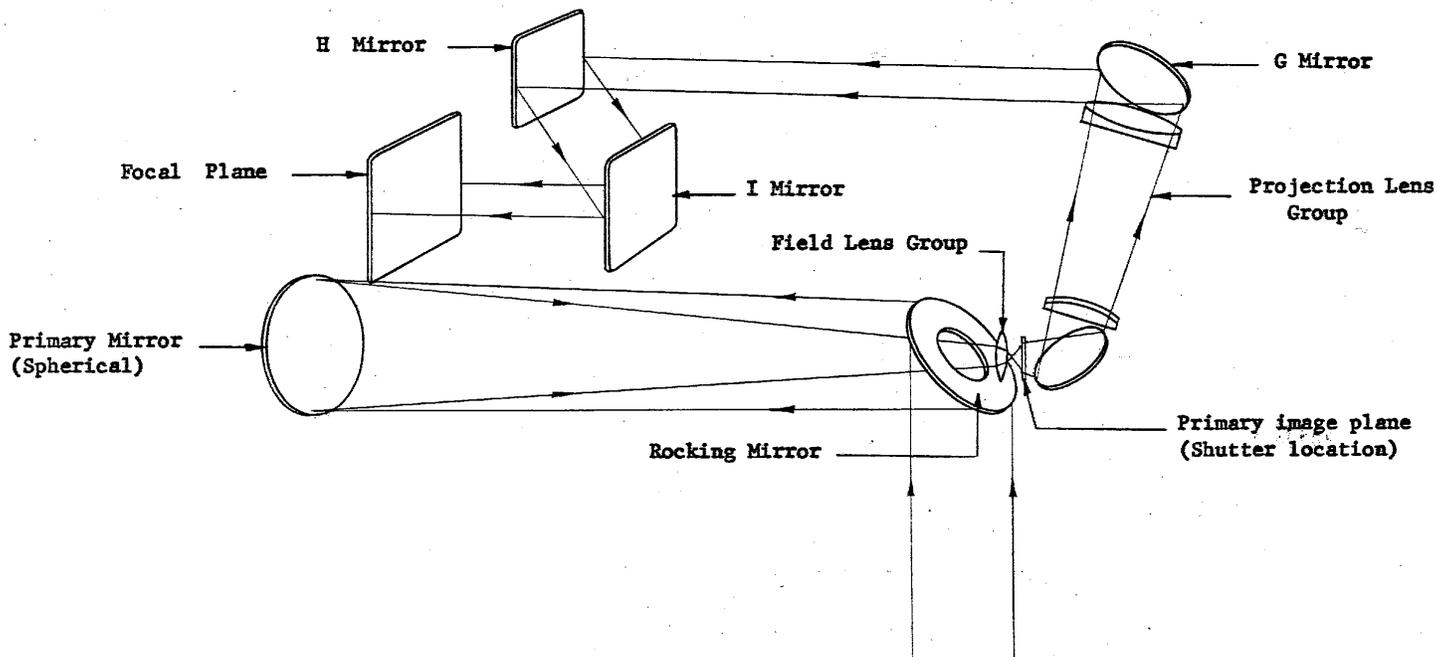
FIGURE XII

C SYSTEM

During the first year of work on the "C" Configuration, the original configuration changed several times. Originally it was planned as a 200-inch re-imaging system with 18 x 18 inch format. It became evident that because of space limitations this focal length was impractical, and was changed to a 144-inch focal length system. Optical considerations dictated the next change, to a 120-inch re-imaging system. The final dimensions of 180-inch focal length, and 13 x 13 inch format were based on the primary need for maximum focal length. A "SKEW-Z" optical configuration was decided upon in order to make maximum use of the available space.

As originally planned, the configuration was designed with three modes of operation. In mode 1, the spotting mode, objects of interest could be selected by the operator of the periscope. This selection could be
