25X1	Approved For Release 2004/03/26 : CIA-RDP78B04560A002900010045-8
- [Approved For Release 2004/03/26 : CIA-RDP / 880456 0A002900010045-8
_	
	PHOTOGRAPHIC INTERPRETATION REPORT
and .	
	POSSIBLE AMM-ASSOCIATED ACTIVITY
	AND OTHER INSTALLATIONS,
_	MOSCOW AREA, USSR,
_	
	25X1D
_	
	NPIC/R-918/64
	November 1964
_	
	NATIONAL PHOTOGRAPHIC INTERPRETATION CENTER
_

25X1	Approved For Release 2004/03 /26 : CIA RDP78B04560 A002900010045-8	25X1
~	NPIC/K-918/04	25X1
	INTRODUCTION	
 	This report describes changes and additions at the following installations, as requested by CIA requirement C-RR4-81,664: Moscow SAM Sites E05-1, E15-1, E24-1, and E33-1, the Naro-Fominsk Suspect Phased-Array Radar Site, the unidentified installation at 55-21N 33-38E, and the Kirzhach Area Suspect Space-	25X1

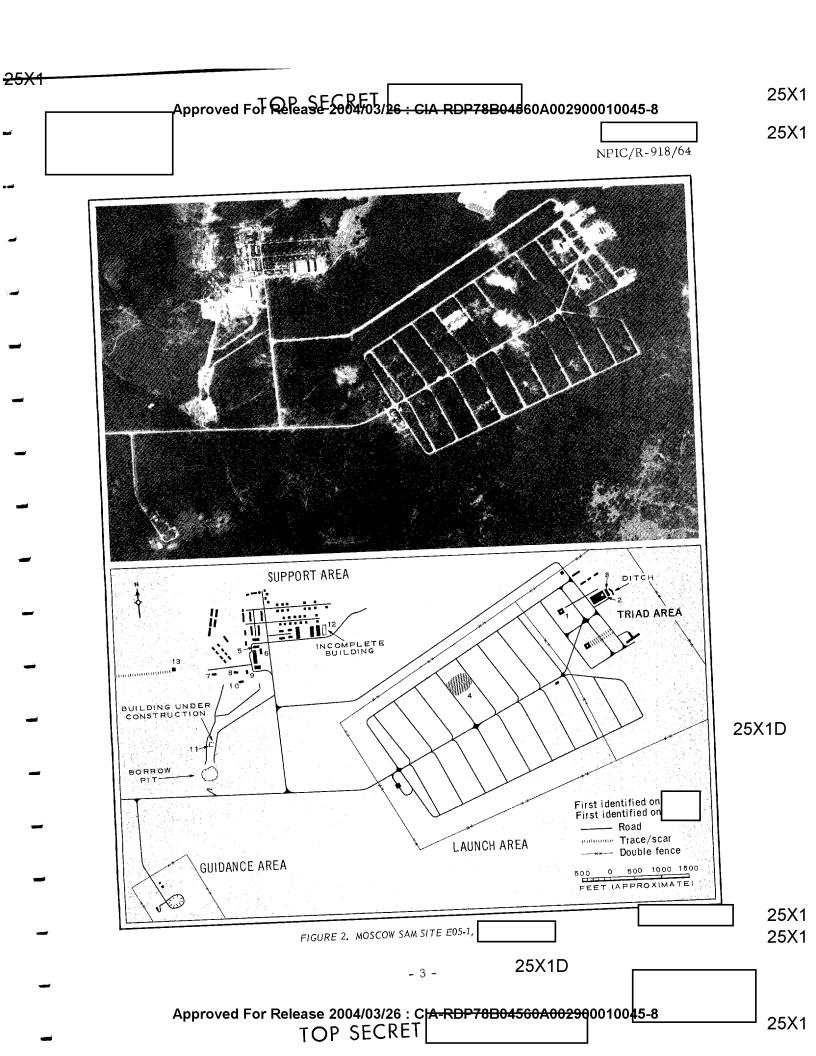
-	25X1D MOSCOW SAM SITE E05-1 25X1D	
	This site (Figure 2) is located at 56-14-34N 38-35-05E, approximately 44 nautical miles (nm) northeast of Moscow. The last detailed NPIC report dealing with the site 1/ was based on photography of	
25X1	service road.	25X1D
	LAUNCH AREA A cleared area of approximately 33,000	25X1D
25X1D	Construction in the triad area continues, with exterior changes observed at 2 of the wildings In the roof of the small the roof of the small	25X1D
25 X 1 25X1D	northwest building (Figure 2, item 1) appeared incomplete, but by	25X1D
25X1D -	triad building is an elevated platform 40 feet square (item 2), similar to that observed in on the large triad identified in the support area on the photography: Description on the large triad identified in the support area on the photography:

-	lel to the northeast end of the building is an unidentified building, 140 by 55 feet (item 3), resembling the buildings similarly positioned at Sites E15-1, E24-1, and E33-1. The building at E05-1 was first observed on the coverage Building 140 by 05 feet, probably gable roofed (item 5) Building 140 by 05 feet, probably gable roofed (item 6) Possible batch plant 105 by 40 feet (item 7)	
_	25X1D - 1 -	25X1
_	Approved For Release 2004/03/26 : CIA-RDP78B04560A0029 0001 0045-8	25X1

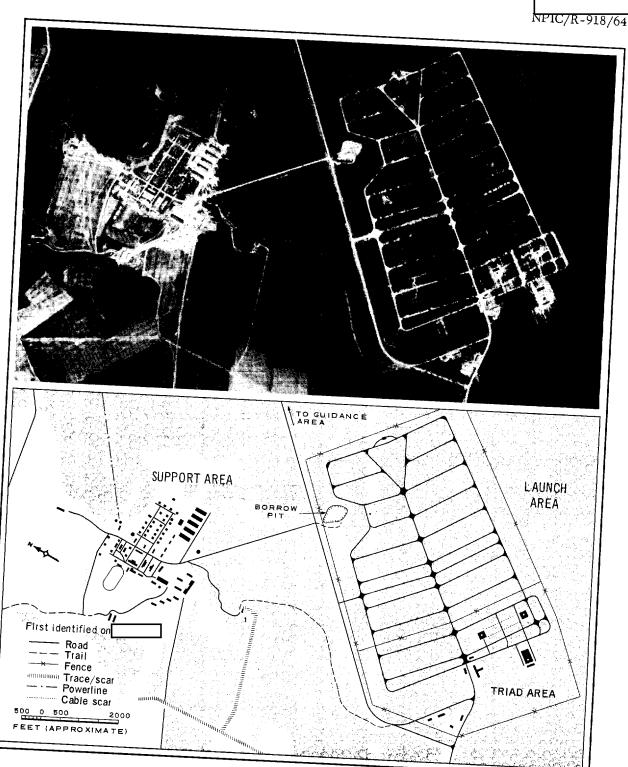
FIGURE 4. MOSCOW SAM SITE E24-1,

- Table large	46,675 square feet (item 2) along the fifth feet south of	side of the
± .	46,675 square feet (item 2) along the fifth feet south of the support area	nately 1,300 in a field
051/4		in a field.
25X1		25X1D
1	MOSCOW SAM SITE E24-1	
1	Site F24 1 (P)	25X1D
	Site E24-1 (Figure 4) is located at 55-21-04N Moscow. The last details INDER	
	approximately 45 nm southwart of	ort dealing
, ì	Except for NFIC/R-836/64 (Sep 64), which touched on it briefly.	
W (repairs)	. Since the	ien, 2 mis-
1		
Î	- 4 - 25X1D

25X1	TOP SECRET	s : CIA-RDP78B04560A002900010045-8	25X1
	Approved For Release 2004/03/26	:: CIA-RDP78B04560A002900010045-8	
		NPIC/R-918/64	25X1
	 25X1D	NPIC/R-910/04	25X1D
	TRIAD AREA No extensive exterior changes have been observed in the triad area between and the coverage. Construction activity is still noted throughout the area. LAUNCH AREA No changes have been observed in the launch area between coverage. GUIDANCE AREA No changes have been observed in the	SUPPORT AREA Two traces or ground scars, portrayed as roads in previous reports, have been identified on the west side of the site on the late photography. One approaches the site from the south, crosses the site service road, and extends northward. The other branches off it, extends east, and terminates at an unidentified structure measuring approximately 30 by 10 feet (Figure 4, item 1). Both traces/scars were present as early as	25X1D

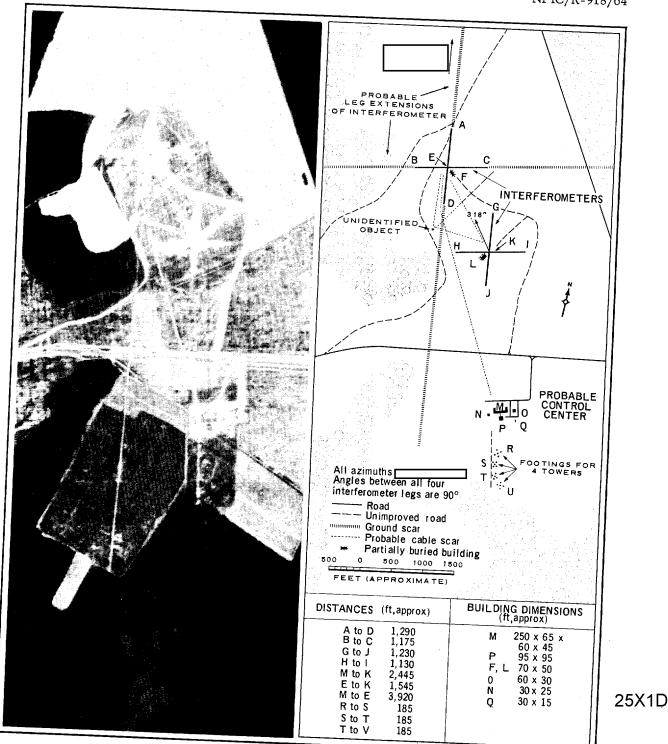
FIGURE 11. INTERFEROMETER SITE, SUSPECT SPACE-TRACKING FACILITY.

the facility 6/ was based on photography through The following information has been derived from Missions	This site (56-04-00N 38-30-25E), which apparently is unsecured, consists of twin, adjacent interferometers and a probable control center (Figure 11).
	SUSPECT INTERFEROMETER SITE	The interferometers are of the standard
	The suspect interferometer site (56-05-05N	Soviet type, such as are deployed singly at the Tyuratam and Kapustin Yar/Vladimirovka Missile Test Centers and at other locations through-
	mately 8,785 by 5,730 feet (approximately 1,156 acres) containing numerous control-type buildings and a network of probable cable scars (Fig.	out the USSR. The clearings for the basefiles, which bisect each other at right angles, are from 1.130 to 1.290 feet long. An apparent modi-
	ure 10). Scars 6,875 feet long form 2 overlapping plus configurations that suggest interferometers with exceptionally long baselines. A building 70 by 55 feet with a possible antenna on the roof is	fication consists of ground scars which form probable leg extensions at the northwest interferometer. Near the bisection point of each interferometer is a partially buried control
