# ACCIDENT FOLDER

<b>USAF ACCIDENT/INCIDENT REPORT</b>							
(Fill in all spaces applicable. If additional space is needed, use additional sheet(s).)							
1. DATE OF OCCURRENCE (Year, month and day)  9 July 1964		2. VEHICLE(S)/MATERIEL INVOLVED (TMS & Serial Nr., if applicable)  A-12			3. FOR GROUND ACCIDENTS ONLY (Base Code and Report Serial Nr.)  N/A

Investigation of major accident involving A-12 aircraft S/N 133 which occurred at Det 1, 1129th USAF SAS, Las Vegas, Nevada on 9 July 1964.

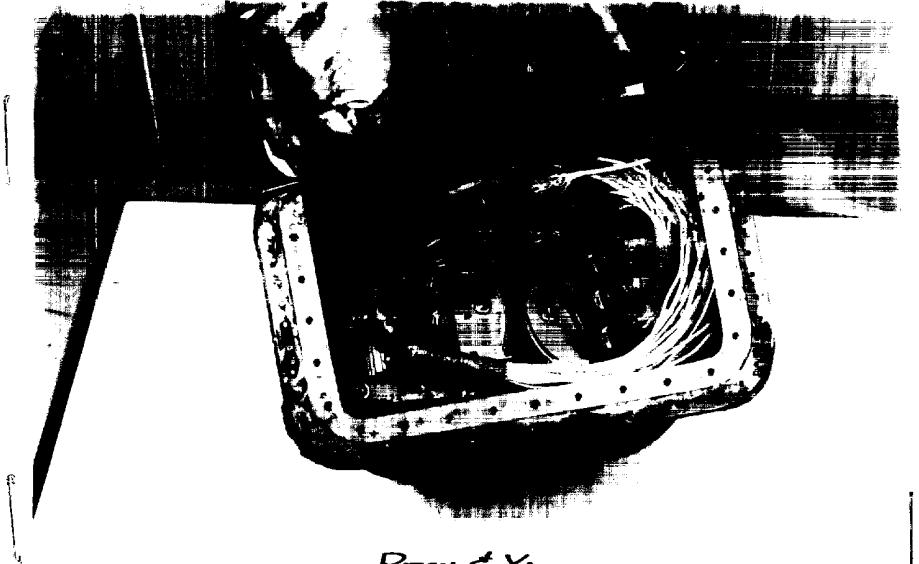
4735

*PITCH & YAW  
RATE GYRO  
PACKAGES*
